# CONSERVATION MANAGEMENT PLAN

## ST MARTIN'S FORMER ANGLICAN CHURCH

22 Rockley Street Perthville, NSW 2795

Date: 21 June 2020

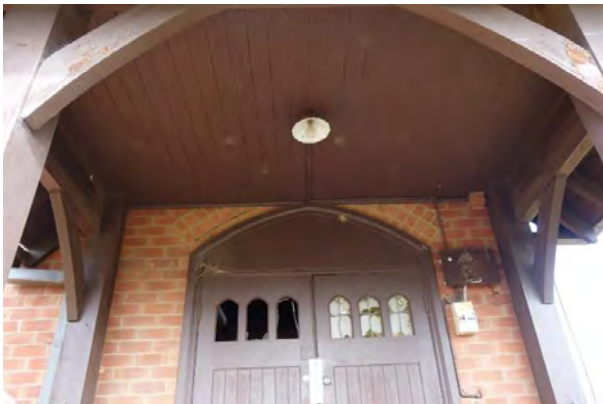
Figure 7 front porch detail. B Hickson June 2020

Entrance doors are double leaf, timber framed with leadlight highlights and panelled timber boards below. The two single doors are similarly timber framed and panelled. The doors are stained and clear finished internally but were later painted 'mission brown' externally. This paint is failing.

**Repairs:** If used for disabled access the front door would need replacement in a similar timber framed and panelled door. The existing timber may be able to be reused. However, as the highlight leadlight has been destroyed, the doors could be rebuilt with plain upper security glass. The leaves would need to be of different widths; one leaf should allow the 850mm clearance required.

All doors need repainting and should be returned to the original stain with clear finish.

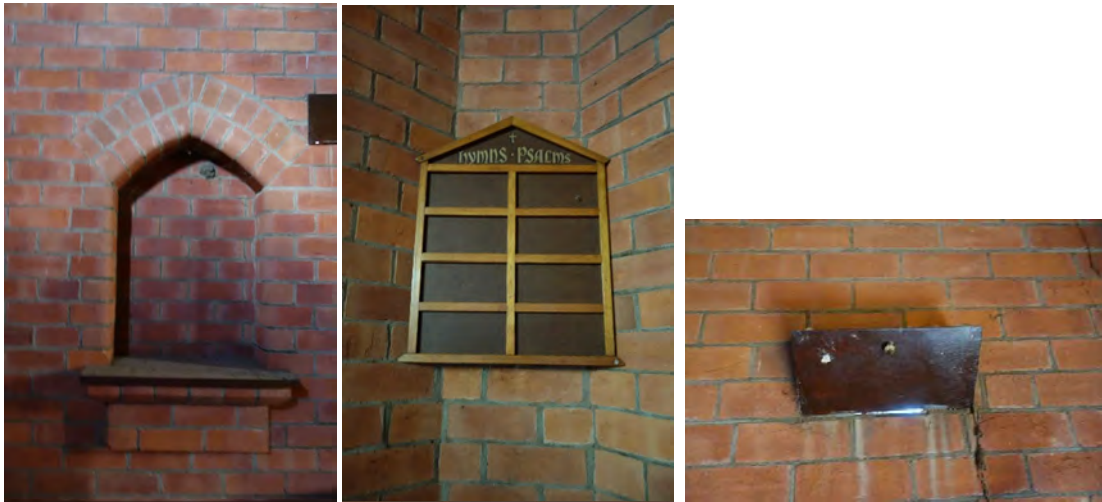
FIGURE 8 THE AUMBRY, THE HYMN BOARD AND A WALL VENT

**Repairs:** Adjust the metal vents for easy operation.

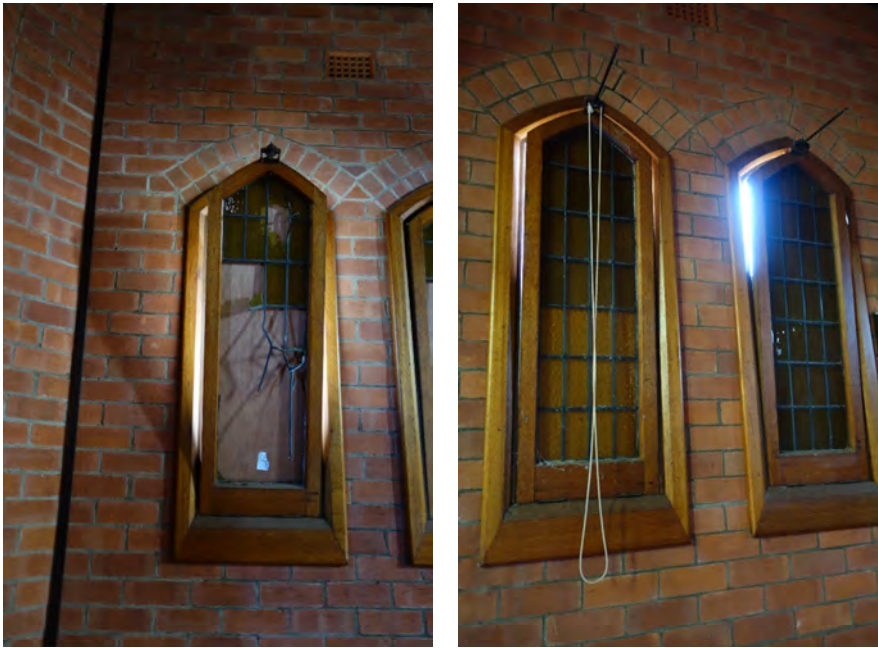
All glazing was originally small rectangular panes of gold coloured cathedral glass in lead and timber frames. Two windows were later replaced with salvaged lead light windows as noted below and, in this case, the frames of the sashes have been removed with the Lead light glass. Much of the decorative cathedral glass is still present but a large amount is broken and severely vandalised. Some

have no glass left. Many window openings are covered with plywood. Only the windows in the former Vestry and two in the Nave are in fair condition.

FIGURE 9 NAVE WINDOWS ABOVE- ONE S-W SIDE BROKEN, AND TWO N-E SIDE IN GOOD CONDITION

**Repairs:** Window pull chords need replacement and pulleys need to be investigated and repaired if possible.

When windows are repaired, there is an opportunity to change the fabric and so they could be reglazed as per original leadlight or reglazed in clear glass, so that natural light is available to the interior of the building.

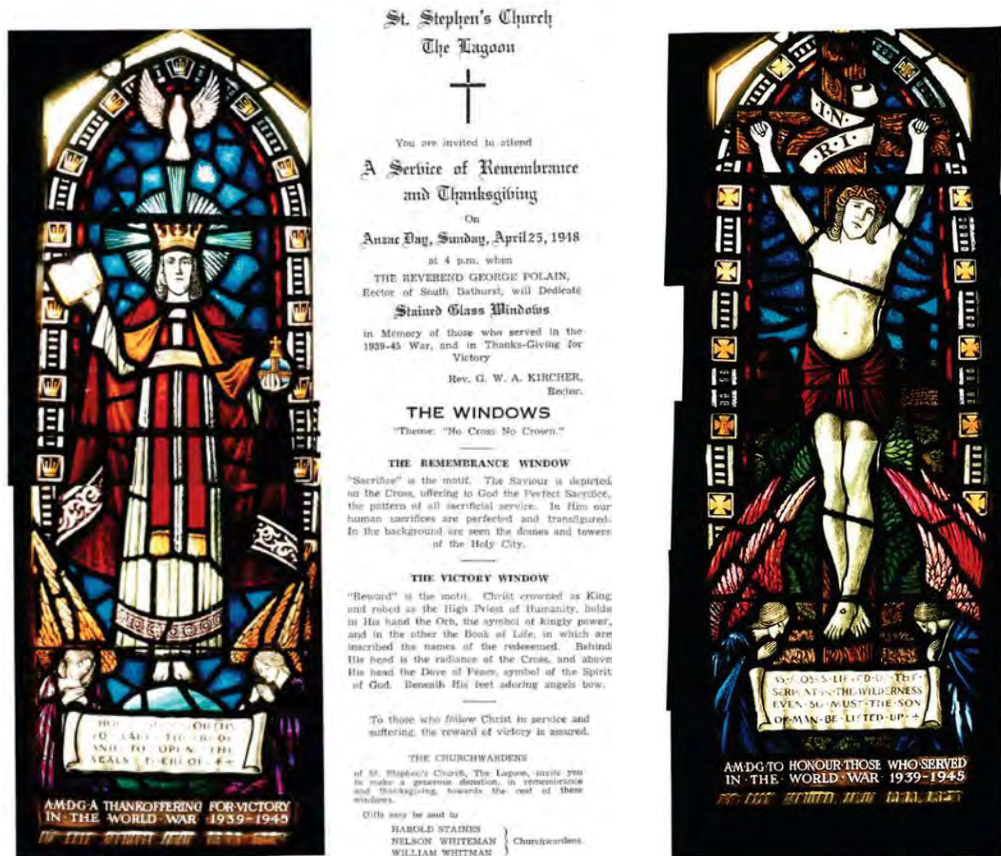
FIGURE 10 THE TWO WINDOWS, THE 'THANKS OFFERING FOR VICTORY' AND 'TO HONOUR THOSE WHO SERVED'. THE WINDOWS WERE ORIGINALLY MADE FOR THE LAGOON CHURCH AND DEDICATED IN 1948, THEN LATER INSTALLED IN ST MARTIN'S C. 1999.

**Repairs:** Clean and reinstall the leadlight windows as directed in window frame or as interpretation device in the Baptistry.

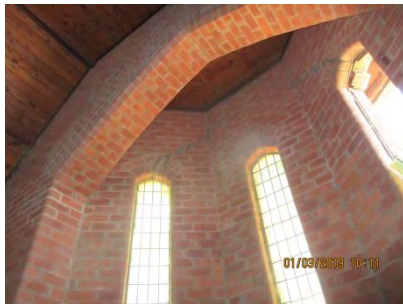
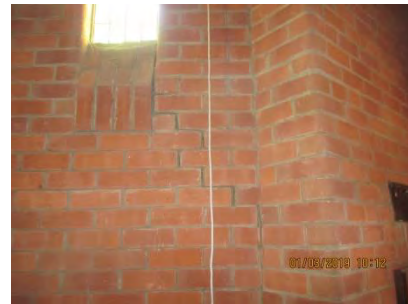
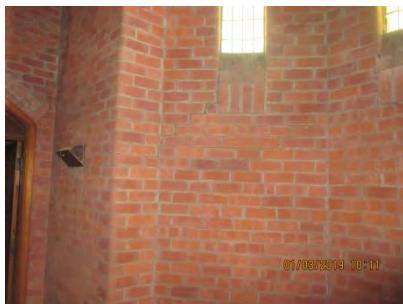
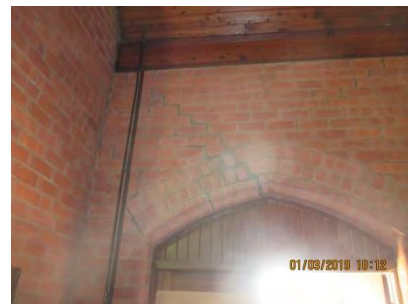
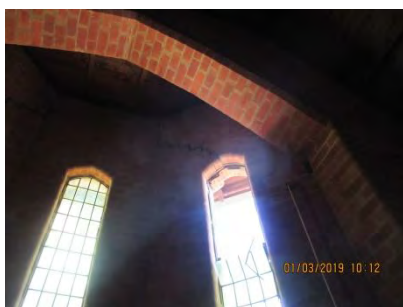
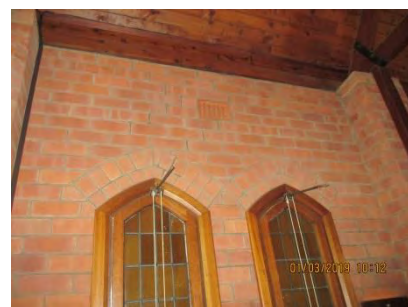
The internal inspection revealed Category 3 damage (range 0-4) throughout the dwelling in accordance with AS2870 Appendix C-Table C1 (vertical and stepwise cracks 5-15mm in width).

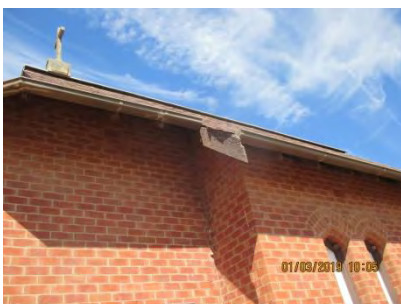
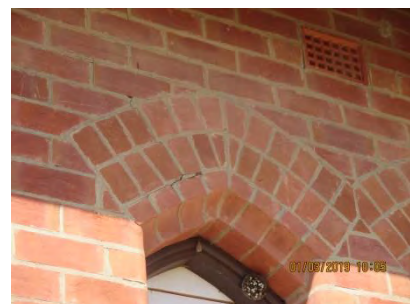
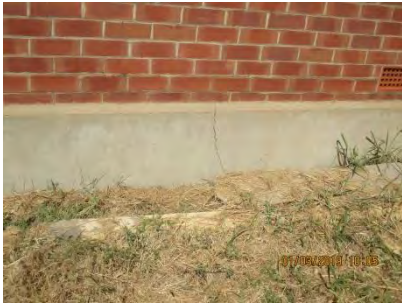
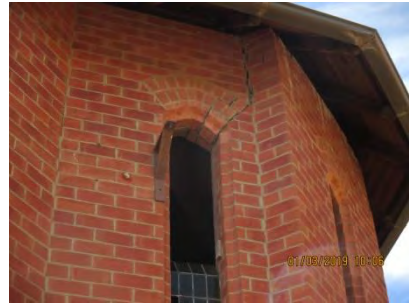
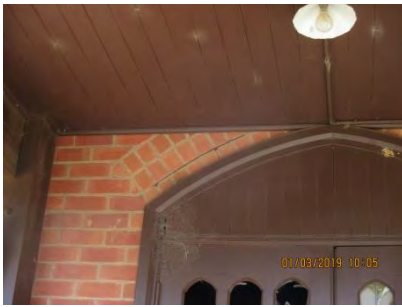
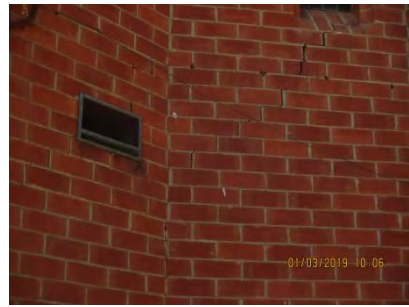
The external inspection revealed some crack damage to the external masonry, up to Category 4 damage (range 0-4) in accordance with AS2870 Appendix C-Table C1 (vertical and stepwise cracks 15-20mm in width).
