URBAN WATERWAYS ASSESSMENT

UPDATE

FOR BATHURST REGIONAL COUNCIL

August 2014

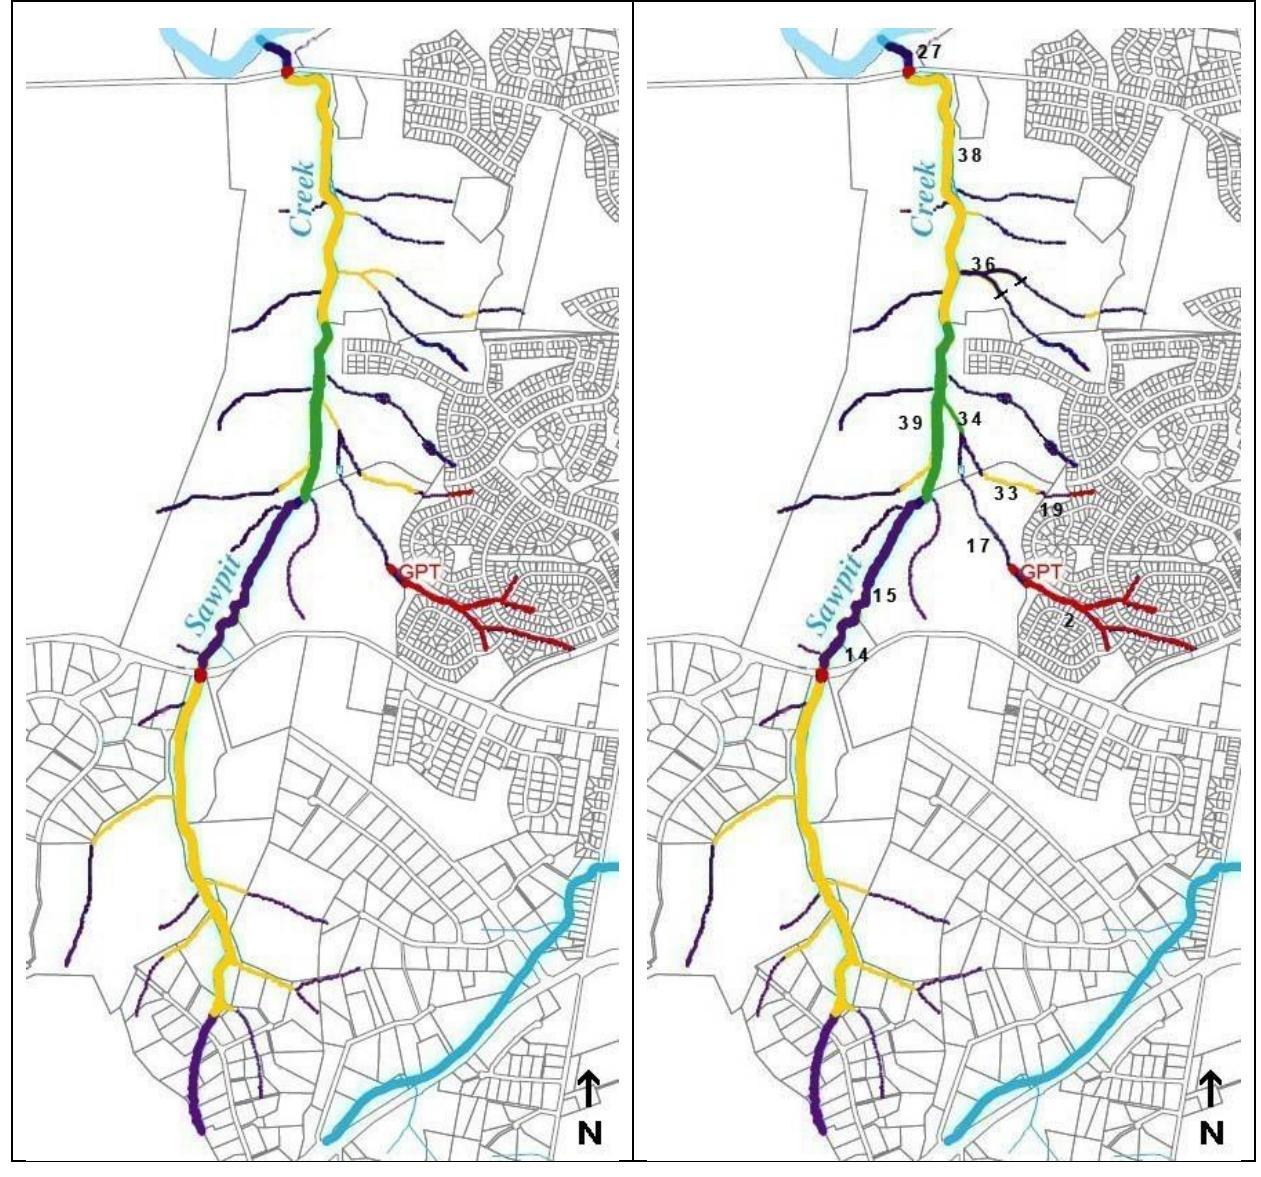
Figure 1: Sawpit Creek condition assessment comparison between the 2009 (LHS) and selected 2014 sites (RHS). Highly degraded (red), degraded (purple), poor (yellow), good (green) and very good (turquoise).

The overall condition rating for Sawpit Creek has remained mostly unchanged since the previous assessment period; however some sites showed subtle trends either towards an improved or degraded state. These trend trajectories were often not significant enough across attributes or indicators to affect a change in overall condition rating. Degradation is mostly due to stock grazing on private land (S17, S33, S36 and S38), localised erosion and nutrient loading (across most sites) and weed invasion (e.g. S14 and S27); whereas the improvements have resulted from management initiatives such as stock exclusion (S15, S34 and S39), riparian zone replanting (S39), weed management (S27) and the installation of instream erosion control structures (S15).

The recent plantings in the stream section engineered with a low-flow pipe (S2) contribute little, if anything, towards the Sawpit Creek aquatic ecosystem due to its disconnection to an open channel. However, when the plantings mature and being to self-regenerate they are likely to provide important visual amenity, habitat connectivity and biodiversity benefits in the area.

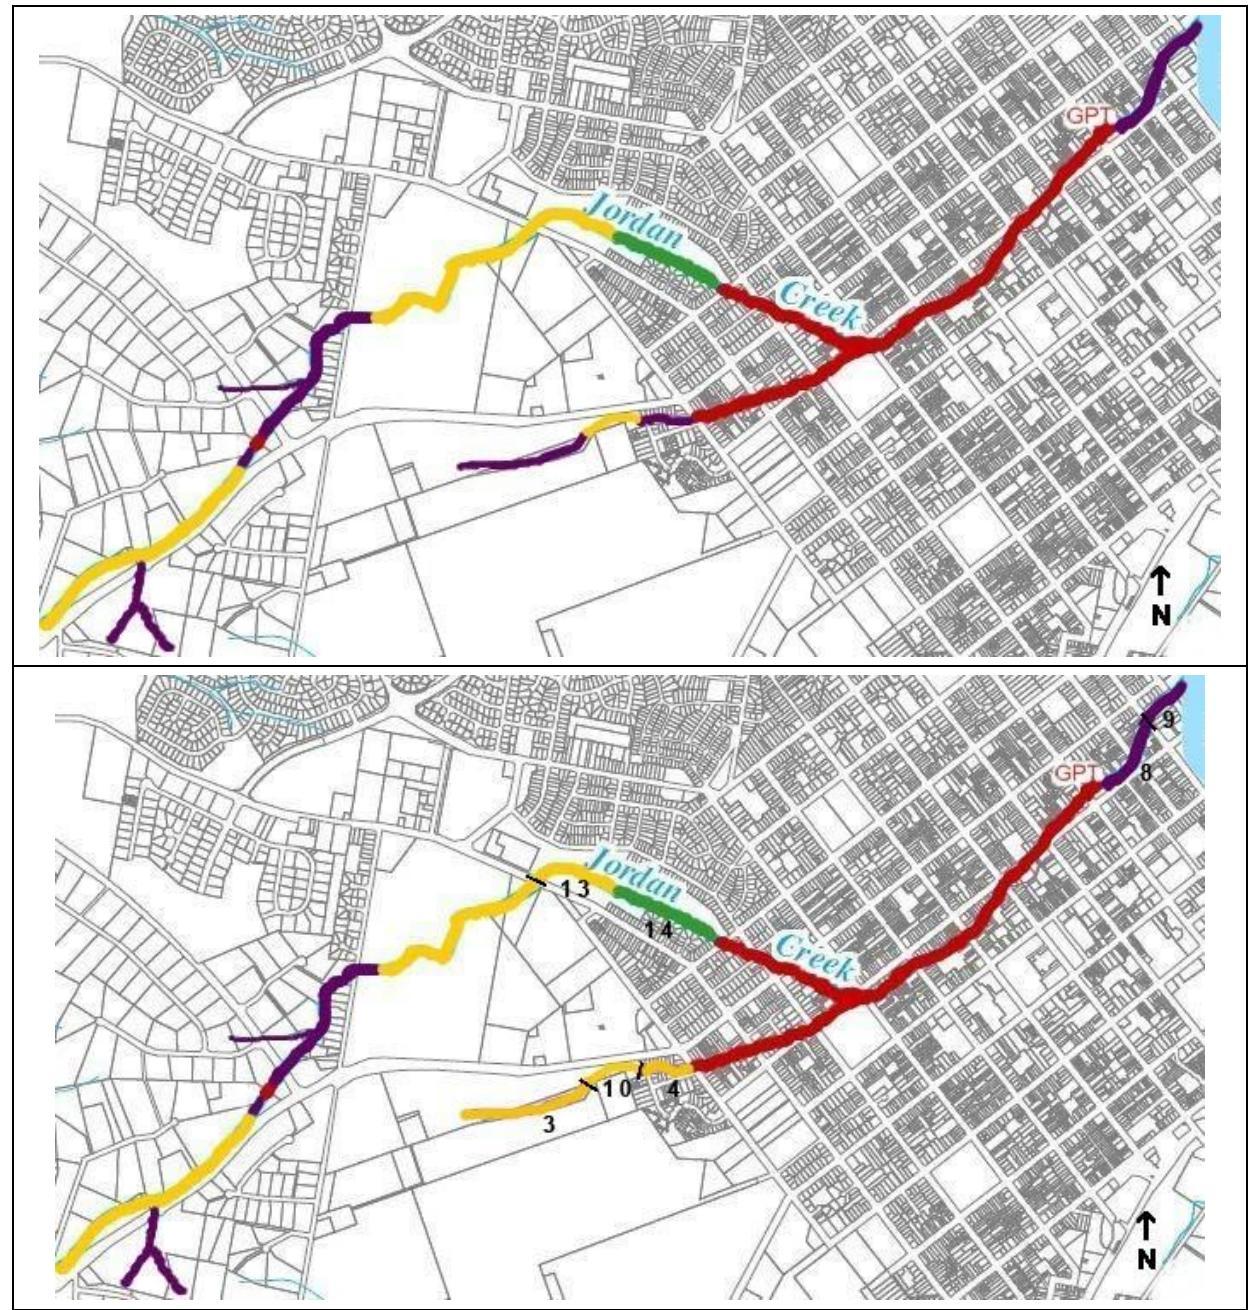
Figure 2: Jordan Creek condition assessment comparison between the 2009 (top) and selected 2014 sites (bottom). Highly degraded (red), degraded (purple), poor (yellow), good (green) and very good (turquoise).

Jordan Creek restoration works have delivered a change in condition since the previous assessment where exotic trees and shrubs have been cleared (J3 and J4). The structure of the Box-Gum Woodland in the upper reaches of Blayney Road Common has improved and the increase in the available light to the stream channel in the Browning Street Reserve has allowed for instream vegetation to grow and regenerate, while enhancing its value for habitat and channel erosion control. Restoration works involving the staged processes of clearing, replanting, engineered channel stabilisation structures and weed management are contributing to the improved condition of Jordan Creek where these practices occur. Where these practices are absent (e.g. J8 and J9) the trend towards ecological and geomorphological degradation is continuing.

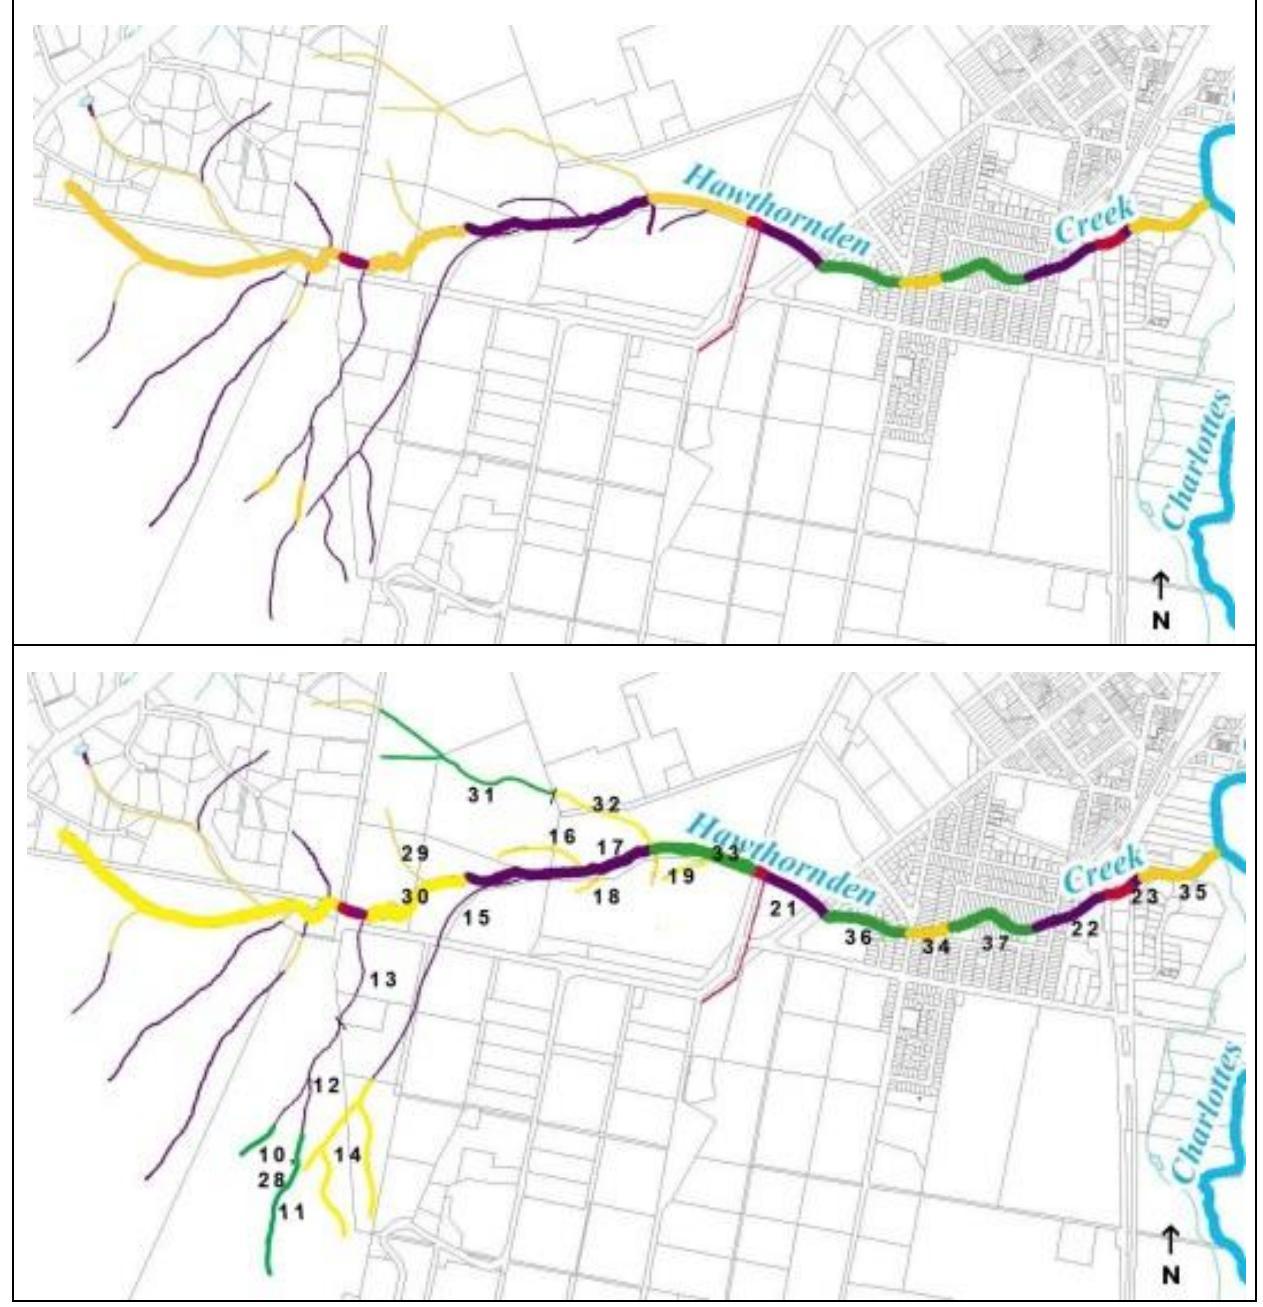
Figure 3: Hawthornden Creek condition assessment comparison between the 2009 (top) and selected 2014 sites (bottom). Highly degraded (red), degraded (purple), poor (yellow), good (green) and very good (turquoise).

Hawthornden Creek is diverse in respect to its morphology along its length, current management regime, restoration practices and condition trends. However, there are some generalised trends that can be drawn from the assessments that reflect management decisions and ecosystem processes. First, in areas excluded from stock since the previous assessment (H10, H11, H14, H18, H19 and H28) the condition rating of the waterways has improved¹, most notably because of the increased groundcover, improved channel stability and regeneration of native species. In some areas where stock is excluded the impacts of grazing kangaroos is reducing the cover of vegetation. As yet this is not critically affecting waterways resilience or condition.

A positive change in condition was also observed in H33 (upstream of Panorama Avenue) where the willow-dominated site was cleared. The extant Eucalypt fringing woodland is slowly regenerating and in concert with the now dense cover of groundcover vegetation provides valuable riparian habitat resources and channel stability.

Significant geomorphic changes were observed in Hawthornden Creek where Schauberger Sills and other instream erosion control structures have been installed as part of 'Stage 1' works along the main creek channel (H17, H30) and at the confluence with a tributary stream (H15). The trend is towards channel aggradation, increased cover of bed and bank groundcover vegetation and improved channel stability. While these trends are significant the depth of gullying in the main trunk limits the site to any geomorphic condition rating increase. 'Stage 2' erosion control structures have more recently been installed at the confluence with tributary streams (H19 and H32) and along the main creek trunk in the downstream section of H17 and upstream section of H33. It appears there has not been enough time lapsed from installation to assessment for these latter structures to retain significant amounts of sediment.

Compared to sites where willows were removed the retention of these species in the creek below TAFE (H21) has not affected a change in stream condition. The site is further compromised by the lack of extant Eucalypts and the immaturity of the new riparian plantings. The willows continue to inhibit the growth of bed and bank vegetation and therefore limit habitat value and channel stability. A mix of trees and shrubs (both native and exotic) either densely planted or invading the stream channel (as opposed to the floodplain) has significantly reduced available light reaching the stream bed and bank (H18, H22, H35). The consequent low cover of grasses and forbs has tended to expose the channel to erosion with the condition unlikely to improve while they remain *in situ*.

A subtle trend towards riparian vegetation degradation was observed in areas where there is an abundance of exotic grasses that are not grazed or mown. These areas are often found in public recreational areas within the urban environment (e.g. Jaques Park). The grasses have become dense and moribund, thereby reducing habitat value, species diversity and the ability of less dominant species to regenerate. Despite these degrading trends in vegetation composition the ground herbage is critical in providing geomorphic stability and structure for protecting water quality.

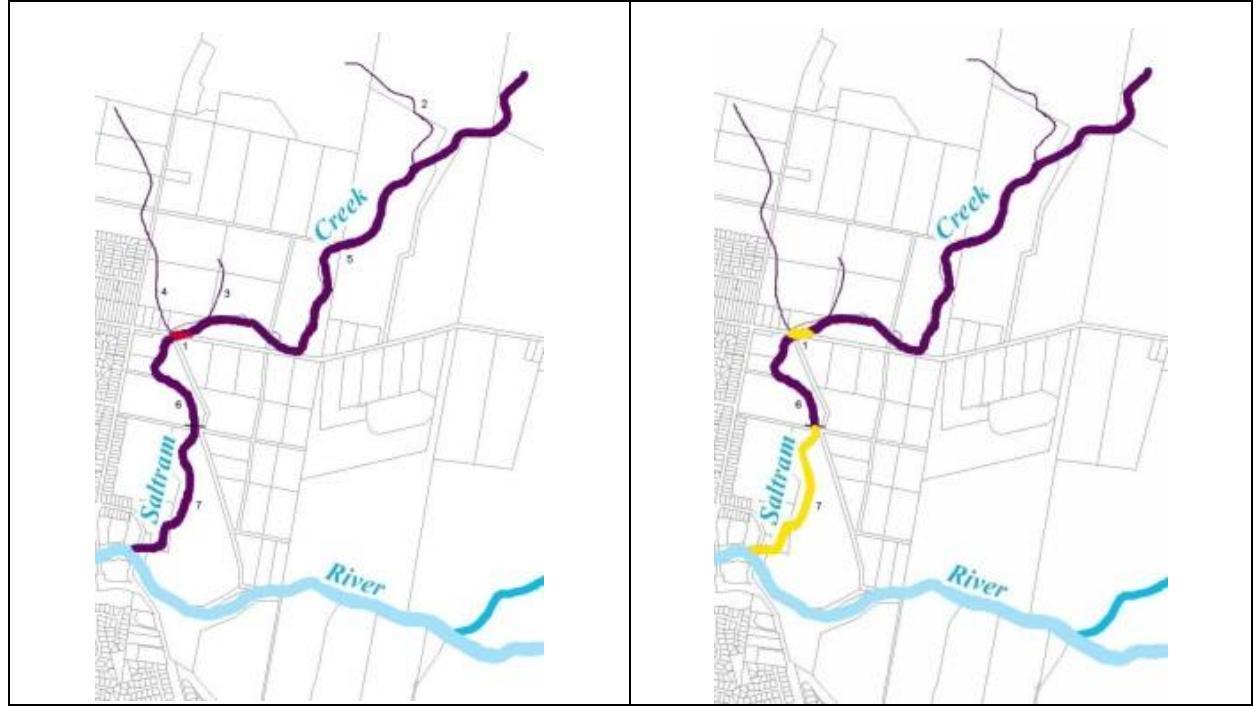
Figure 4: Saltram Creek condition assessment comparison between the 2009 (LHS) and selected 2014 sites (RHS). Highly degraded (red), degraded (purple), poor (yellow), good (green) and very good (turquoise).

The removal of upperstorey exotic trees, particularly willows, on Eleven Mile Drive (M1) and at the confluence with Macquarie River (M7) has had a significant influence on the condition ratings in these stream sections of Saltram Creek. Instream vegetation has flourished and along with erosion and deposition sequences in the stream, which create small pools fringed with macrophytes and grasses, the habitat has become more complex. Further, in a stream with highly mobile sediments a well vegetated stream channel has contributed to sediment aggradation and channel stability. Despite the notable changes in instream vegetation there are consequent losses to the ecosystem with the removal of an upperstorey canopy.

Grazing of the riparian zone and instream vegetation continues to impact on the creek downstream of Eleven Mile Drive and the condition rating remains stable.

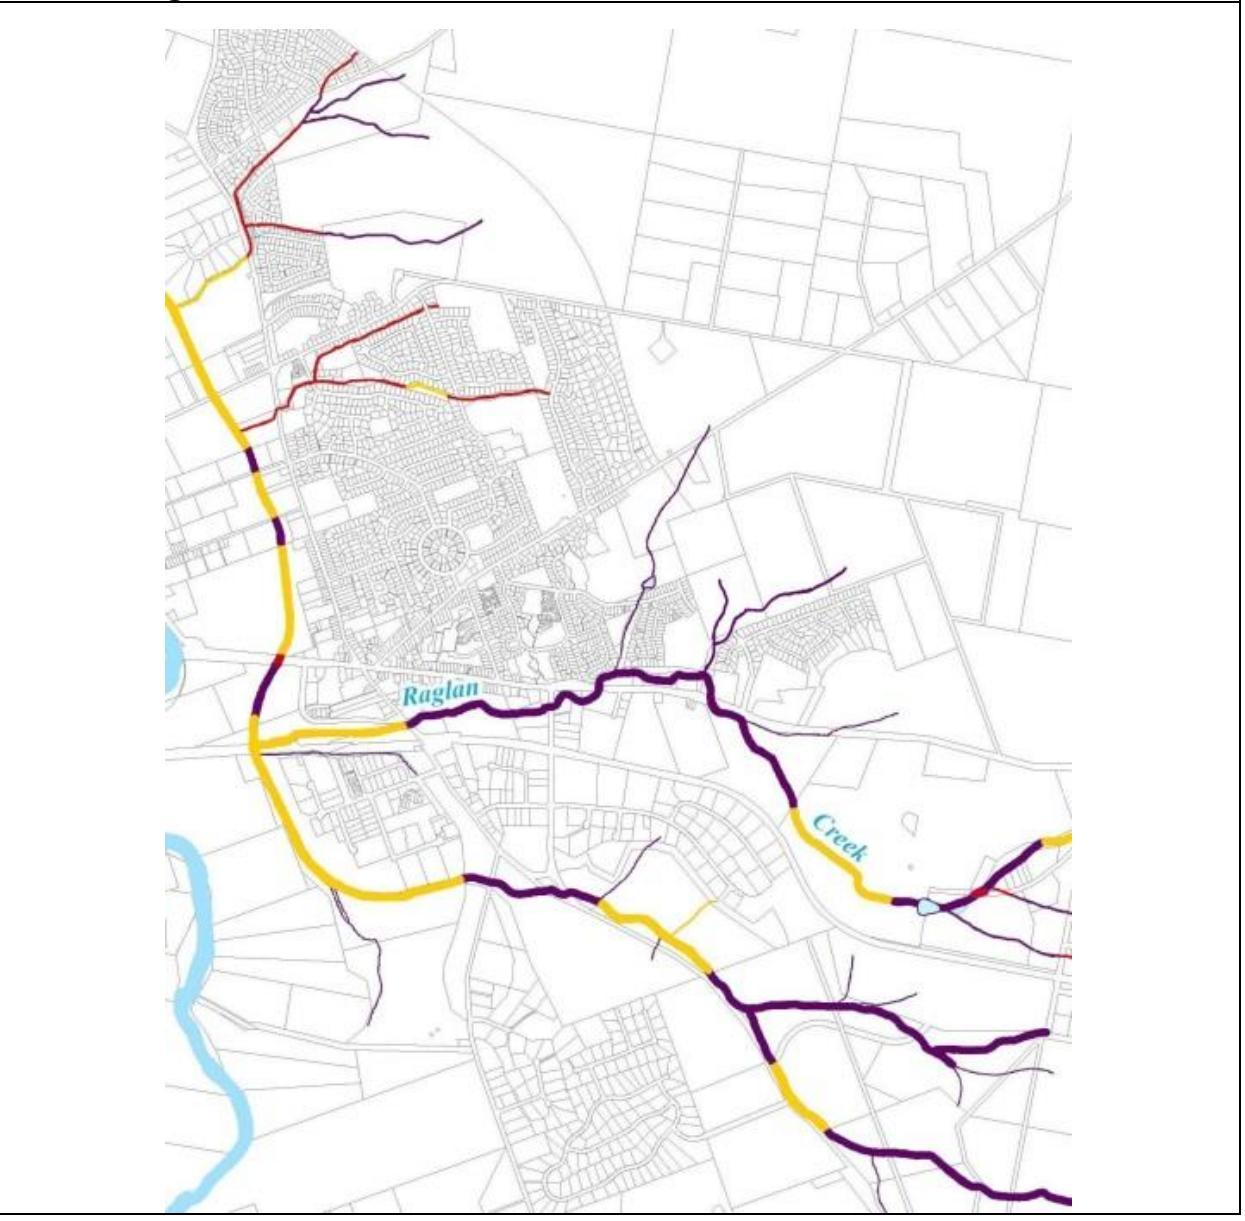
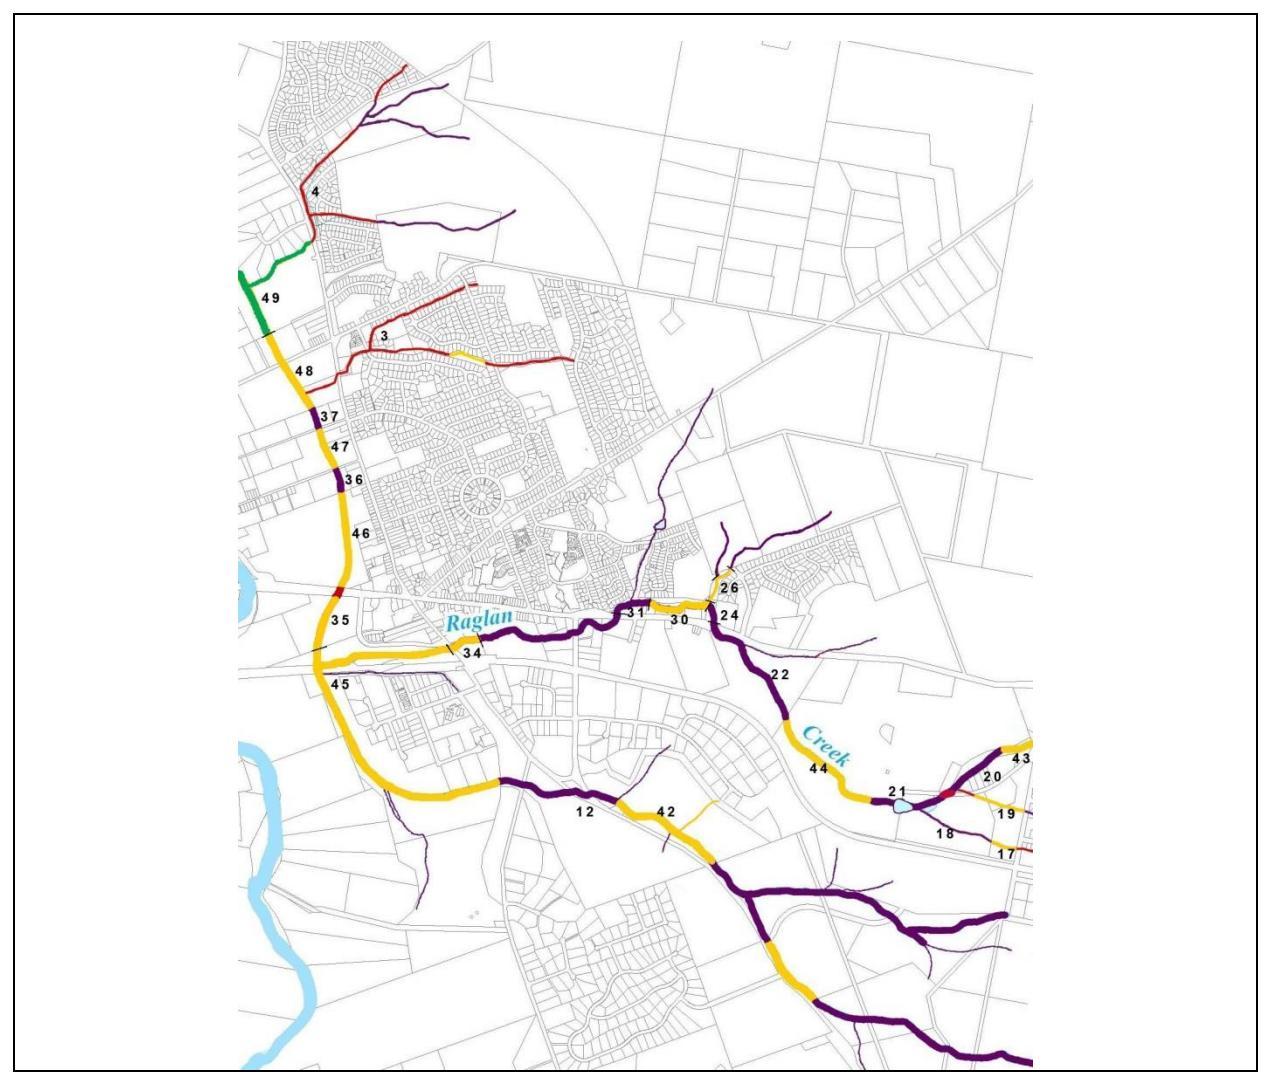
Figure 5: Raglan Creek condition assessment comparison between the 2009 (LHS) and selected 2014 sites (RHS). Highly degraded (red), degraded (purple), poor (yellow), good (green) and very good (turquoise).

Most of the sites assessed for the update have remained relatively stable in terms of overall condition rating. This overall stability does not reflect the subtle changes evident in some stream sections that have positively or negatively influenced the condition, but have not carried enough weight to affect an overall rating change.

A replanting program has been undertaken along the engineered drainage lines of sites R3 and R4 and similarly to site S2 the contribution these plantings have on aquatic ecosystems is minimal where there is a disconnect to an open channel. However, when they mature they are likely to add considerable value to local biodiversity, habitat connectivity and the aesthetic amenity of the area – as in the case for site R43 where the instream groundcover vegetation has also been left unslashed.

The main Raglan Creek channel running along the floodplain is essentially unchanged. Exceptions were observed in site R35 where instream vegetation has flourished with the exclusion of livestock and R49 where the instream vegetation has developed good structural integrity and species diversity compared with the Typha dominated communities upstream. The smothering of the creek channel with Typha generally diminishes habitat value and reduces species diversity.

Grazing is still practiced in some areas of Raglan Creek. The creek channel on the floodplain, where horses access for watering and grazing (R36 and R37), is devoid of vegetation except for a narrow fringe of aquatic and semi-aquatic macrophytes (sedges, rushes and grasses). The central body of water remains open. A dense growth of Typha occupies the whole channel upstream of this grazed area and is truncated at the paddock boundary (a public road forms the downstream boundary). Horse grazing would not be responsible for the complete absence of Typha in the grazed sections and it is suggested that other means, such as mechanical or chemical removal, may be the cause. Horse access to the creek has been restricted in R36 since the previous survey with a moderate improvement in fringing vegetation.

Livestock grazing, channel erosion, instream pugging and the unfettered growth of willows and other exotic trees and shrubs contribute to the degradation of R21 and R22 – particularly the latter that was cleared of invasive species prior to the baseline assessment. Uncontrolled stock access to the fenced-off restoration area (R44) is impacting on the riparian vegetation with all the plantings now being destroyed.

The removal of willows and other exotic trees and shrubs in heavily infested sites has tended to improve the overall condition rating (R34 and R26). This is achieved through the enhancement of instream vegetation and aquatic habitat and the increase in vegetation cover that aid bed and bank stability.

Stock exclusion in site R42 has enhanced riparian groundcover composition, instream habitat and channel stability. The deep gully, however, is the greatest factor that limits an improvement in stream condition. Similarly to other areas where the riparian zone is newly planted to improve vegetation structure and species composition, the contribution is likely to improve when the plantings mature.

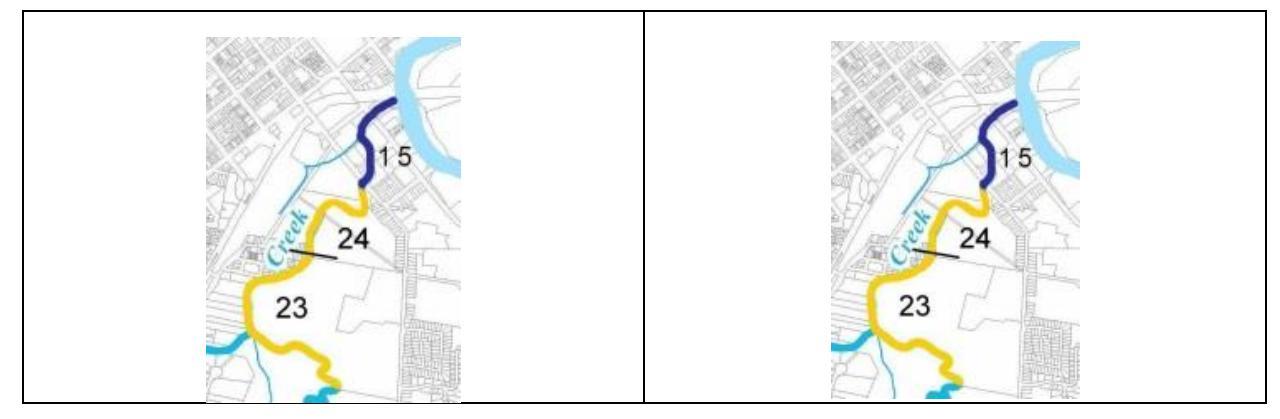
Figure 6: Vale Creek condition assessment comparison between the 2009 (LHS) and selected 2014 sites (RHS). Highly degraded (red), degraded (purple), poor (yellow), good (green) and very good (turquoise).

The condition of Vale Creek in the sites selected is essentially unchanged since the previous survey. Cattle are still grazing site V23 and continue to impact on instream and riparian vegetation, aquatic habitat and to some degree channel stability. The impact is gradual over time and has not exceeded a threshold that would shift the ecosystem to another state – it has already shifted from its natural, pre-European settlement state to its currently expressed 'alternate stable state'.

Further downstream where there is no livestock grazing and the riparian zone was cleared of exotic trees and shrubs prior to the previous survey the characteristics and condition of the stream section is relatively stable. The instream vegetation is increasing in cover and is effective in reducing sediment flux and enhancing aquatic habitat. The predominately exotic groundcover vegetation on the banks and floodplain has become moribund and is of poor species composition and structure. While the density of vegetation affords considerable protection against erosion it is limited in terms of its provision for instream and riparian habitat.

The stream section at the confluence with the Macquarie River is similar to other creek sites where exotic trees and shrubs dominate (e.g. lower Jordan Creek) and inhibit the growth of groundcover species on the bed and banks. As a consequence erosion continues, the creek bed becomes deeper and aquatic habitat compromised. However, the vegetation provides some habitat value for faunal species.
