*Chifley Home*  
10 Busby Street, Bathurst

**CONSERVATION MANAGEMENT PLAN UPDATE**  
for  
**BATHURST REGIONAL COUNCIL**

**SENTHILPAVAI KASIANNAN**  
Heritage Consultant, Katoomba, NSW  
Final report, November 2019

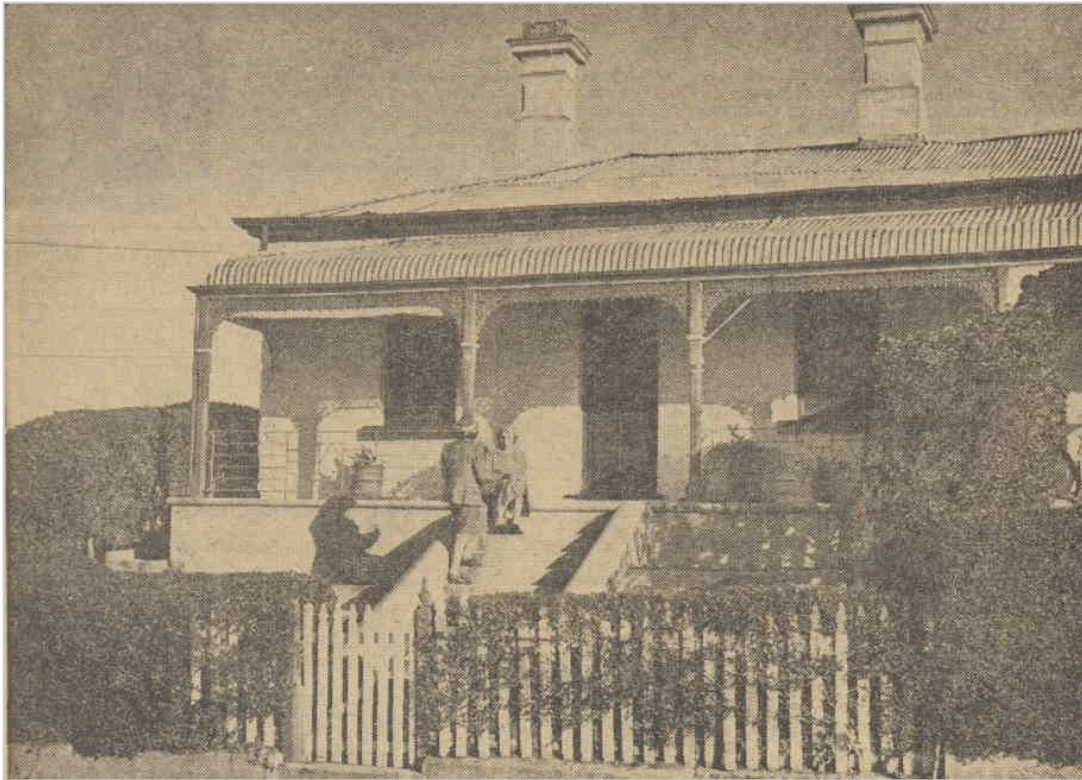
Figure 15 Chifley Home—view from Busby Street, photograph taken in 1945. Note the verandah has a wrought iron balustrade, but the picket fence along the street remains unchanged (Source: “The Chifleys' home is modest Bathurst cottage”, *The Australian Women's Weekly*, 28 July 1945).

A palisade fence runs along the property to the east and along the boundary between 10 and 12 Busby Street to the rear of the properties. A decorative picket fence can be seen along the front of the property, from the edge of the verandah to the street, between Chifley Home and the vacant lot. The earlier picket fence (evident in old photographs of the house) along the street was replaced by a wrought iron fence during the Chifleys' occupation of the house (see Figure 15, Figure 16).

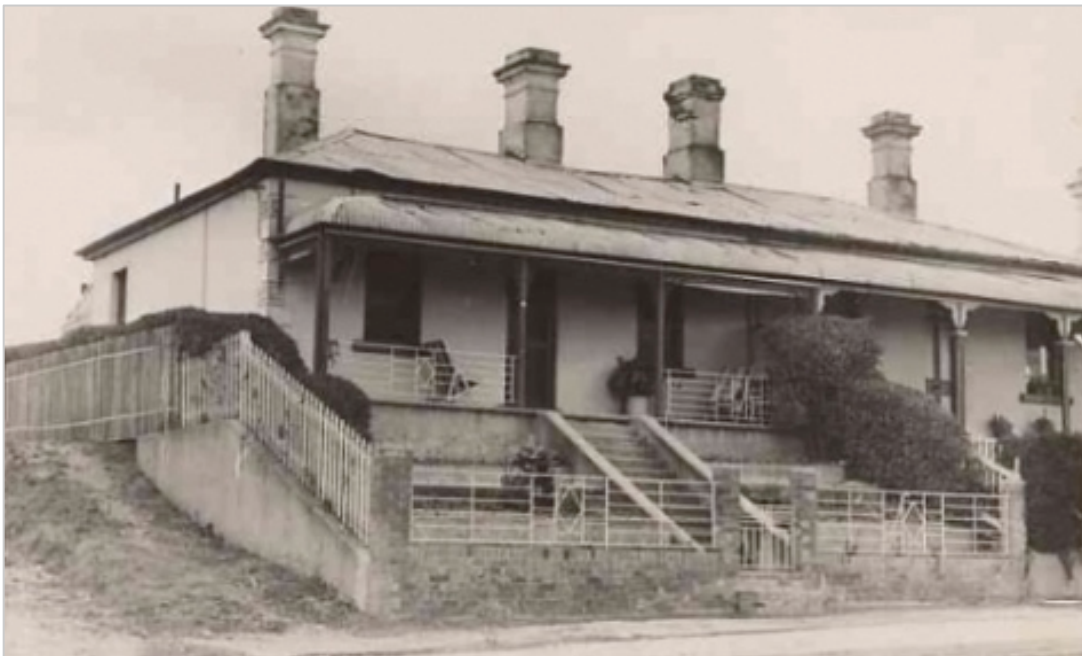
Figure 16 Chifley Home from Busby Street. The wrought iron fence and verandah balustrade were added by the Chifleys. The fence to the street was added after 1945 as established by the earlier photograph at Figure 14 (Source: <http://www.chifleyhome.org.au/the-house/history-of-the-house.html>)<sup>44</sup>

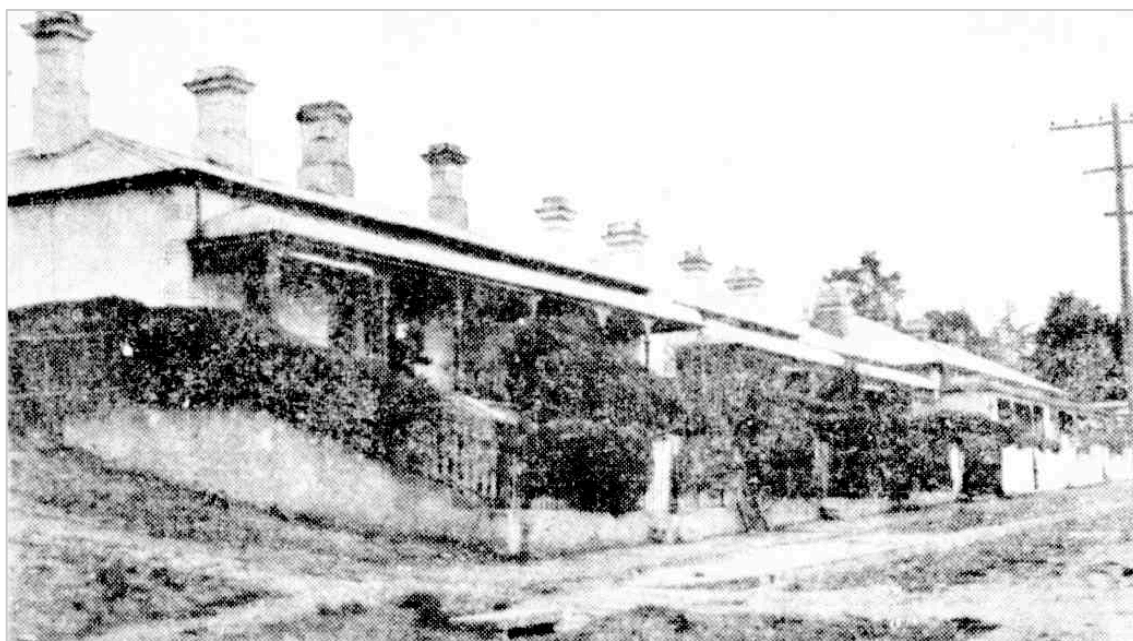
Figure 17 Chifley Home and the Busby Streetscape in 1945 (Source: <http://nla.gov.au/nla.news-article981155>)

The Chifley's were one of the first to have a telephone due to Ben's political activities. Neighbours often came over to receive calls on the Chifley landline. The streetscape view in Figure 17 establishes the uniformity of the terrace houses in 1945. The streetscape and skyline along the south side of Busby Street remains largely unchanged at the time of this report in 2019.

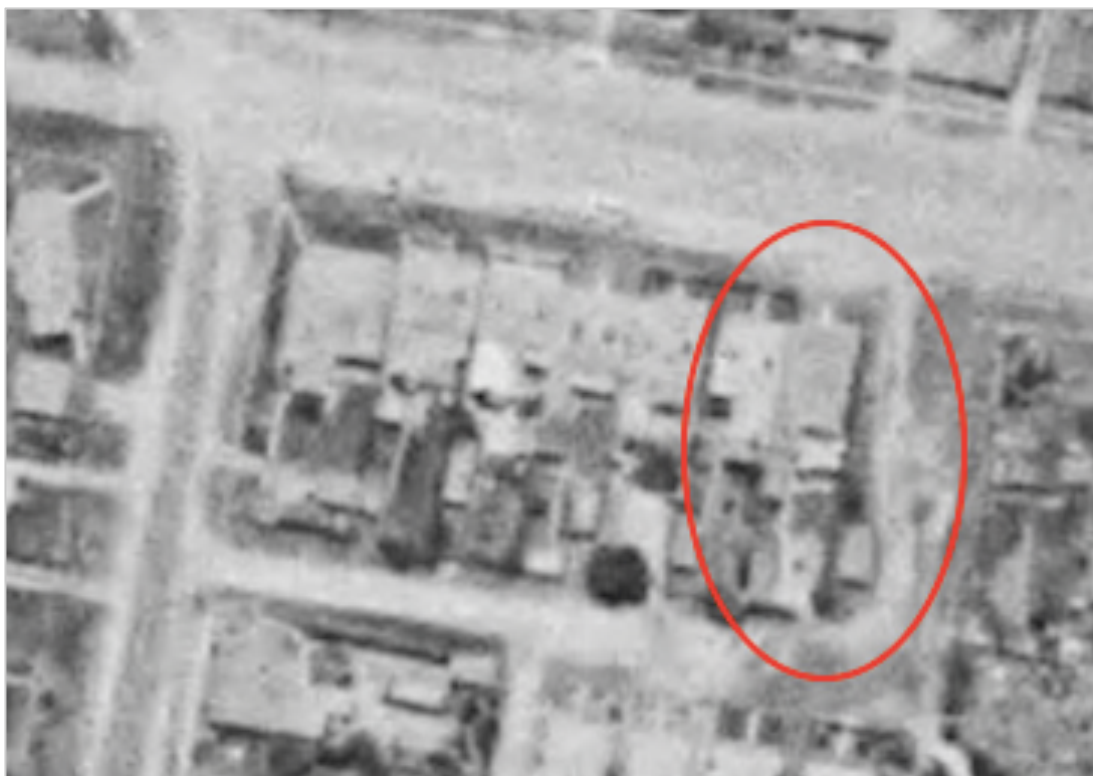
Figure 21 Aerial Photograph, 1964 showing 10, 12 Busby Street (indicated) and the adjacent vacant block—note that the vacant lot is used as an access way between Logan and Busby Streets and Chifley's garage is clearly visible in the vacant lot (Source: NSW Government Spatial Services)

They did not fence the lot or make it into a garden. Aerial images at Figure 21 and Figure 22 show that this lot was always used for access between Logan Street and Busby Street. The disabled access ramp was built in 2003. Some interpretation panels are installed along the walkway.

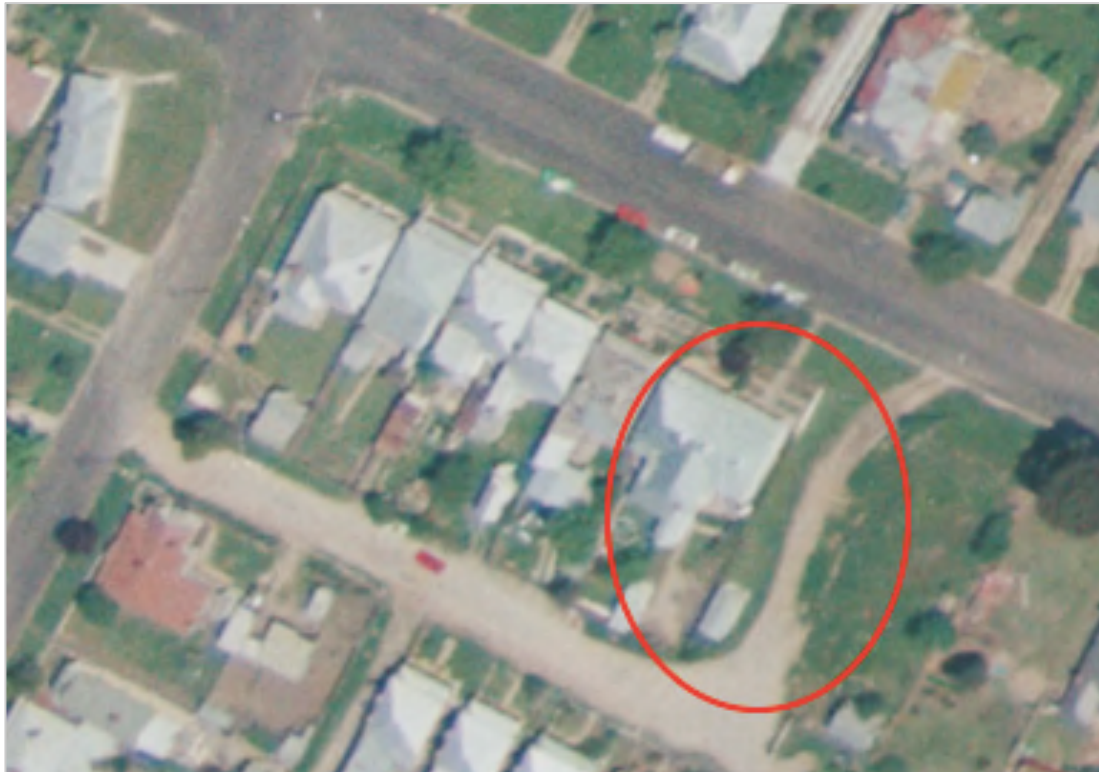
Figure 22 Aerial Photograph, 1964 showing 10, 12 Busby Street (indicated) and the adjacent vacant block—note that the vacant lot is used as an access way between Logan and Busby Streets and Chifley's garage is clearly visible in the vacant lot (Source: NSW Government Spatial Services)

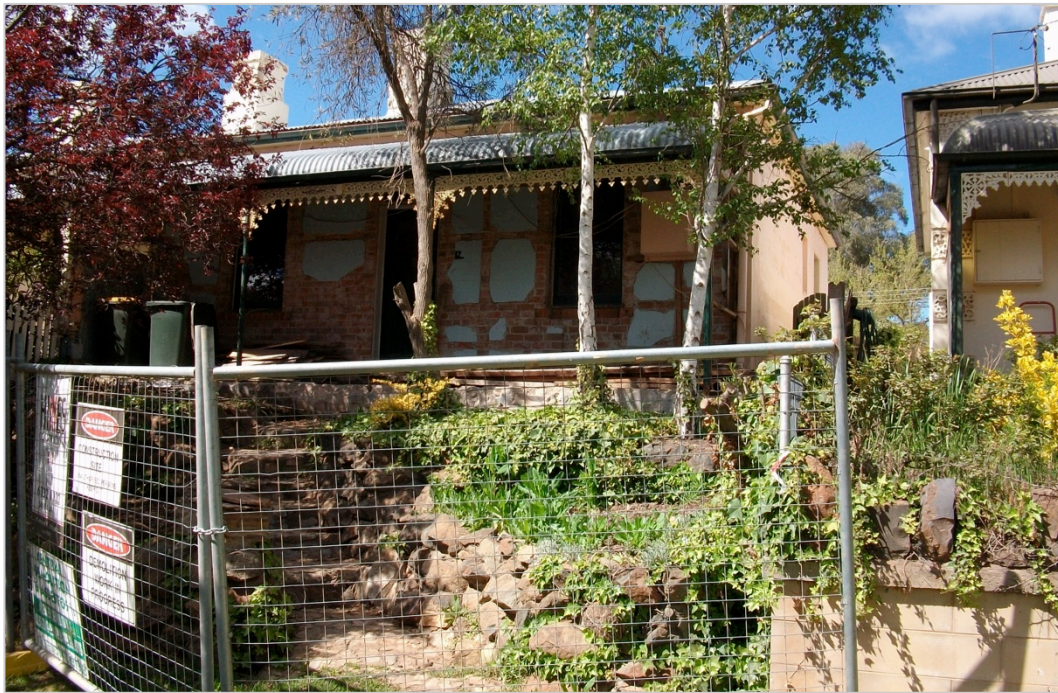
Figure 26 Demolition and redevelopment works to 12 Busby Street—works to the front (Source: Bathurst Regional Council Records)

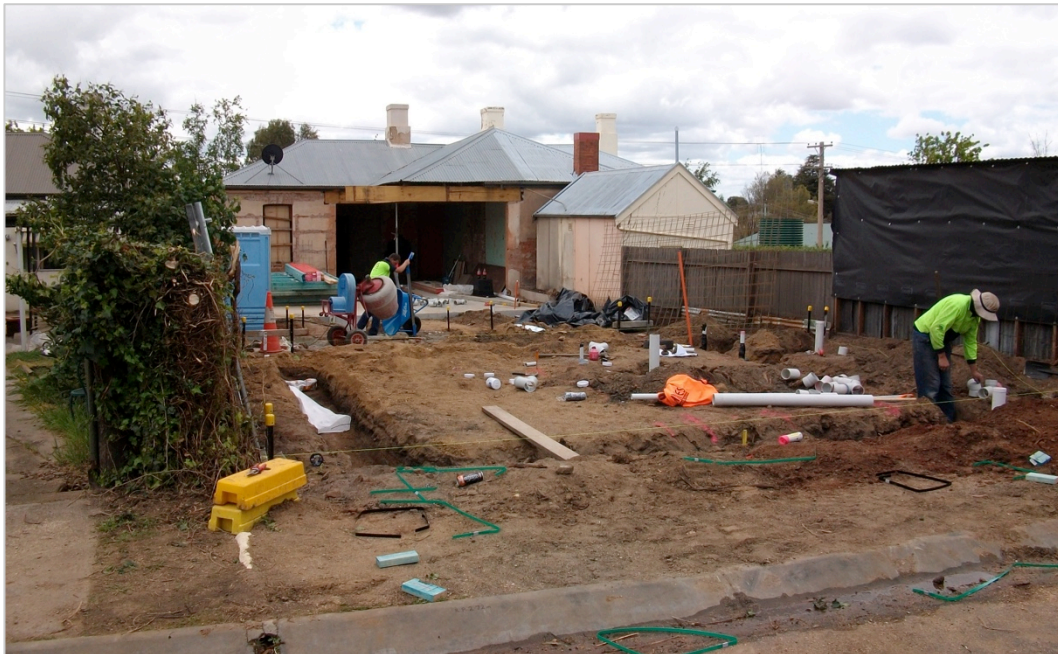
Figure 27 Demolition and redevelopment works to 12 Busby Street—works to the rear (Source: Bathurst Regional Council Records)

The site to the rear of the property was extensively worked and the entire site was completely levelled prior to the construction of the garage/shed and toilets (Figure 27).

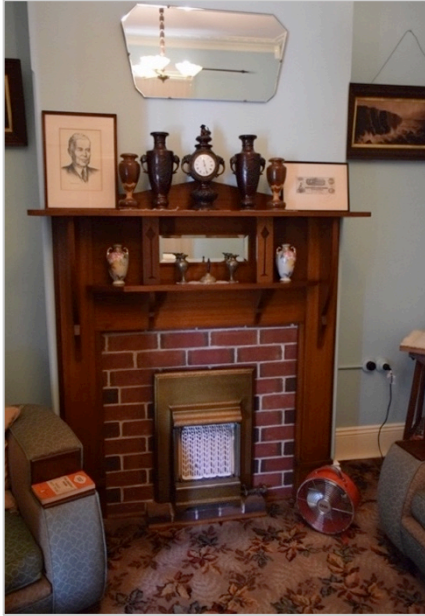
Figure 37 Fireplace with the gas heater added by the Chifleys

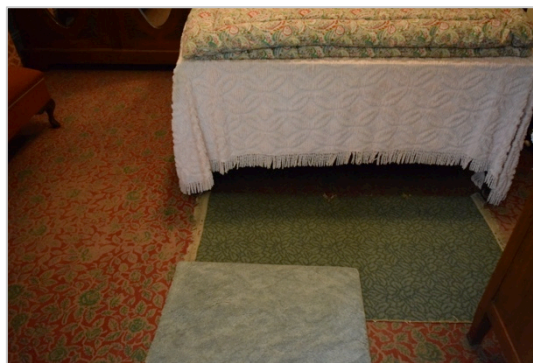
Figure 42 Original carpets and protective mats to help prevent deterioration due to visitation

*Strategies to reduce the wear and tear of original carpets and floor finishing in the Chifley Home should be worked out. Solutions should be trialled before identifying the best mechanism to protect the existing floor finishes.*

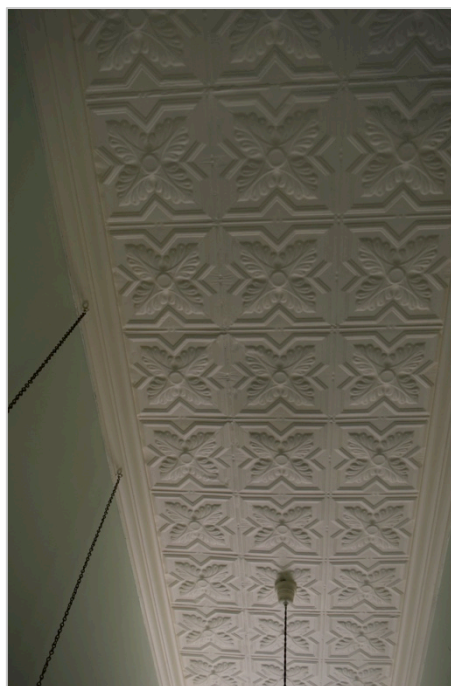
The hallway is typical of the residences of this period. There is no evidence as when the pressed metal ceiling was added—during the Chifley occupation or before.

Figure 44 Pressed metal ceiling detail in the hallway

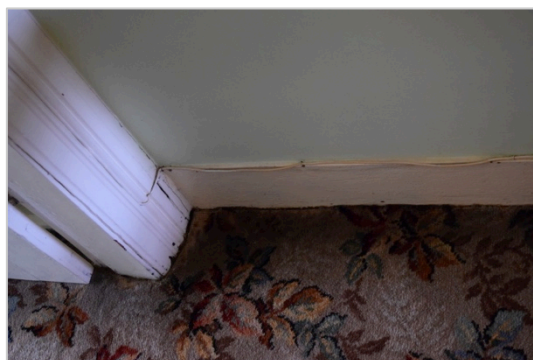
Figure 52 Deterioration of carpet in the dining room

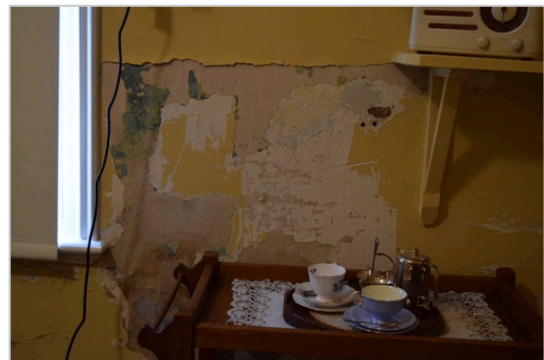
Figure 58 Damage to the plaster of the external wall is clearly evident.

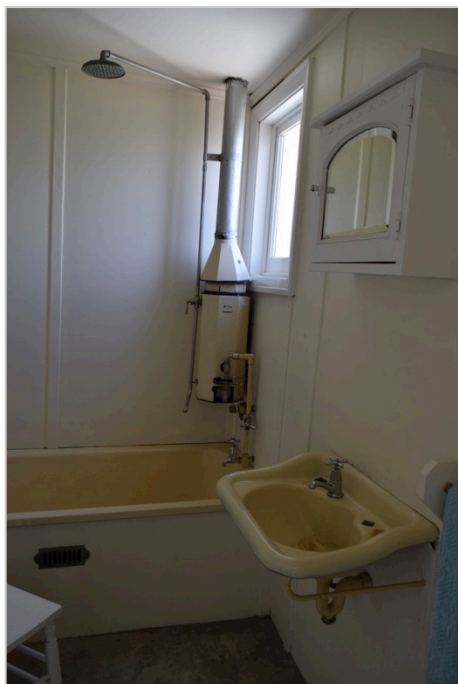
Figure 63 Bathroom—enclosed from a section of the rear verandah. Hot water mechanism for shower and sink.

The bathroom has an enamelled cast iron bath, with an enamelled gas water heater over the bath, supplying the bath and shower (over bath) with hot water. There is also a wall mounted enamelled hand basin with a small mirror fronted cabinet above. This was provided with cold-water tap only.

It is demonstrative of the domestic life in the early twentieth century and the discomfort endured in using an outdoor bathroom in extreme cold winters. It highlights the austere nature of the room with its simple hand basin and shaving cabinet together with the 'Metters Ltd' gas heater used to supply hot water to the bathtub and shower.<sup>77</sup> The gas water heater and the wall hung hand basin were installed by the Chifleys.

The Bathroom had extensive works done in 2000. The toilet has had some work done to it in 2002, when the previously replaced plastic cistern was replaced with a concrete one, sympathetic to the period. In 2010, works were done to the laundry and toilet. The concreting to the rear of the house at the rear verandah were identified as not original to the Chifley period, but added later, and this can be verified as it is partially covered the vent in the rear wall of the house (also see Appendix 4, p118).

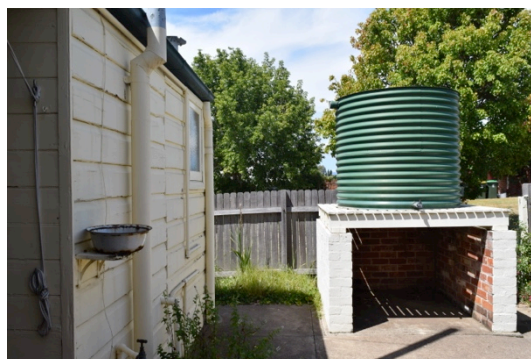
Figure 66 Water tank replaced the original water tank in this location.

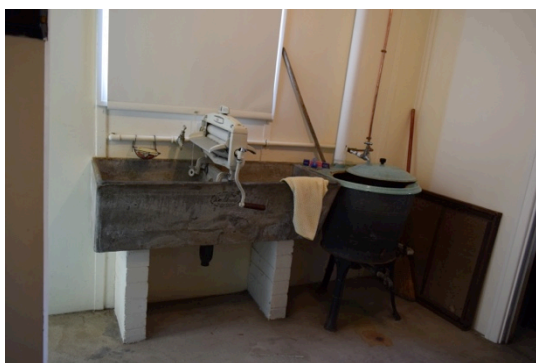
Figure 69 Laundry tub, clothes wringer and boiler

The layout of this room was common to most laundries of the period. The twin cement tubs supported on brick walls is accompanied by the manual clothes wringer and gas heated boiler. There is only cold water supply to the laundry tubs and the copper.<sup>78</sup>

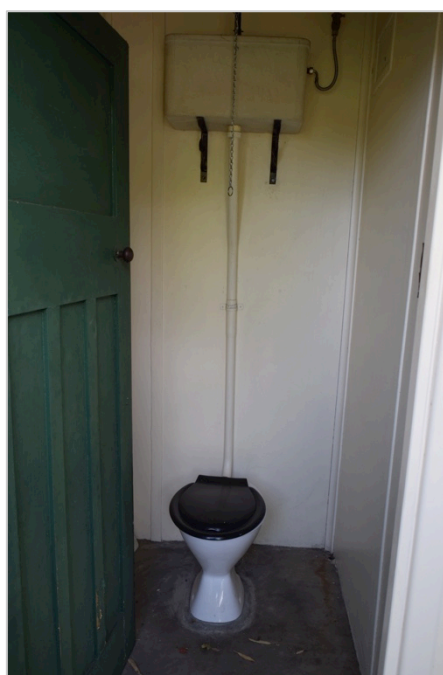
Figure 71 Toilet accessed from outside.

The toilet is located a short distance from the house along the garden path to the rear of the kitchen. The modern vitreous china pan and plastic cistern are replacements for an earlier water closet with chain activated high set cistern that was located where the current toilet stands. It is not evident if this was the same location as the pan toilet that would have been in use prior to the connection of the sewerage system.<sup>79</sup>

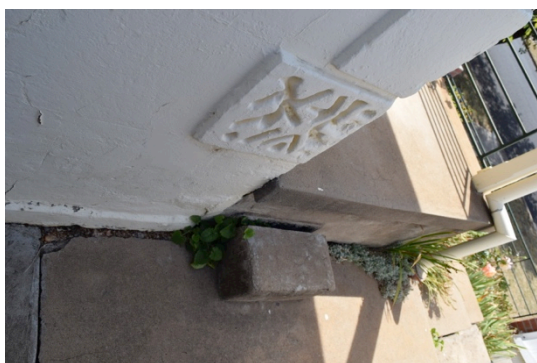
Figure 81 Plaster peeling on the external wall on the east side of the cottage

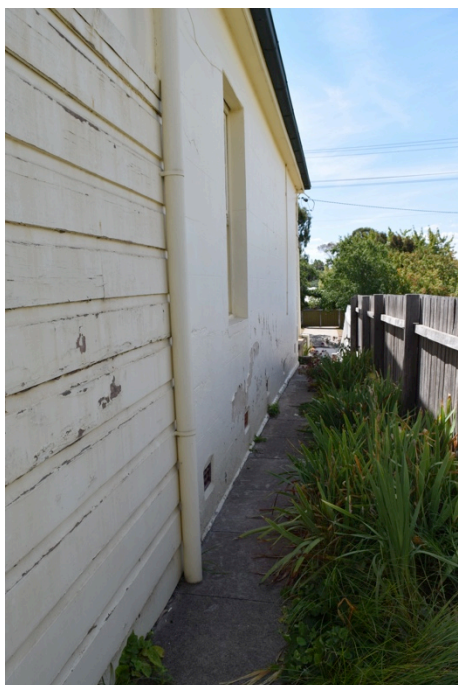
Figure 82 Eastern façade—paint peeling is evident, but not severe.

Externally, the maximum damage to the building is seen along the eastern wall of the property. Issues relating to damp can be seen in the form of peeling paint and a very small loss of render. There is a gap at the junction of the verandah roof and the front façade wall (evident in Figure 83 above), should be addressed quickly.

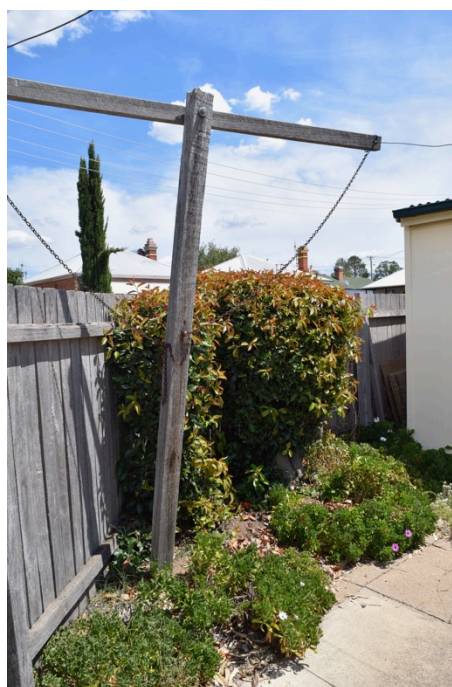
Figure 90 Clothesline pole next to the front fence—note the leaning away from the fence

The timber clothesline would need some immediate attention to ensure its long-term conservation. The vertical post near the fence is leaning away from the fence and this would need to be fixed. The clothesline in some places hangs low, posing a hazard. The 1998 report noted that the props for the clothesline were missing at the time of their report.

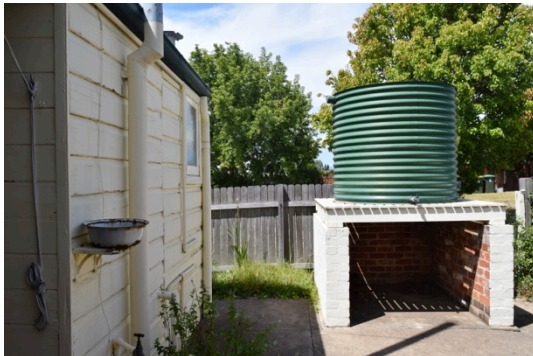
Figure 93 View of the external wall of the bathroom and the water tank

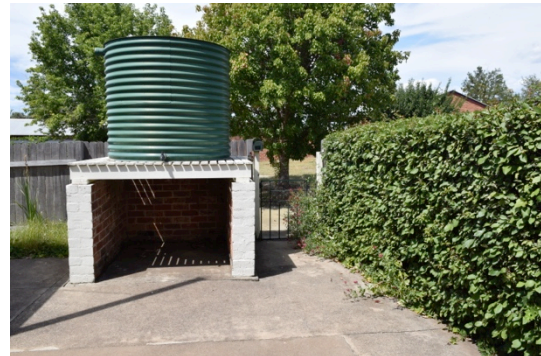
Figure 94 Water tank and the hedge—a gate leading out of the property is located next to the hedge

2003–04 CHMP states that the garden was both flowers and vegetables and this character should be retained. The hedge (a form of plum) and grapevines on the Western side along the fence are most likely original plantings. A number of other plants were possibly planted by the caretaker who took care of Chifley Home in the years 1972–2000, when it was functioning as a house museum.<sup>80</sup>

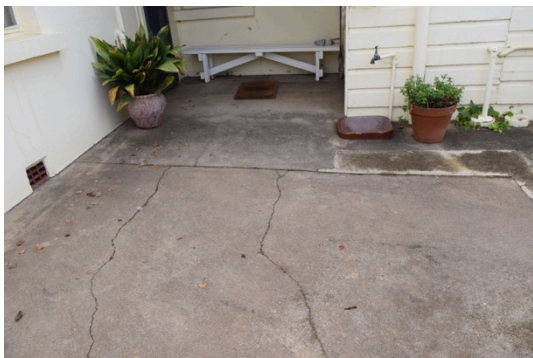
Figure 95 External concreted area (rear verandah)—note the cracks on the concreting (this section was identified in 2010 as not original to the Chifley period – Appendix 4)

*The concreted areas outside the cottage should be repaired and a 30–50 cm gap created externally, along the walls, to allow for the moisture to escape through the ground covered with suitable material for water to drain and not get trapped in the walls. Technical information sources provided in this report should be referred to.<sup>1</sup>*

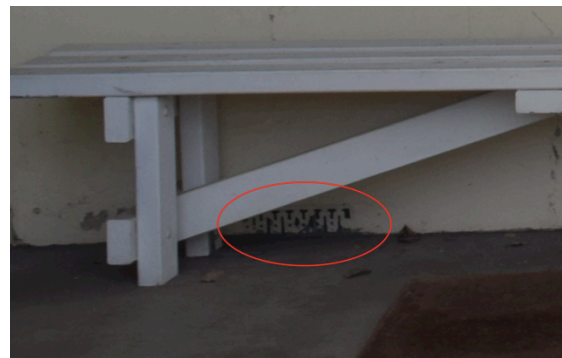
Figure 96 External concreted area (rear verandah)—note the partially concealed vent below the seat (indicated).

*Regular maintenance works include cleaning gutters, checking down pipes and checking underfloor ventilation and providing additional ones, if necessary. The build up of ground level should be checked and lowered where required, in particular in the rear verandah area, where the vent is partially covered. Sub floor inspection will help clarify the state of the other vents. In carrying out sub floor inspections, sufficient precautions should be taken to avoid damage to the original floor furnishings.*

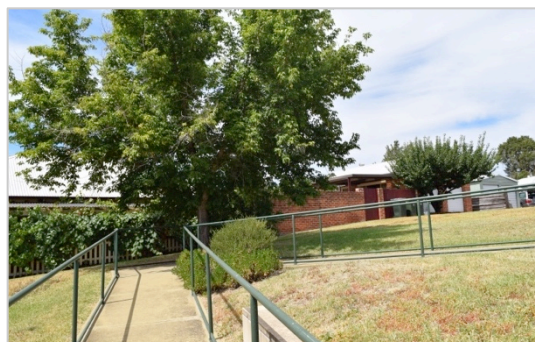
Figure 104 Access ramp—looking east

The vacant lot adjacent provides the disabled ramp access from Busby Street to Logan Street and is in good condition. The lawns are periodically mowed and it appears well maintained as evident in the photographs above.

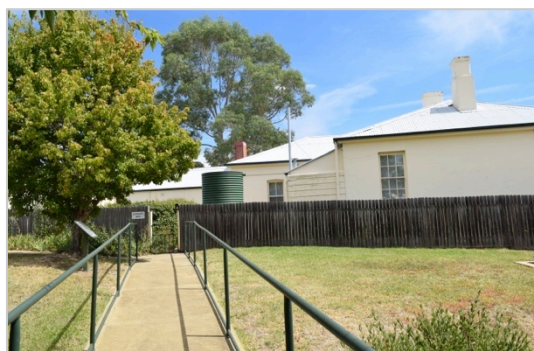
Figure 106 Access ramp—looking towards the house and water tank.

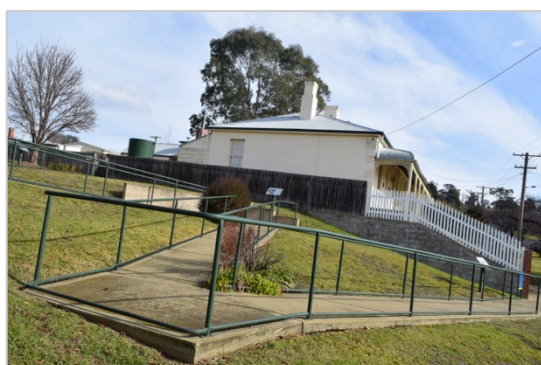
Figure 107 View of the ramp from the corner of the vacant lot towards Chifley Home

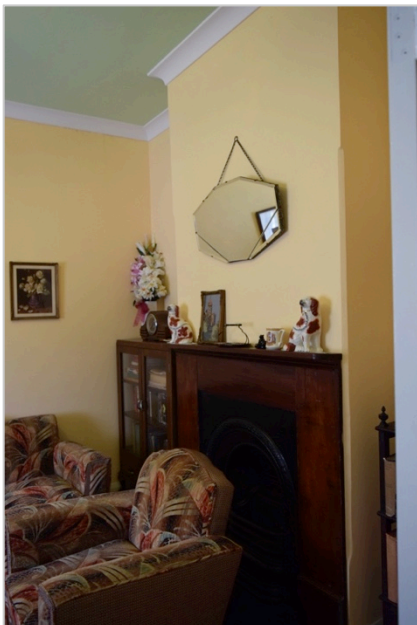
Figure 113 Fire place retained in the model parlour

The parlour in the education centre provides an opportunity for the visitors to interact with the interiors of a working class home, as this is not a museum space, where only visual interaction is permitted. The fireplace has been retained or restored to reflect the period, and the cornice details are also intact. The external walls have been retained as original.

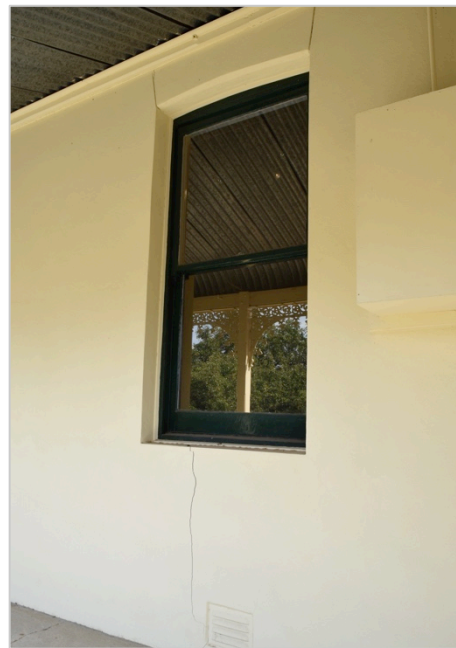
Figure 122 Front window along the verandah—note the crack below the window sill

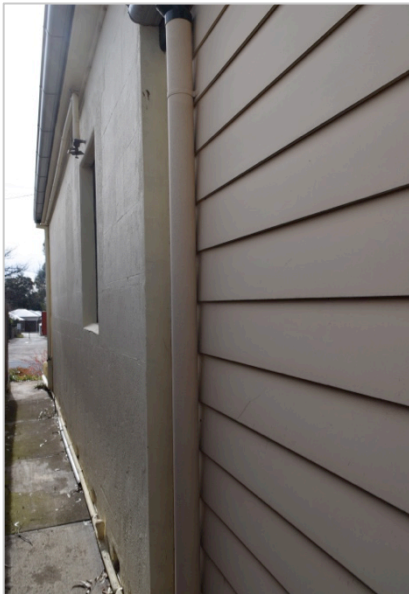
Extensive works were carried out to 12 Busby Street while developing the site as an Education Centre. Apart from the front section of the cottage, the rest of the building is a new construction. The new section in weatherboard is clearly discernible externally from the western side of the building.

Figure 125 Western wall—new construction in weatherboard is evident

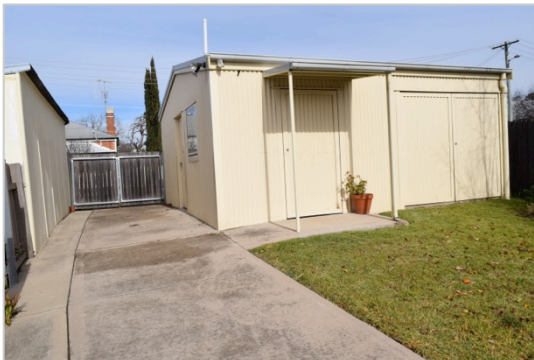
Figure 127 Toilet/garage block to the rear

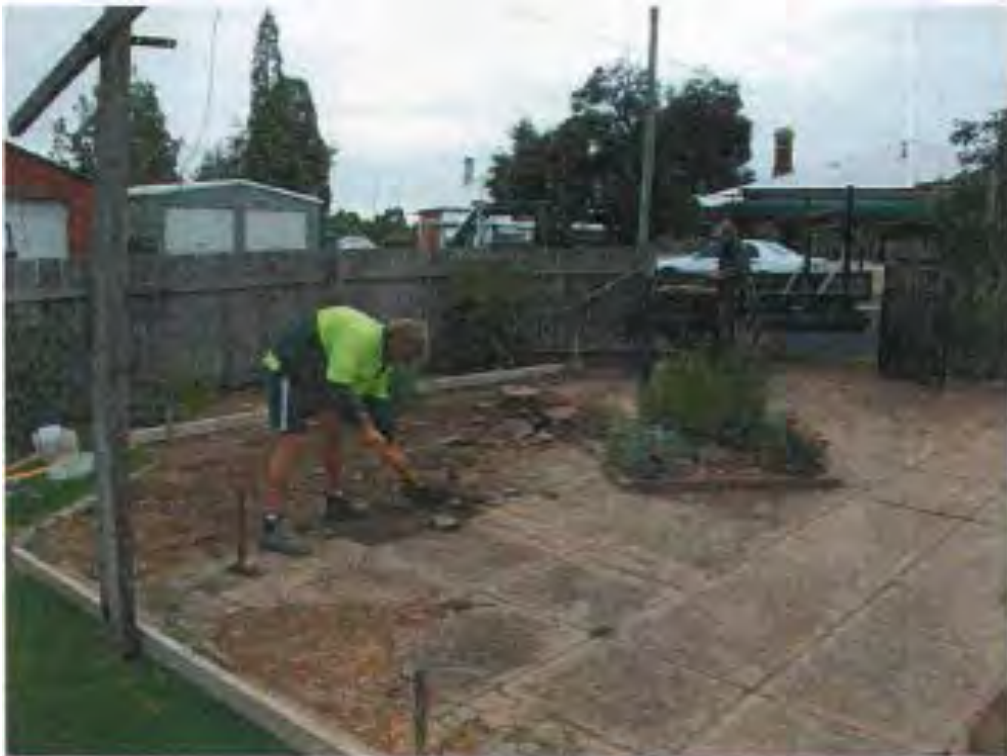
Image 1: Removing damaged concrete at Chifley Home

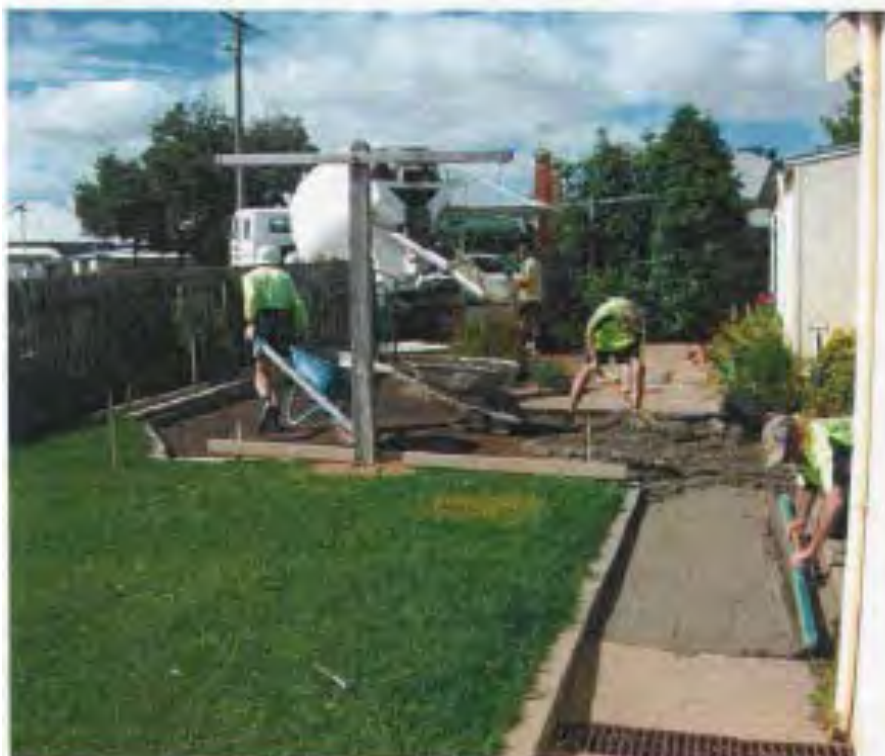
Image 2: Pouring and laying new concrete at Chifley Home

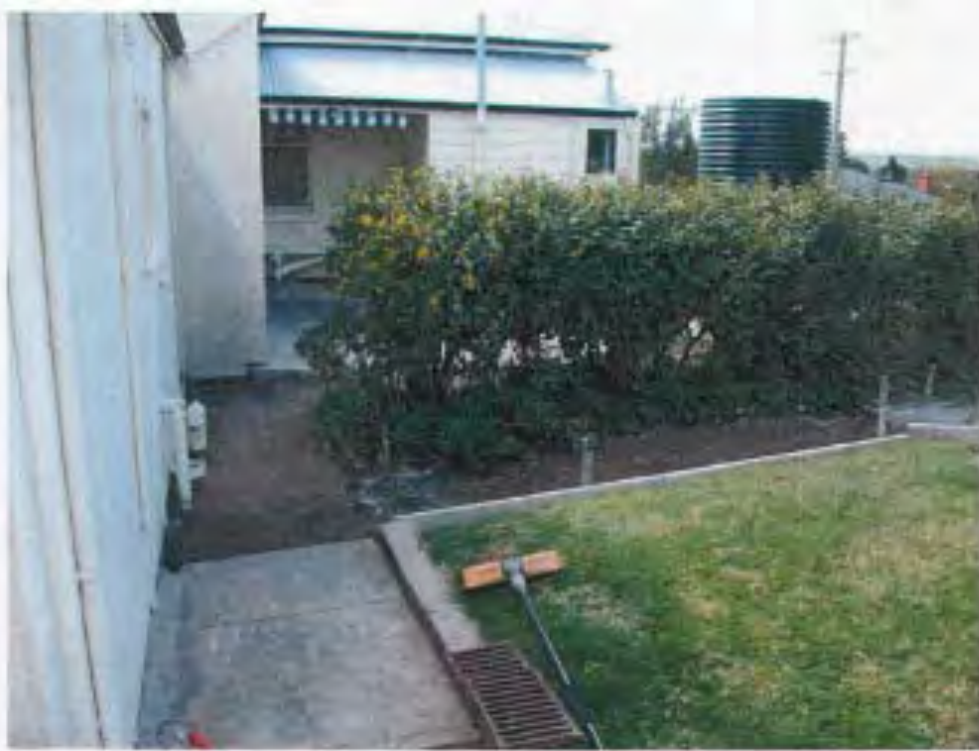
**Image 3: Repairs and replacement of concrete pavers and edging at Chifley Home**

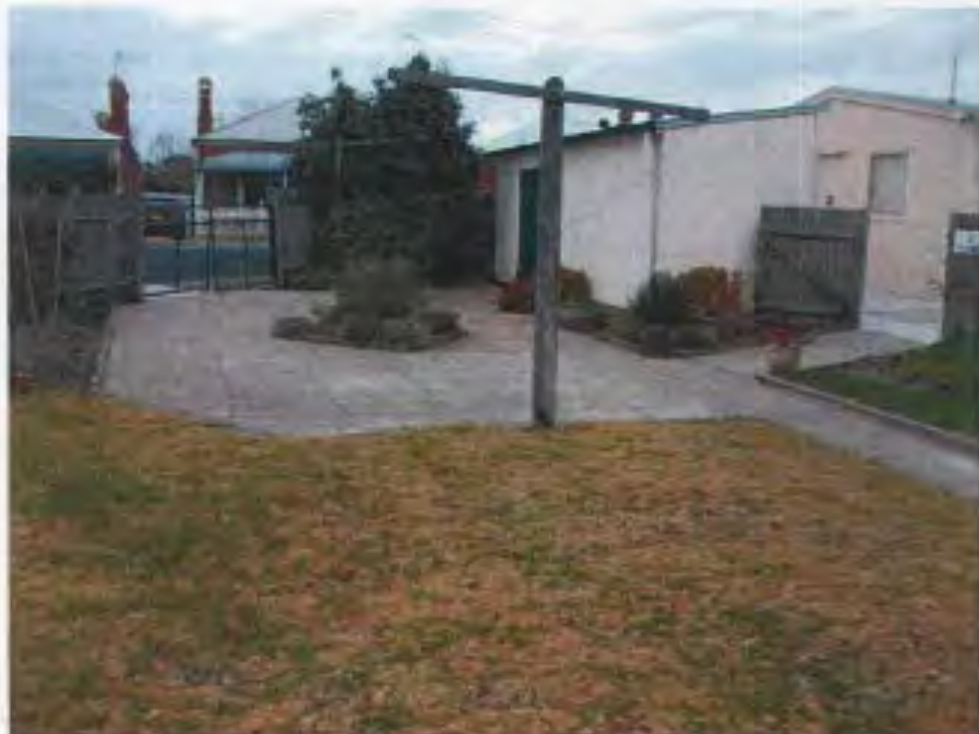
**Image 4: Completed works to concrete pavers and edging at Chifley Home**

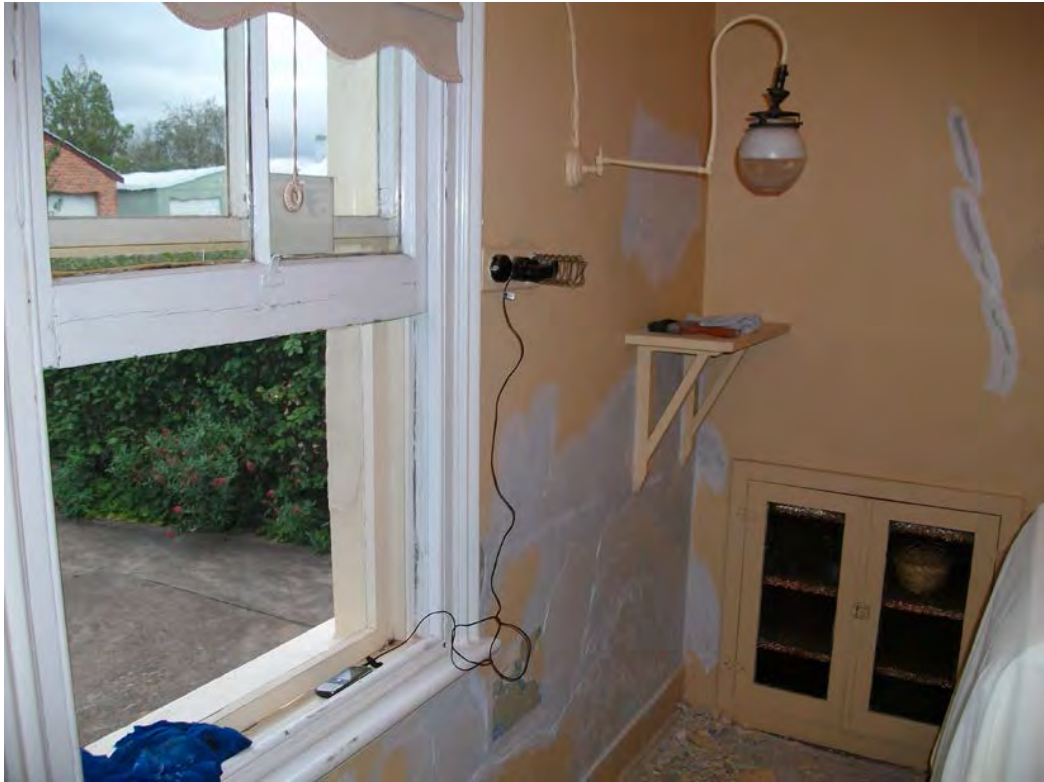
Bathurst Region Heritage Fund grant obtained for repairs/replacement of fascia boards on laundry outbuilding. Repairs and repainting of internal kitchen wall.

Kitchen – works in progress

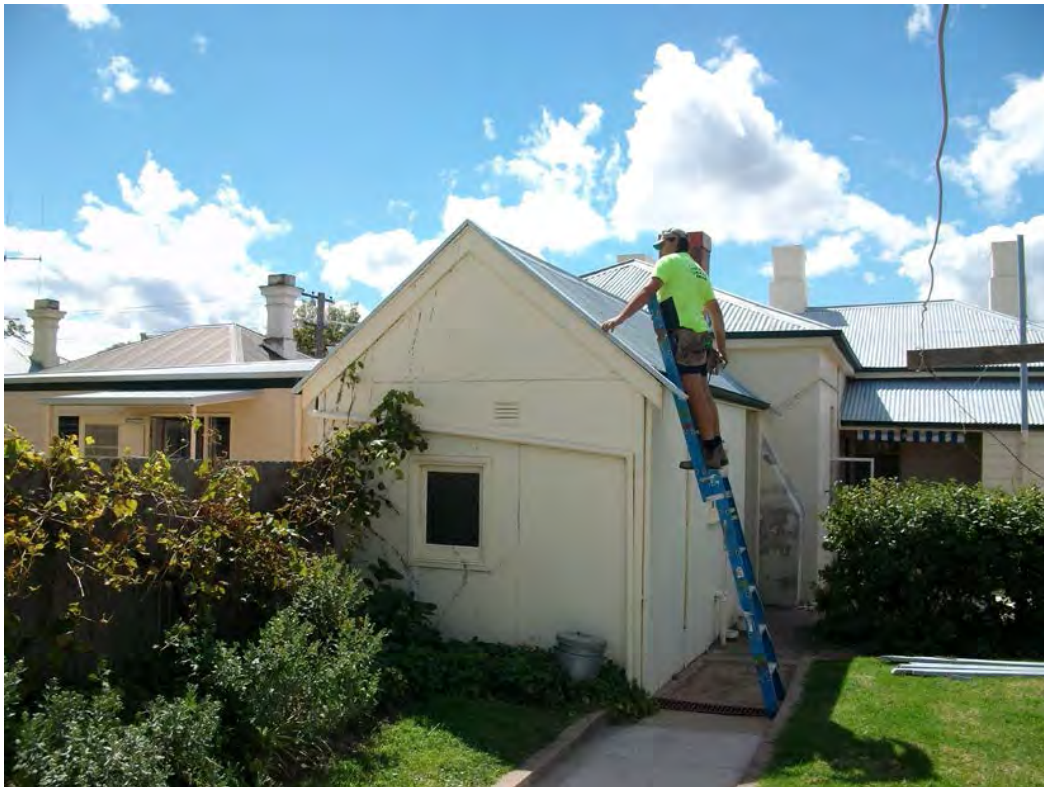
Laundry – works in progress – roof joinery

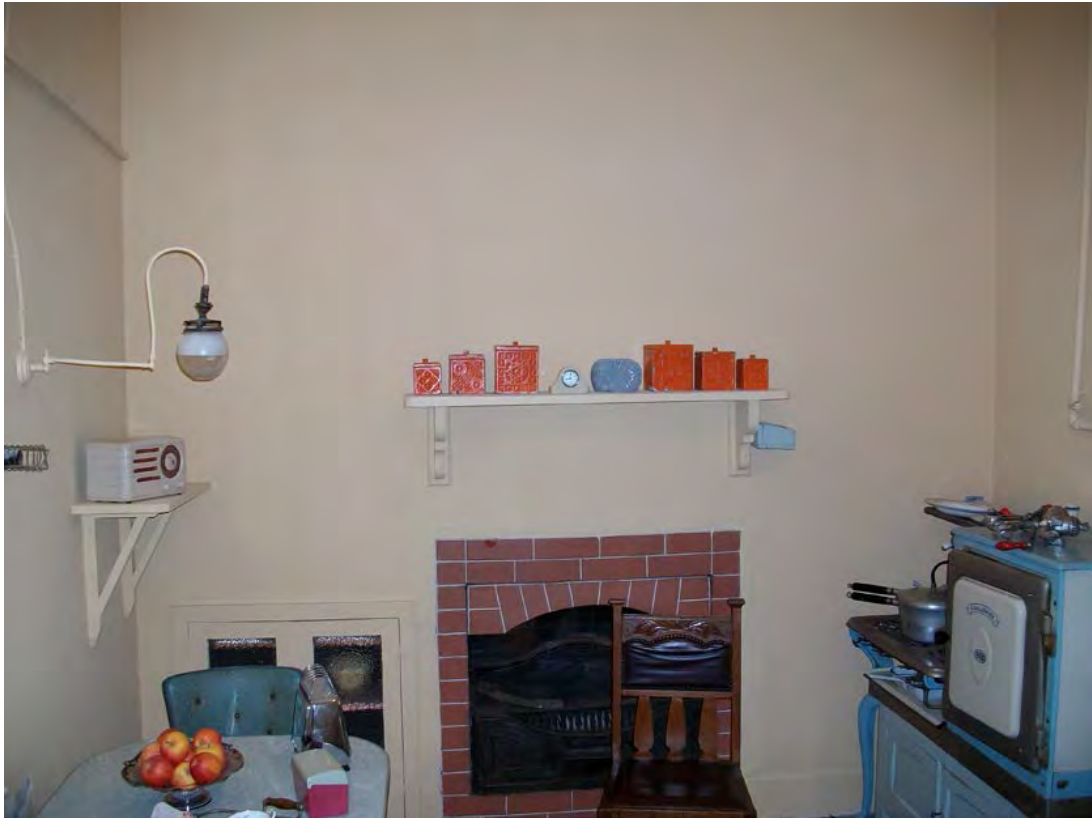
Kitchen – south wall – completed works

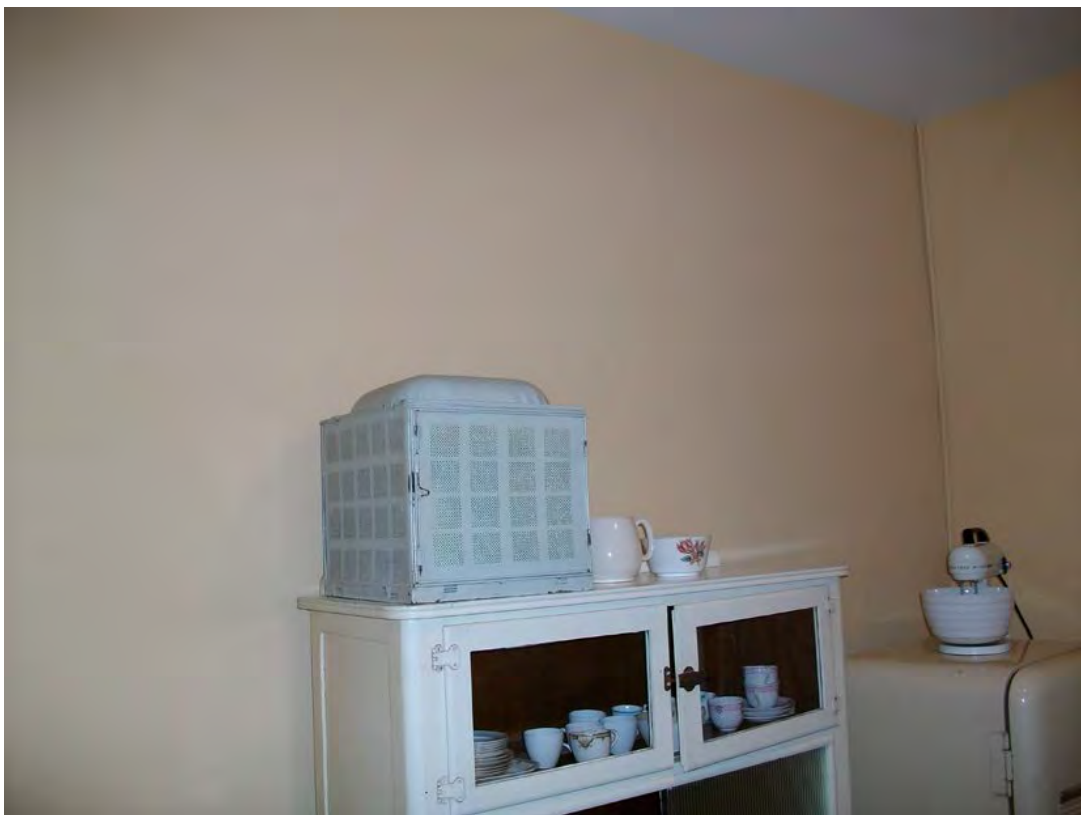
Kitchen – west wall – completed works

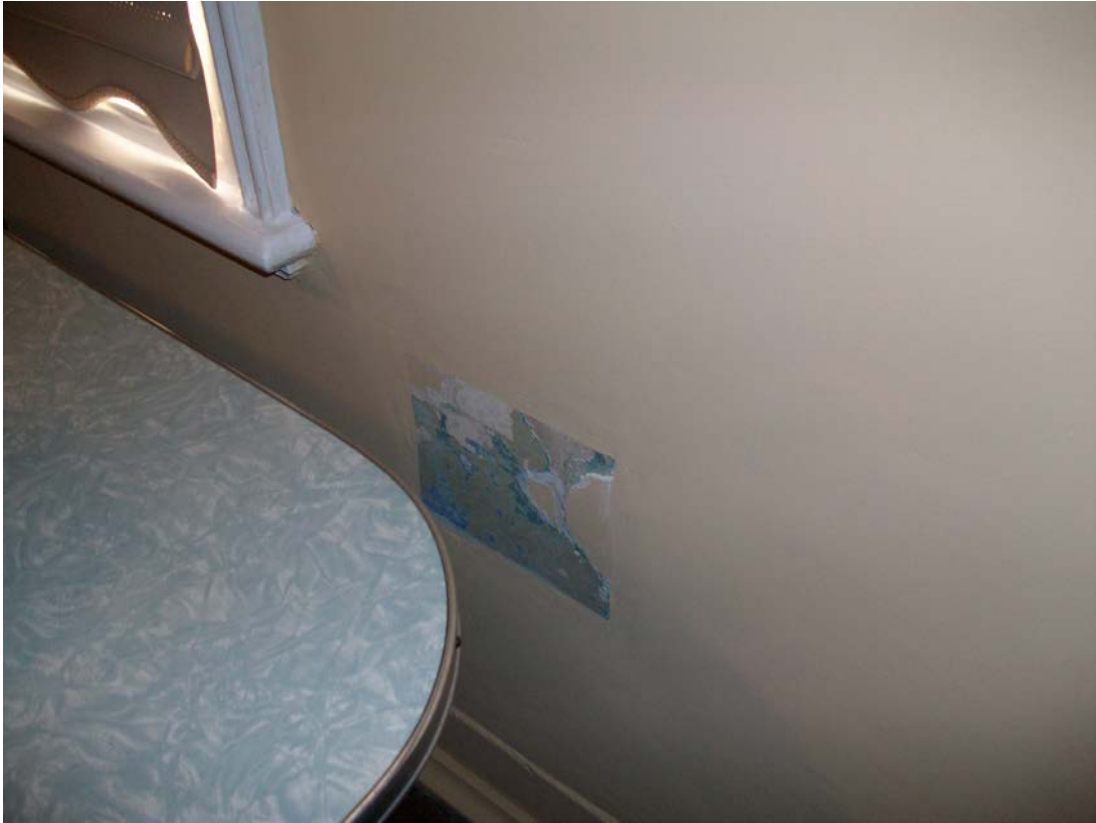
Kitchen – evidence of earlier colour schemes

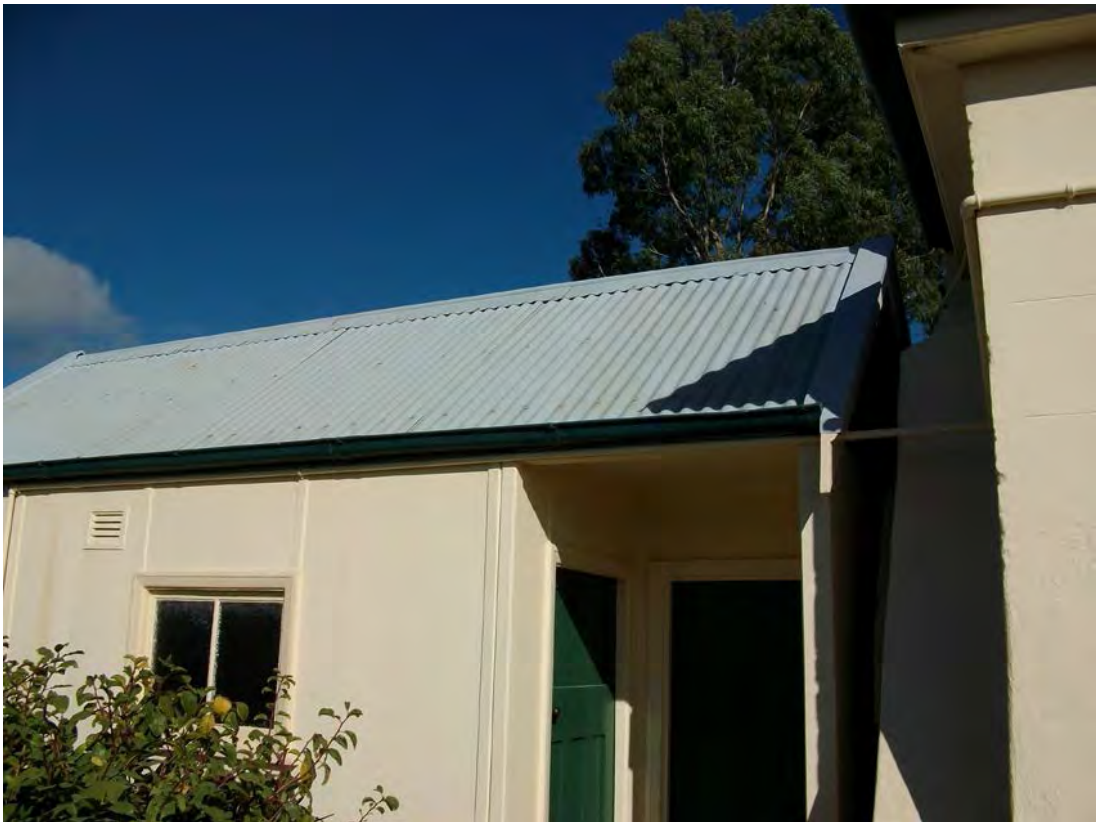
Laundry – completed works – roof joinery

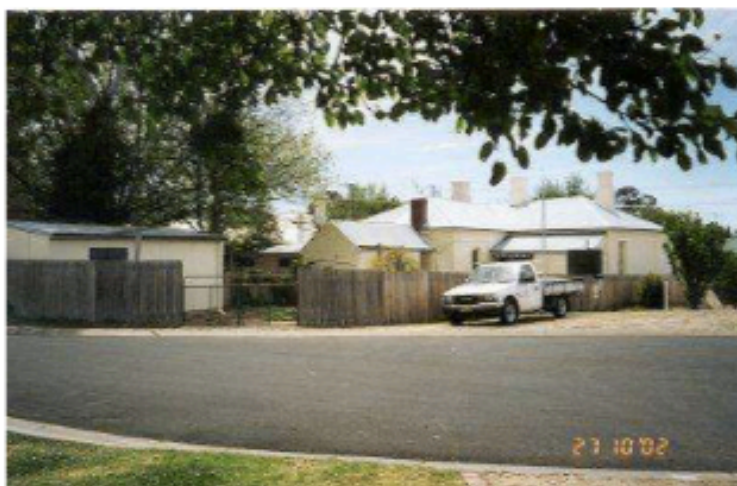
**Caption:** East side and rear from Logan Street showing surviving outbuildings.
