FORMER BATHURST DISTRICT
AMBULANCE STATION
**CONSERVATION
MANAGEMENT PLAN**

Corner of Durham and William Streets, Bathurst NSW
Issued January 2023 | Final

Former Bathurst District Ambulance Station, Conservation Management Plan

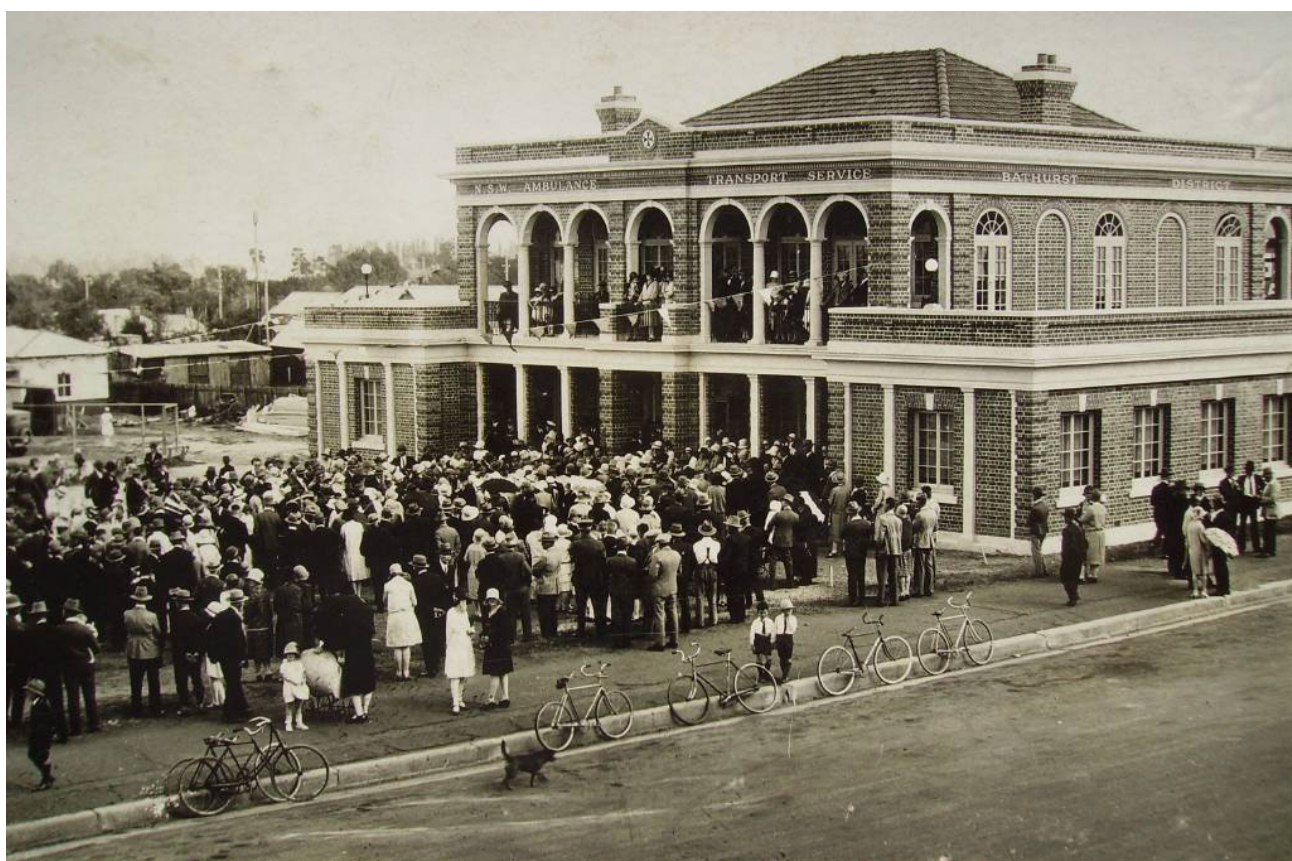
Figure 20 Opening Ceremony of the Bathurst District Ambulance Station in March 1929. Source: Bathurst District Historical Society

A photograph of the opening day festivities (see Figure 20) shows the roof to have been tiled, probably Marseilles tiles.

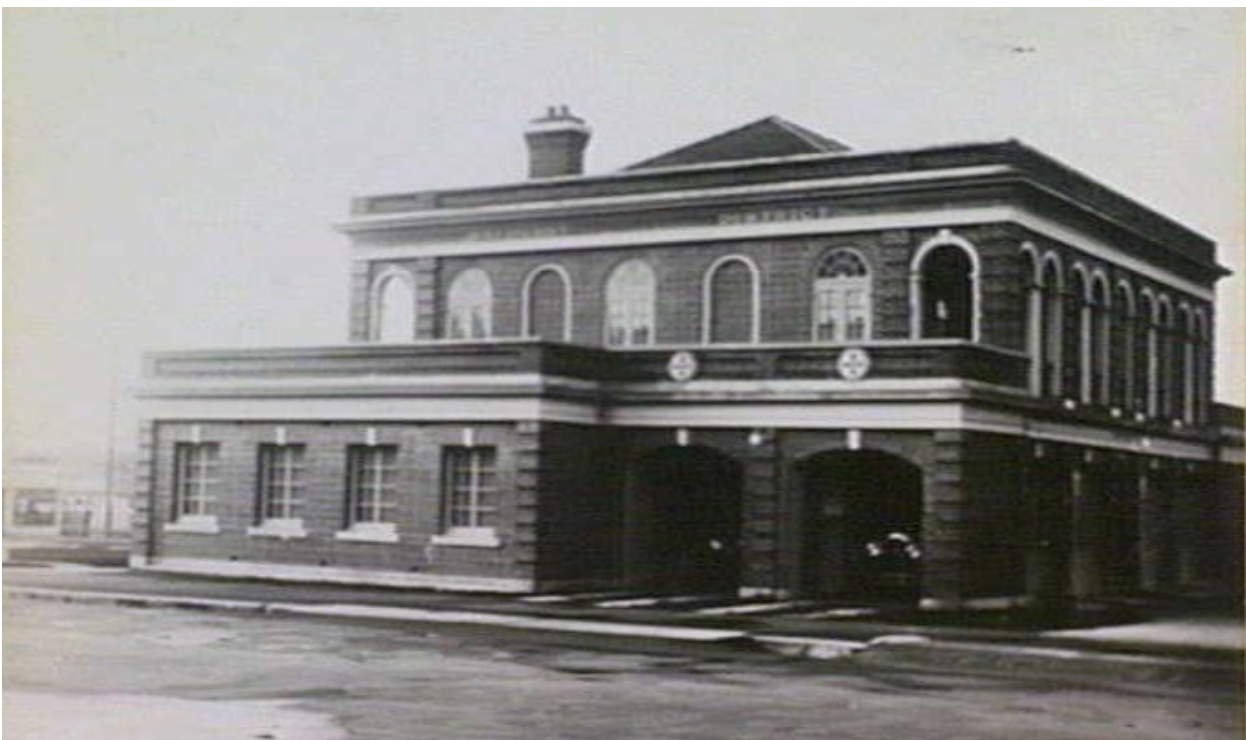
Figure 21 Undated Post card (prior to 1941) of the Bathurst District Ambulance Station held in the State Library of Victoria.
Source: SLVIC image a09760

The Ambulance Bay doors survive to two elevations. A 1941 post card (see Figure 21) shows these doors to have been painted a dark shade whereas the keystones to the brick arches are a light colour. Above each bay facing the street is a St John's Cross and these can be seen in the historic postcard. In a 1954 image the doors appear to be painted in a green shade with similar exterior features.

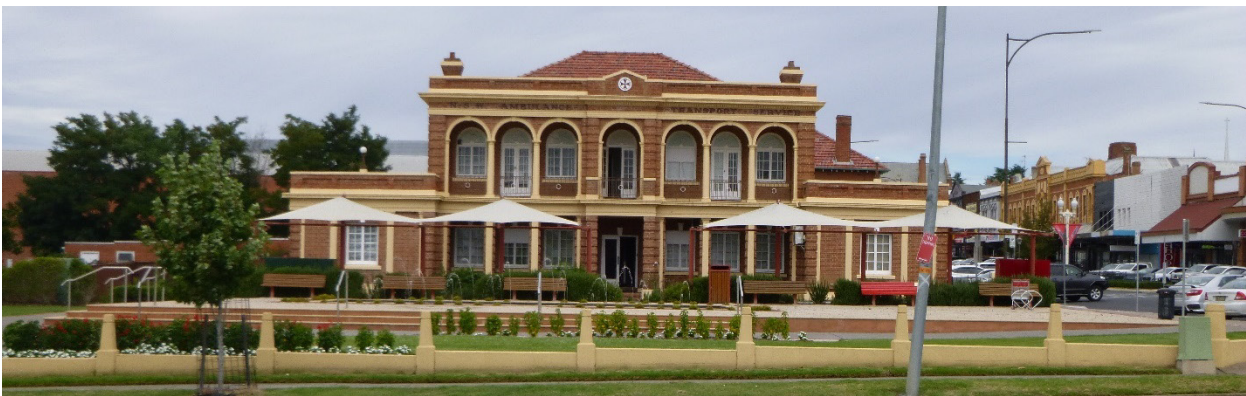
Figure 22 View of the main front of the former Bathurst District Ambulance Station.

The former Bathurst District Ambulance Station is a symmetrical two story brick building located near the corner of Durham and William Streets, Bathurst. The building is set back from the corner of William and Durham Streets and is sited within the Haymarket Reserve. The drive to the carpark for the reserve also serves the front entrance to the former Ambulance Station. The historic photographs show that the drive was not installed when the building was opened however Norman Weekes' perspective shows that there was to be a paved forecourt. The reserve is in the foreground in views towards the main frontage of the building. These views were part of the intended design.

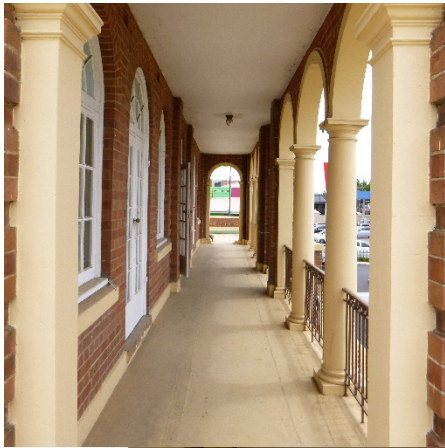
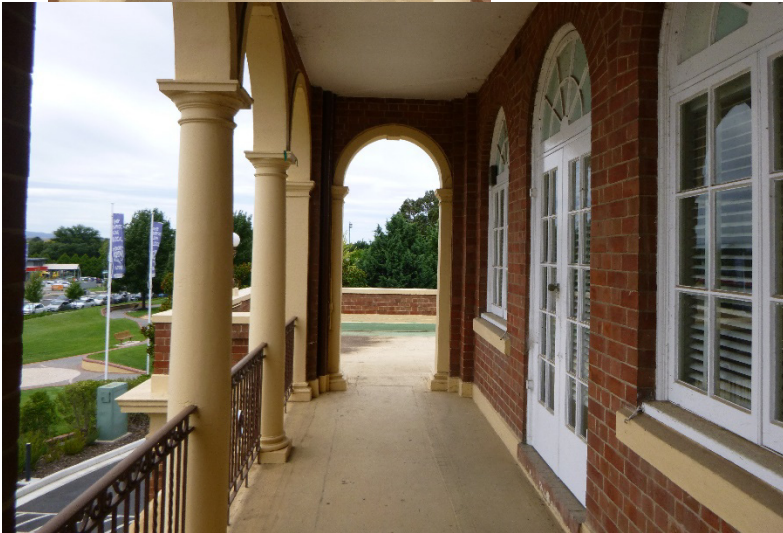
Figure 23 View of the first floor arcade of the former Bathurst District Ambulance Station.

The arcade to the upper level features rendered columns whilst the colonnade to the lower level is composed of rendered pilasters affixed to rusticated brick piers. A cornice and frieze separates the ground and first floors. Above the colonnade is a rendered string course, a brick frieze with the lettering NSW Ambulance Transport Service to the front and Bathurst District to William Street surmounted by a second cornice. The Ambulance Cross has also been utilised in the detail of the wrought iron balustrading.

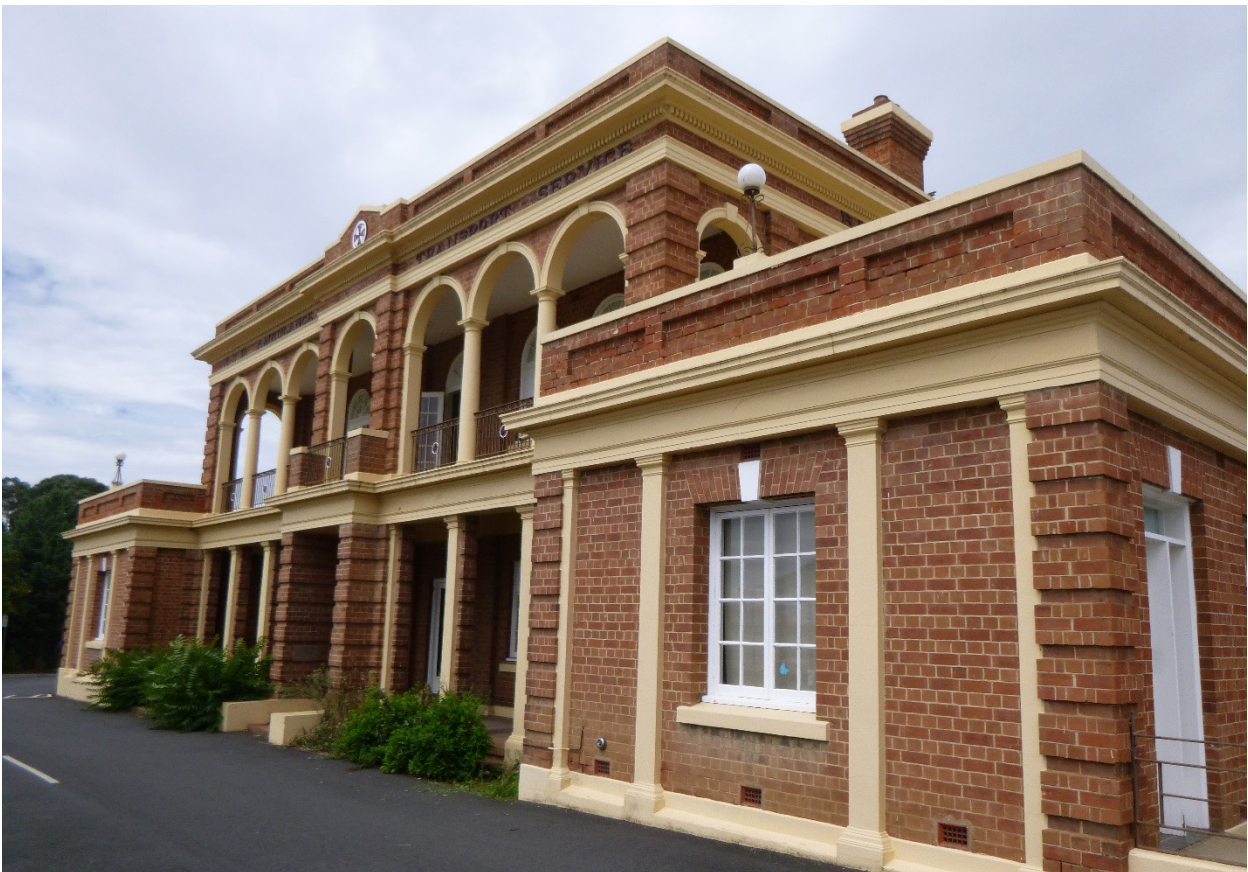
Figure 24 View showing the arcaded main façade with two story central section and flanking wings.

The arcaded main façade of the building, with its two storey central section and symmetrical flanking wings overlooks the Haymarket Reserve. This form of symmetrical façade layout is frequently termed Palladian; however the source of the design is more likely to be more contemporary civic buildings and municipal buildings that utilised Palladian motifs such as the arcade motif and symmetrical side wings. The style was loosely termed Renaissance, with the other buildings in Bathurst similarly described however these buildings are all designed in revivals of historic architectural styles. The style of the Ambulance Station has also been described as Interwar Mediterranean. The arcade form is rare in Bathurst, the colonnade and the verandah being more commonly employed. Municipal buildings such as the now demolished Fish Markets in Woolloomooloo utilised a symmetrical façade and arcade however this building no longer survives. The choice of the arcade was also a practical one, as the arcade shades the rooms within.

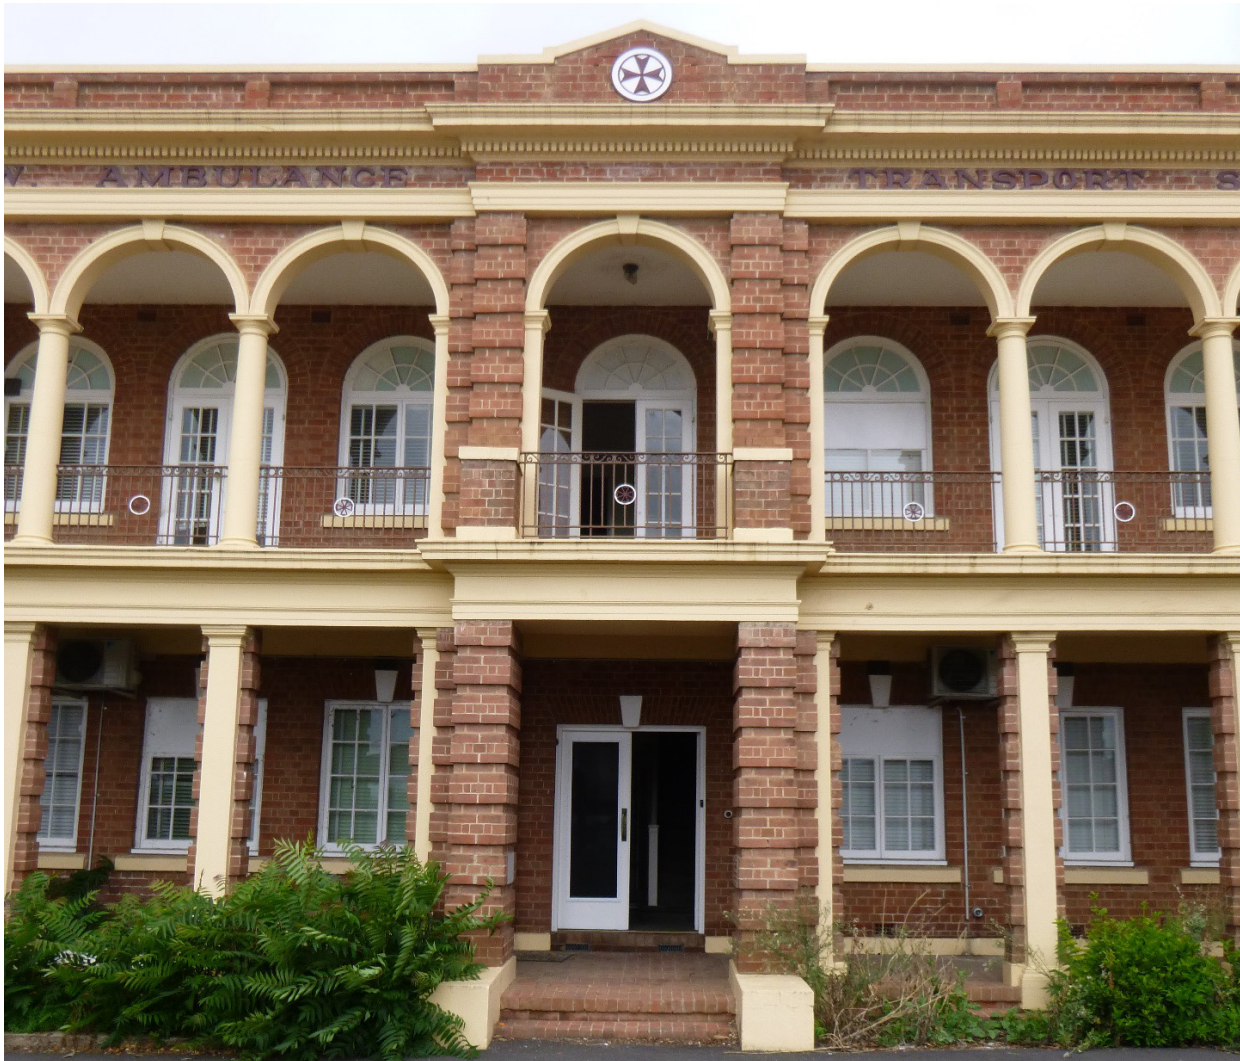
Figure 25 Main entrance located in the façade facing the reserve, showing the logo and station name on the brick frieze, below the pediment bearing the Ambulance Service logo.

The main entrance to the Superintendents Residence and lecture room for the Ambulance Officers, as well as to the operations and casualty rooms and bearers' quarters is in the centre of the main façade. The rusticated piers are constructed of brickwork and there is a triangular brick pediment bearing the Ambulance Service logo. This is the customary location for the logo on an NSW Ambulance Station. The two dwarf piers at first floor level may have been intended for urns, lamps or statues however none are shown on the photograph of the opening of the Ambulance Station. The round globe lamps on stands can however be seen.

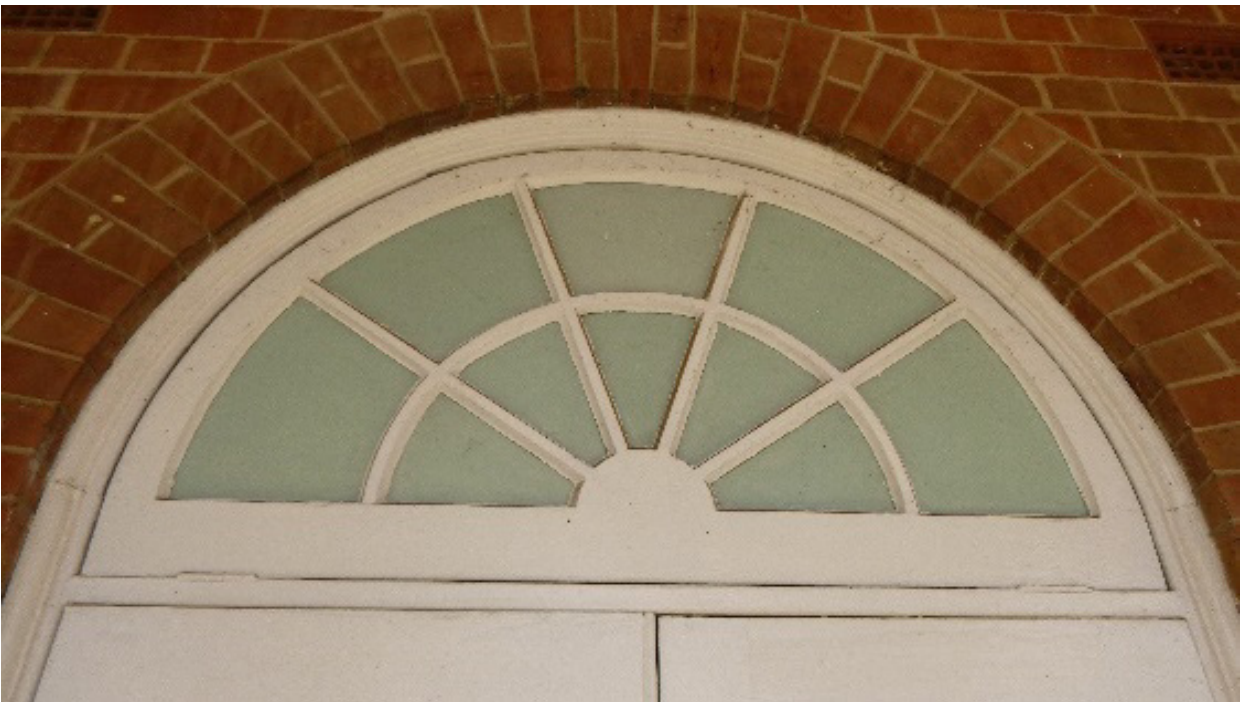
Figure 27 Fanlight over French doors onto terrace area on first floor.

French doors, with curved fanlights over, open onto the terraces at first floor level. These French doors alternate with blind arches. The arches are carefully set out brick arches, potentially of rubbed bricks. The façades overlooking the two roof terraces are not identical, as the uses of each side of the building varied. The section of the building that was the Superintendent's residence is evident in the arrangement of the windows.

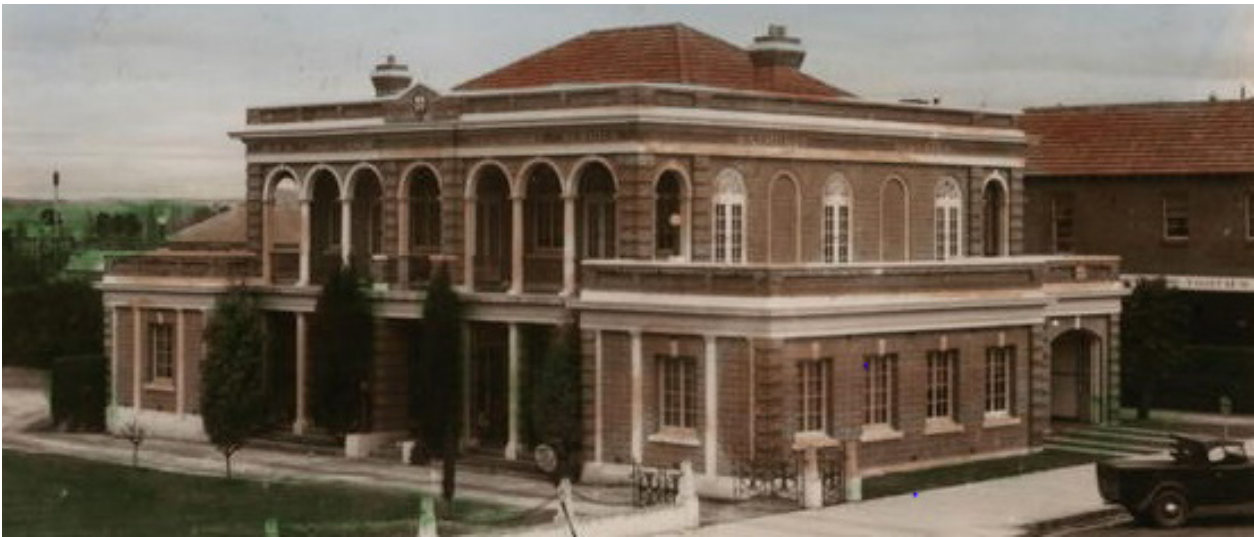
Figure 28 1954 Bathurst Ambulance Station view with one bay door visible. Photograph by A G Howett Studio of 179 George Street, Bathurst. Source: cardcow.com

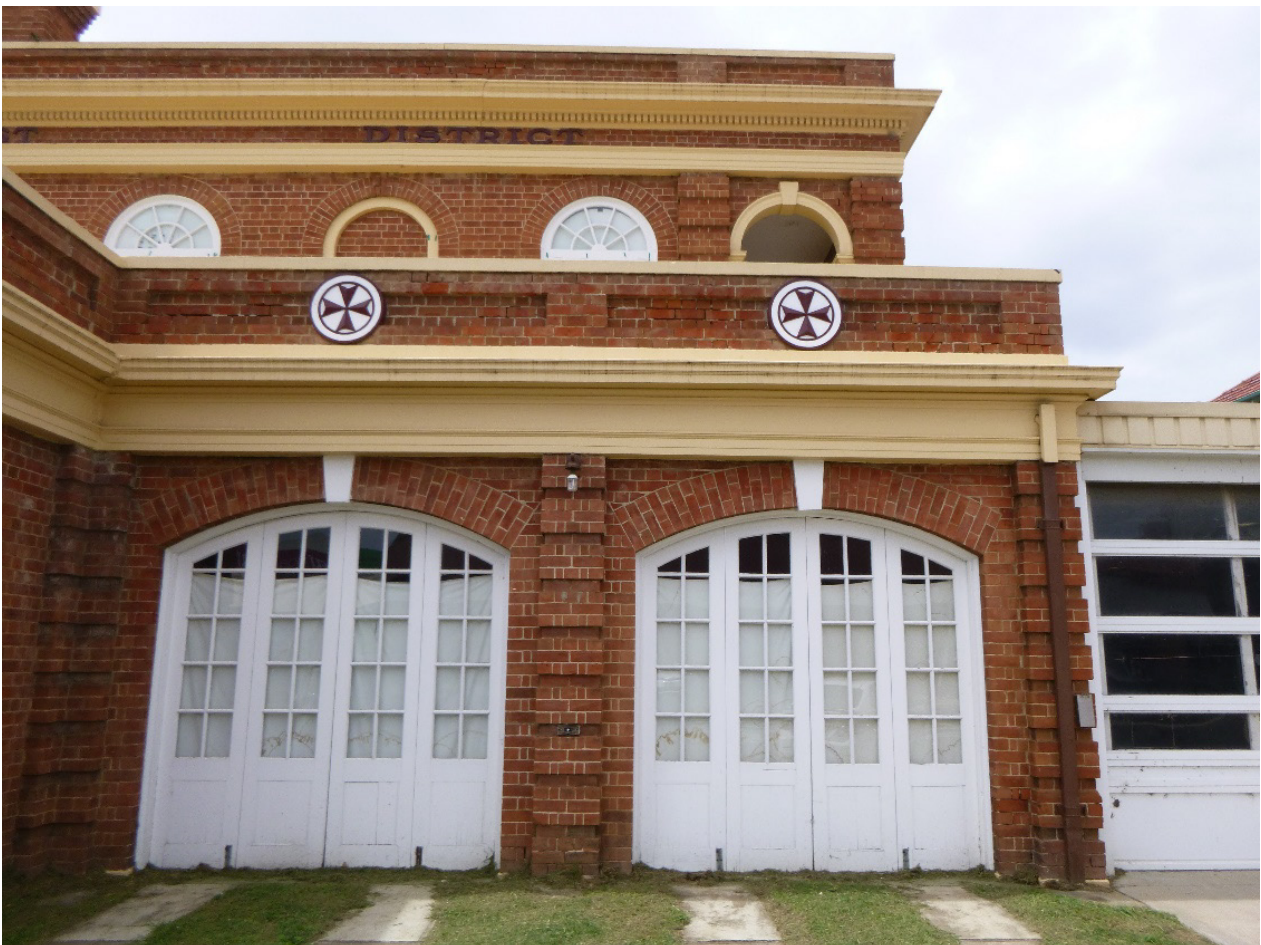
Figure 29 View of the Ambulance Bay Doors, Bathurst District Ambulance Station.

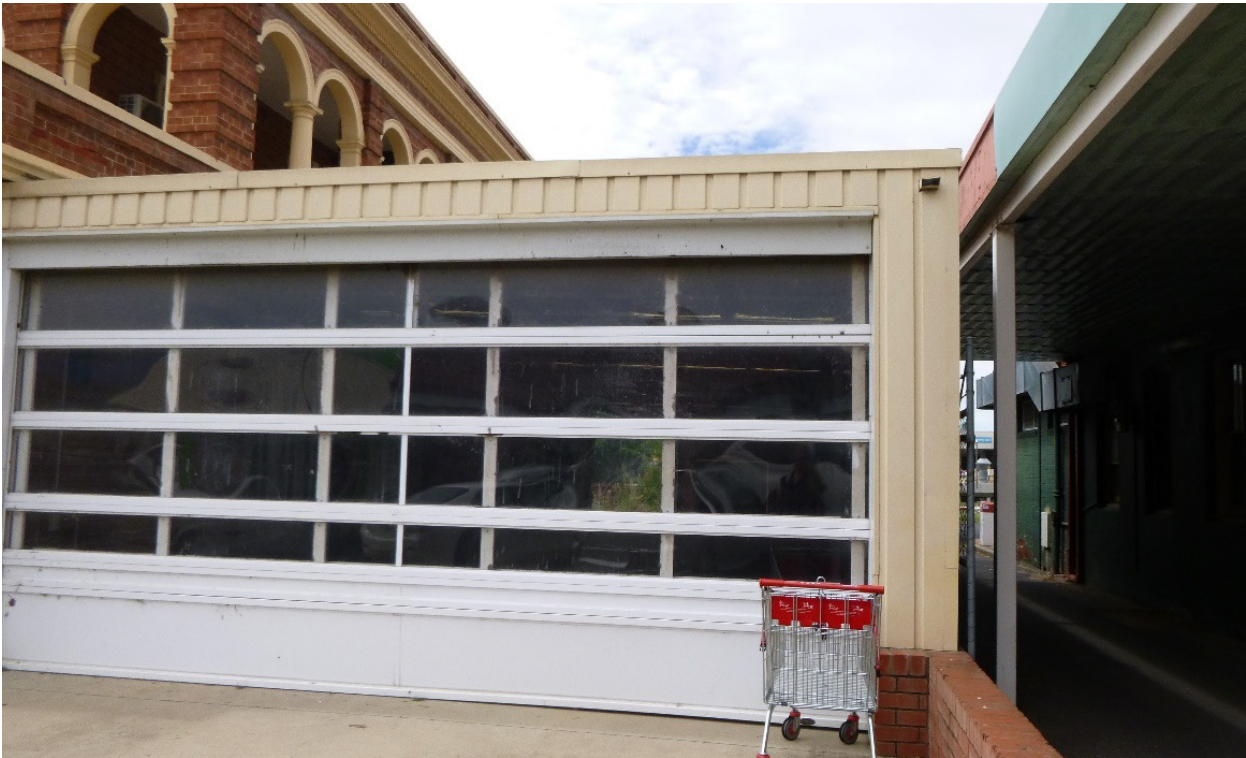
Figure 30 View of the modern covered area, Bathurst District Ambulance Station.

In its original configuration the first floor arcade to the rear and the ambulance bays at ground level were visible from the street. A hard stand area located adjacent to the Ambulance Bays has been roofed over with a modern roof and modern garage doors.

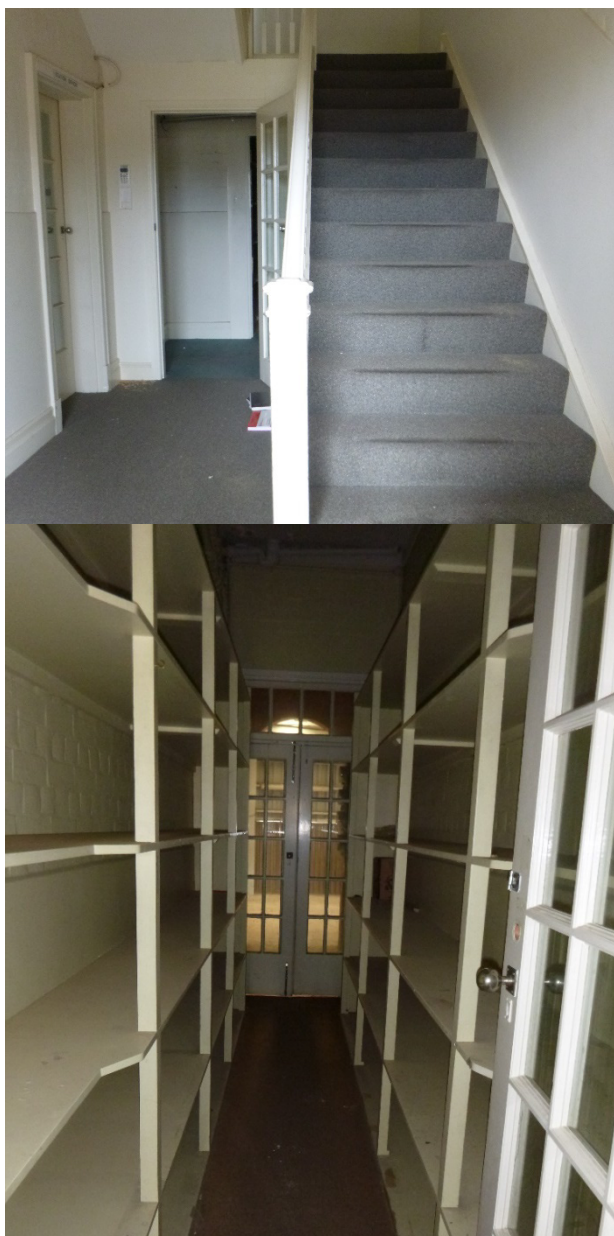
Figure 34 Entry stairs and passage between ambulance bays leading to the rear yard.

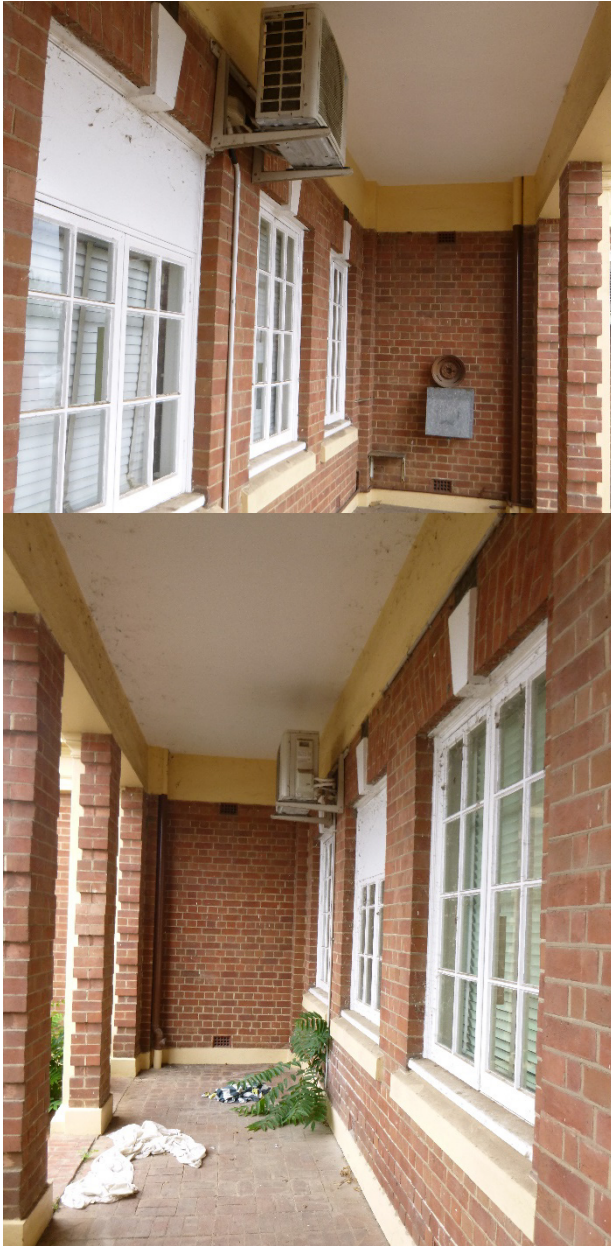
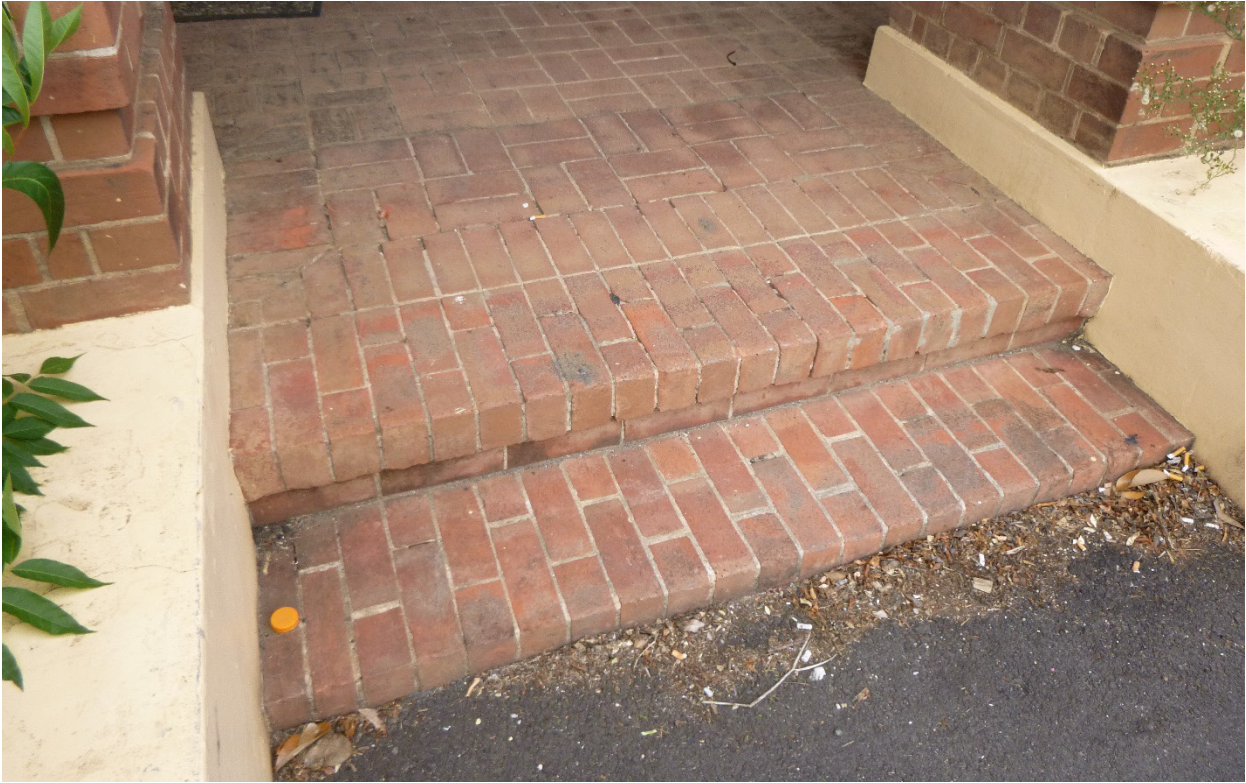
Figure 35 View of the vestibule area including entry stairs.

Although the colour scheme and other finishes have been altered, the volume of the hall and the staircase survives. The finishes are as in the other main rooms on both levels.

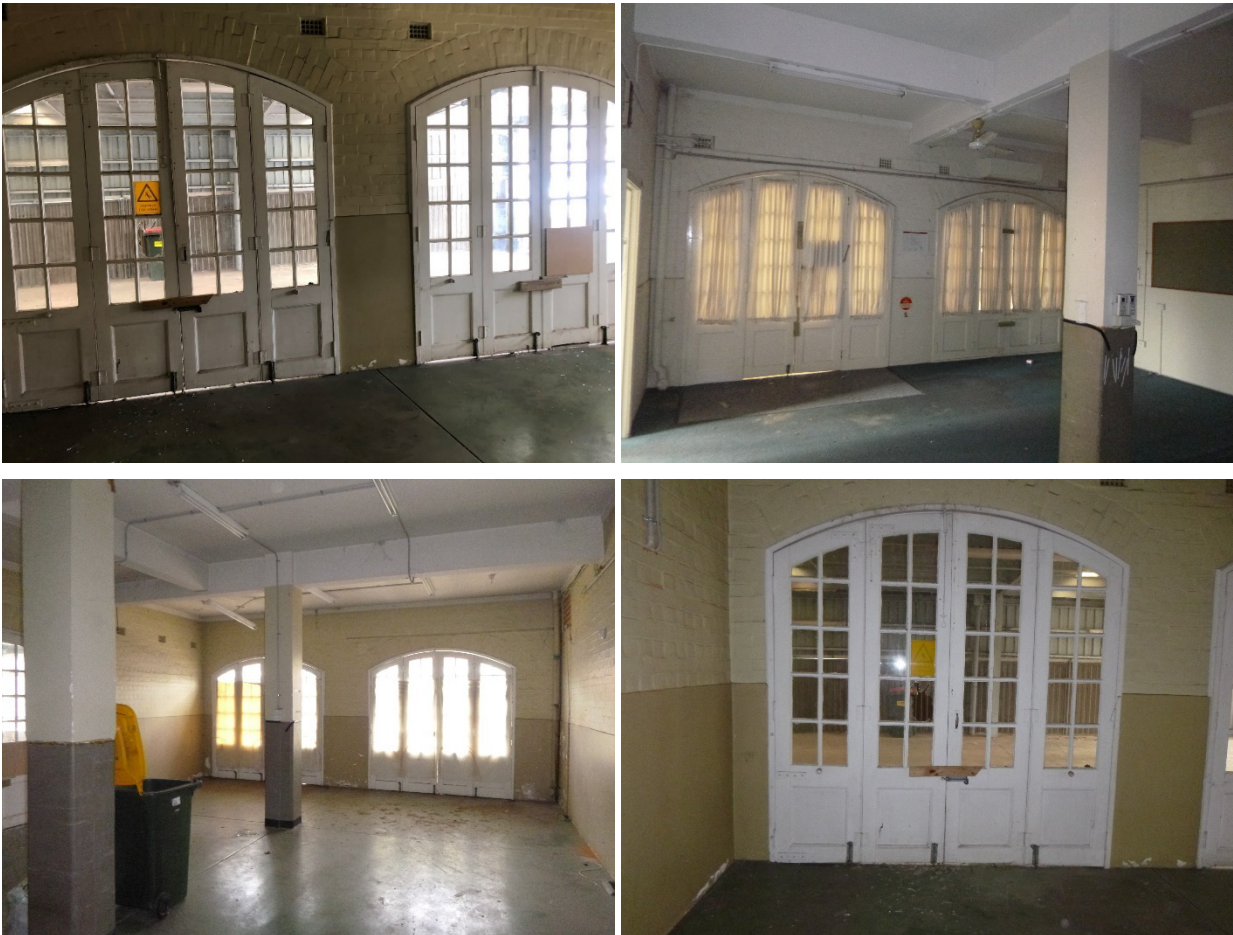
Figure 36 Internal views of one of the Ambulance Bays

Unlike most NSW Ambulance Stations there are two separate areas for vehicles. The front bay is located closer to the casualty room. The back bay is likely to have been utilised for maintenance.

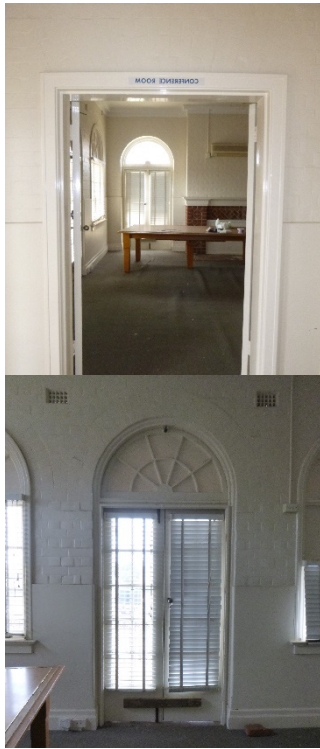
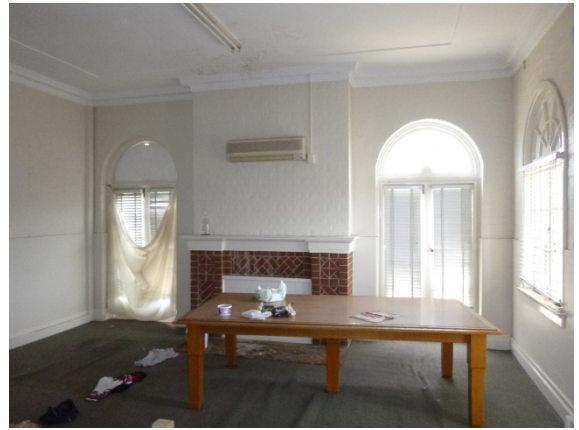
Figure 38 View of former lecture room with detail of verandah door.

The Lecture Room on the first floor largely retains its original character. The room volume, joinery and detailing survive, including the French doors with fanlights above that open onto the arcade and roof terrace. The fireplace has distinctive herringbone brick work, and it appears that the wall above the fireplace was intended to be face brick as well, however this element is now painted. The cornice and fibrous plaster ceiling survive. The light fittings are modern. A doorway connects the lecture hall to the superintendent's flat, but this may be a later addition.

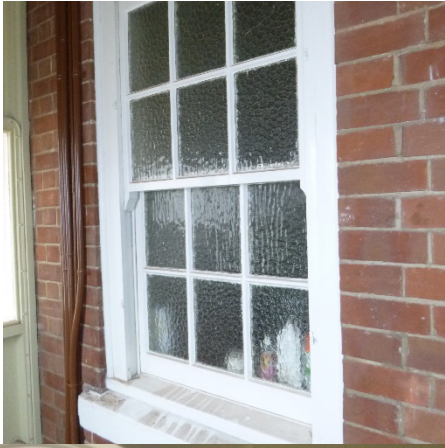
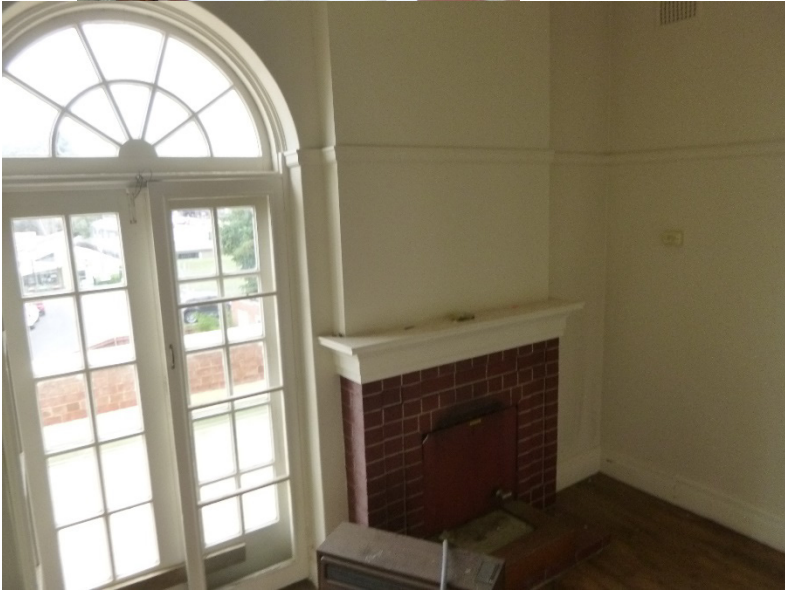
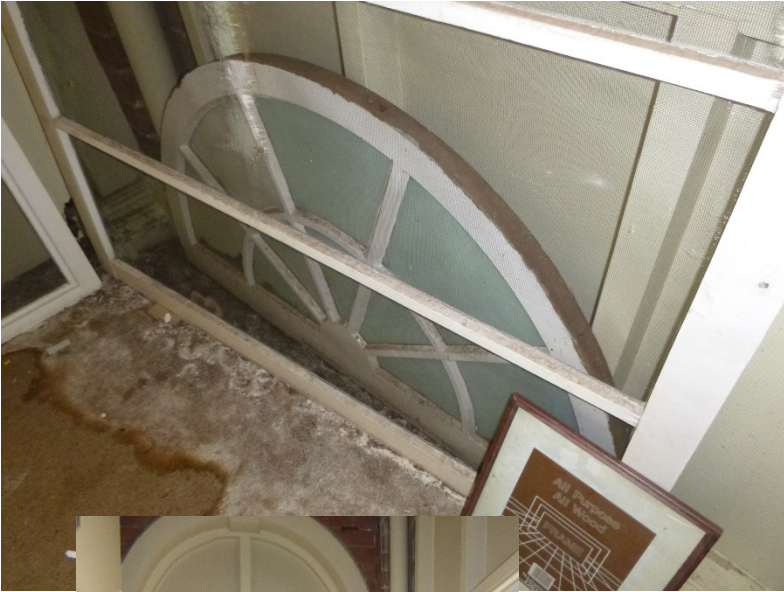
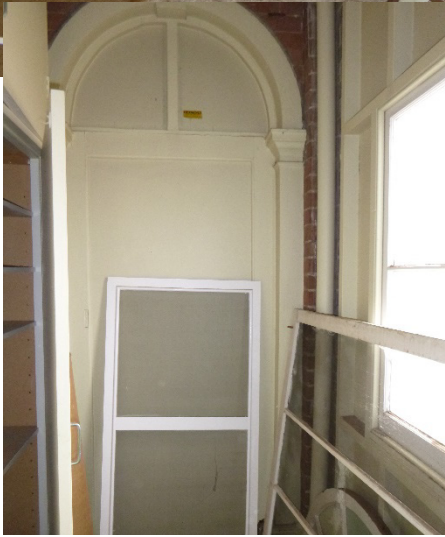
Figure 40 View of the former Superintendent's residence showing window, fireplace, rear verandah area and lounge.

The same architectural vocabulary as the remainder of the building is utilised in the residence. Face brickwork to the fireplaces in the lounge and breakfast room survives. The lounge room and breakfast room also have a picture rail. In the lounge surface mounted conduits intersect this rail. The air conditioning unit has been placed above the fireplace. The glazed French doors to the breakfast room also survive and this room opens onto the terrace. The kitchen cupboards and oven and sink are more recent. The bathroom fit out retains some interwar elements but has been altered.

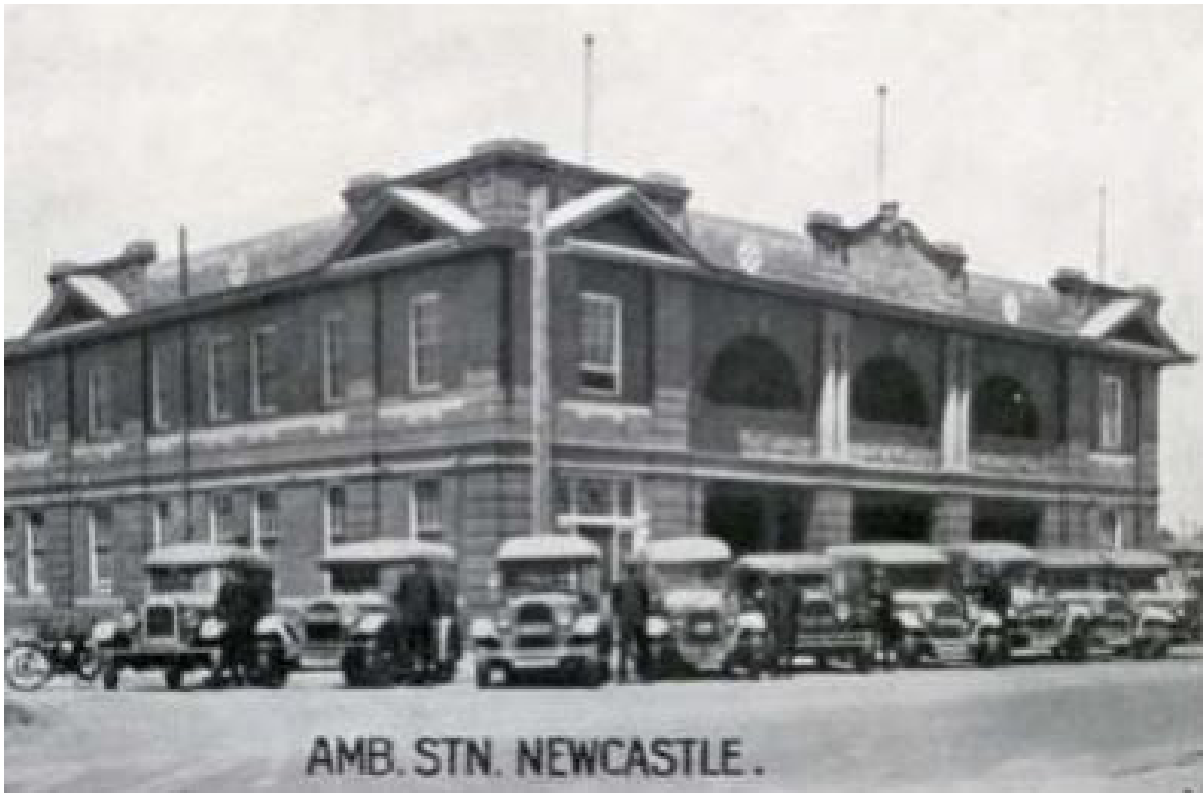
Figure 43 Ambulance Station, Newcastle. Source: Flickr.

The station will be a brick two-storied building with a frontage of slightly over 90 feet. The ground floor is planned to hold 18 cars, and in conjunction is a main office, casualty room, storeroom, kitchen for the bearers, and recreation room. The superintendent's office will be connected with his residence. Upon the upper floor there will be a lecture room, 64 feet by 25 feet, portion of which can be partitioned off by sliding doors and used as a board room. The floor will also contain bedrooms for nine bearers, and bathrooms. The superintendent's residence will contain four bedrooms, sitting-room, bathroom on the top floor, the dining-room, kitchen, and laundry being on the ground floor. A large balcony, 10 feet wide, will occupy the front of the building, and at the rear there will be another balcony of the same width. A repair shop, carpenter's shop, fumigating house, an oil store, and a shed for the washing of the cars, will occupy the ground at the rear of the main building. The ground floor will be laid of concrete with the exception of the plant room, which will be laid with red ironite. A Bowser

petrol filling apparatus will be installed for the brigade's cars. The estimated cost of the building is £6500 [pounds]...⁶¹

The mining and industry in the Newcastle area resulted in the need for such an extensive complex, the Bathurst District Ambulance Station was designed for four cars, had fewer bearers' bedrooms and the superintendent's flat was smaller.

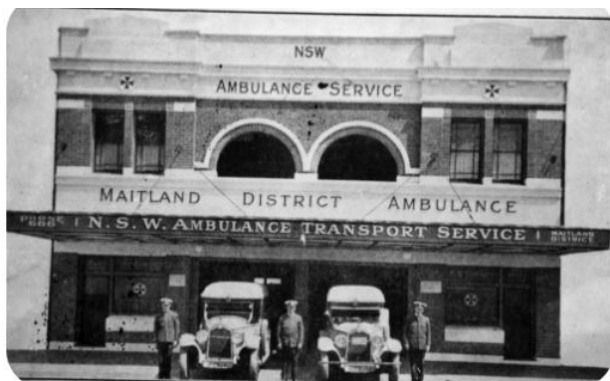
Figure 44 Maitland Ambulance Station. Source: Flickr.

Other Ambulance Stations that were opened in 1929 include Maitland and Wagga Wagga. The Maitland example was also slightly larger than the new station at Bathurst and was designed for six Ambulance cars. Historic photographs show that the station had a smaller street frontage, lacking the side pavilions and landscaped setting found at Bathurst.

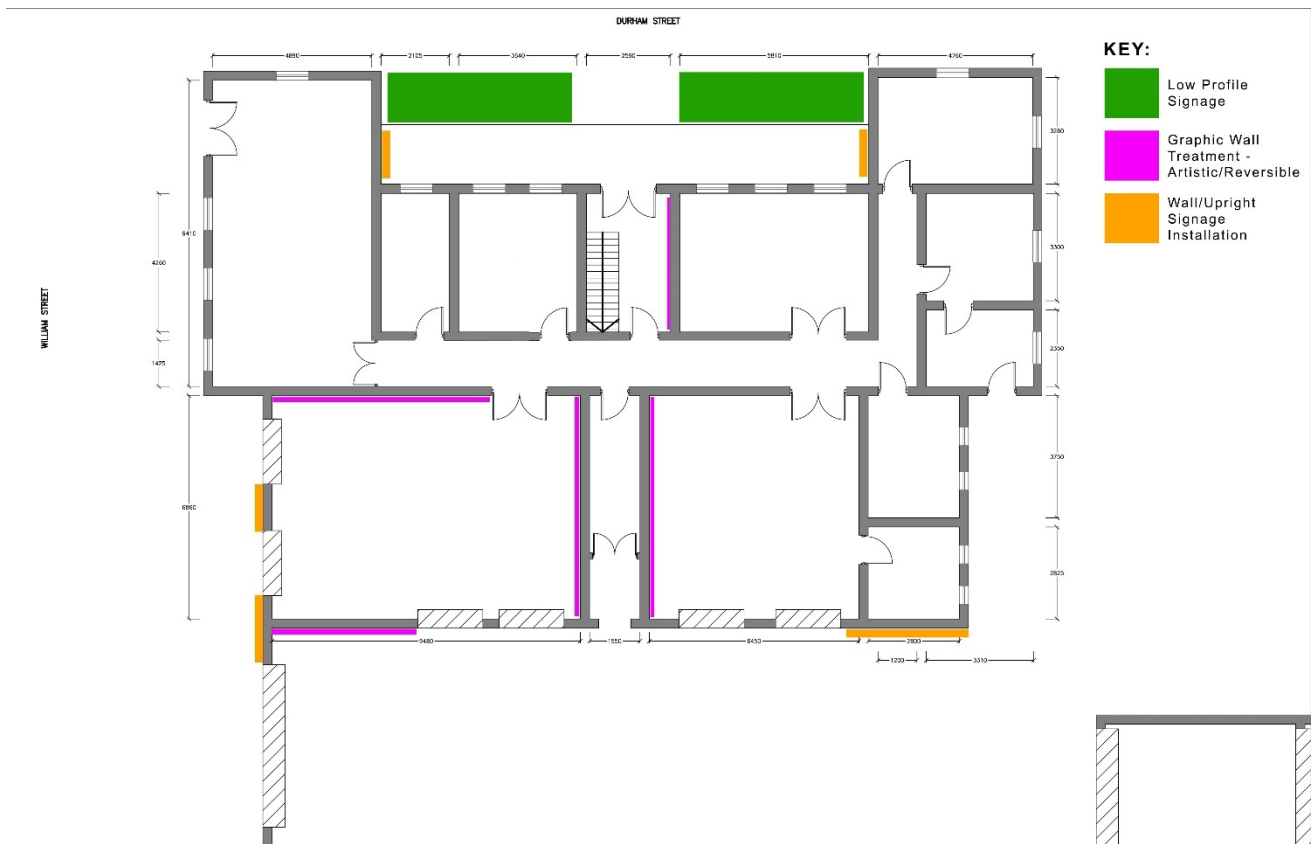
Figure 48 Location for various on-site interpretation devices depending on decided usage. Note: It is not recommended to use all of these places concurrently, it shows opportunities to suit future requirements.

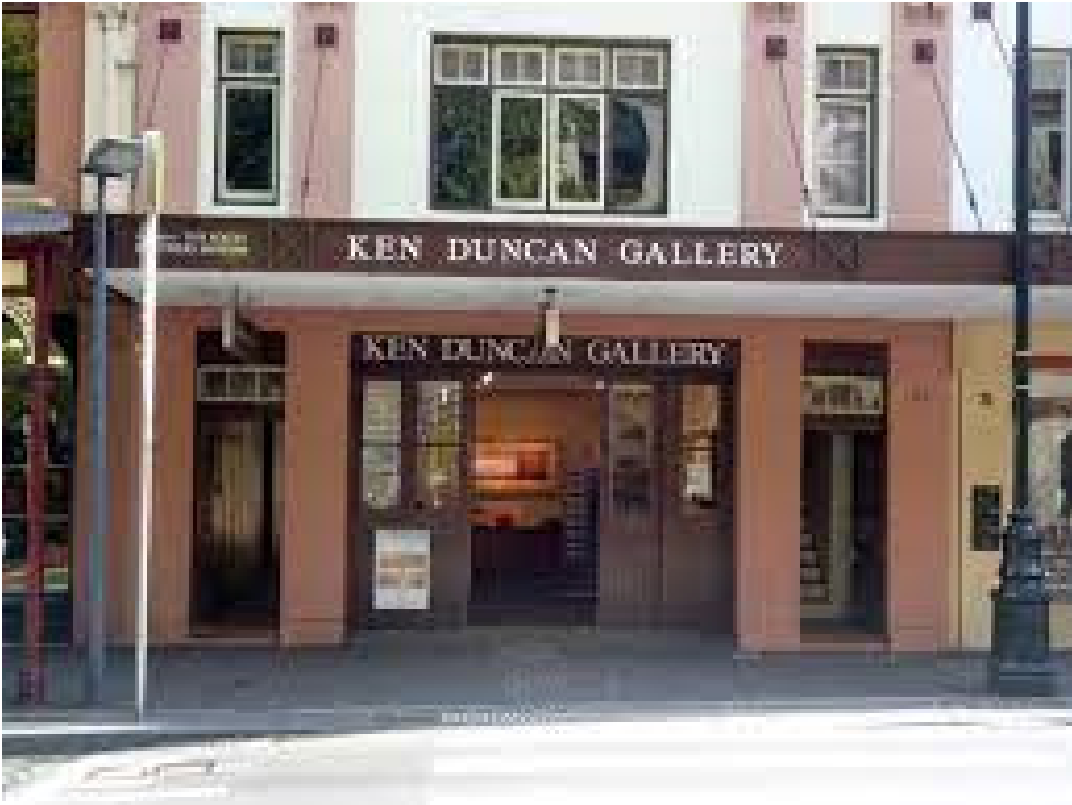
Figure 51 The former Central District Ambulance Station now an art gallery.

The former Central District Ambulance Station in George Street North, which was not a purpose built ambulance station but was installed into an earlier building, has operated as a gallery for many years. The characteristic Ambulance Station doors were retained.

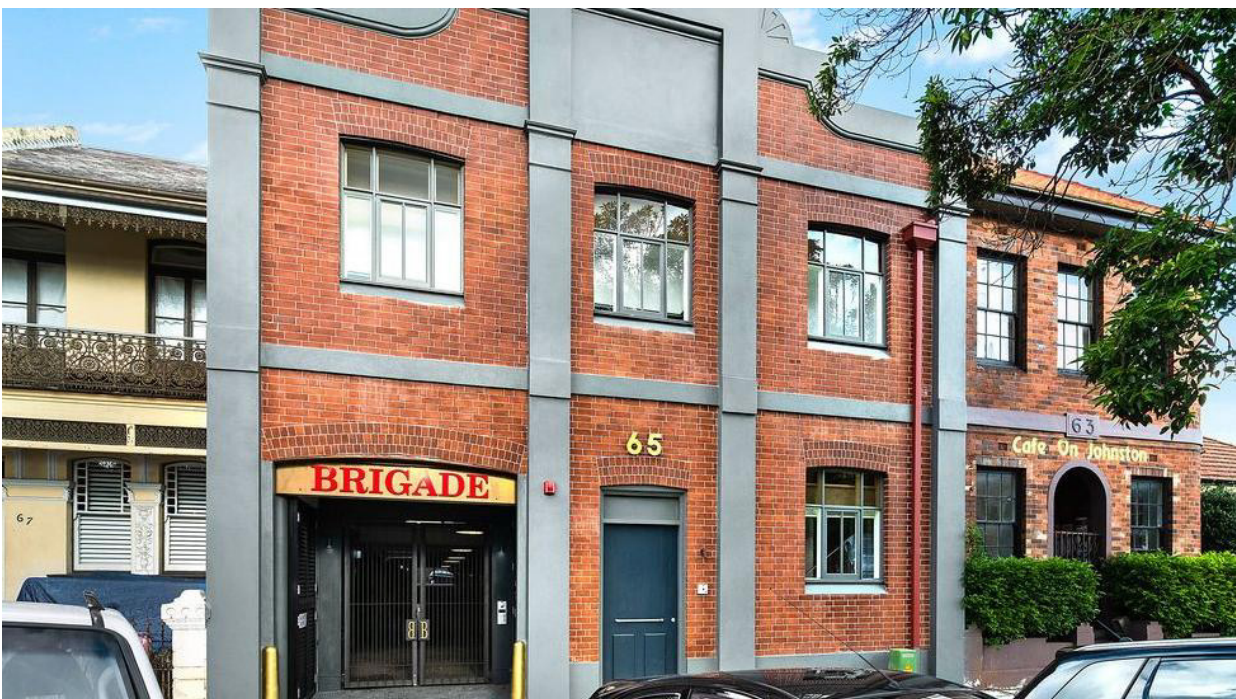
Figure 52 The former fire station on Johnston Street Annandale.

The former fire station on Johnston Street Annandale now contains apartments and a café. Other than the signage, it is difficult to determine the previous use of this building. Likewise, the former Ambulance Stations at Coogee and Manly have been so altered in their conversions that they are no longer recognisable as such. This outcome is not a desirable one and the characteristic Ambulance Station doors should be retained.

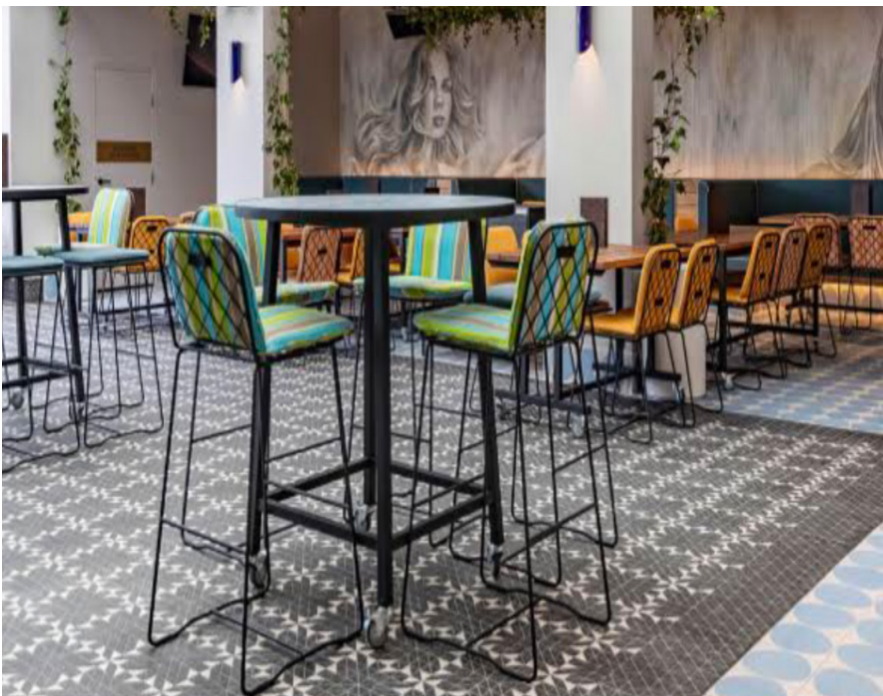
Figure 56 Example of a canopy over approach to a hardstand area. Source: General Gordon Hotel.

The canopy over the hardstand area could be replaced with a much more elegant roof, such as the opening roof that has recently been installed in the courtyard of the General Gordon hotel in Sydenham, Sydney. Currently the roofed courtyard is very utilitarian in character.

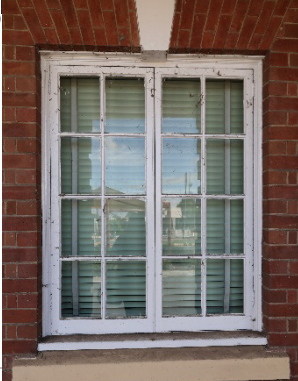
Window No.	Description	Repairs
GROUND FLOOR		
W1.01	Casement, flat arch	Follow   its repairs plan.
W1.02	Casement, flat arch	Follow   its repairs plan.
W1.03	Casement, flat arch	Remove and reconstruct window frame and casement window to match the profiles, details and materials of W1.02.  
W1.04	Casement, flat arch	Follow

its repairs plan.

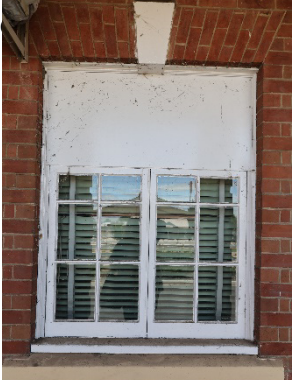
Reconstruct window frame and casement window to match the profiles, details and materials of W1.04.
W1.06	Casement, flat arch	Follo

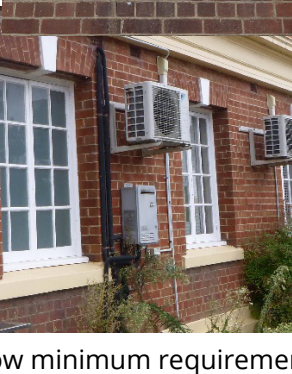
nts repairs plan.
W1.08	Casement, flat arch

Follow minimum requirements repairs plan.

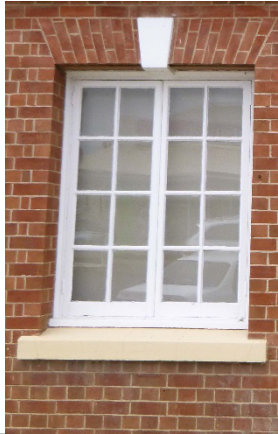
W1.17	Casement, flat arch

<p>Follow minimum requirements repairs plan.</p>
W1.18	Casement, flat arch	<p>Follow minimum requirements repairs plan.</p>
