FORMER BATHURST DISTRICT
AMBULANCE STATION
**CONSERVATION
MANAGEMENT PLAN**

Corner of Durham and William Streets, Bathurst NSW
Issued January 2023 | Final

Former Bathurst District Ambulance Station, Conservation Management Plan

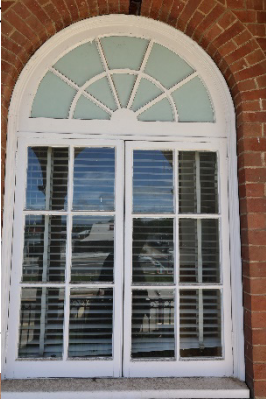
FIRST FLOOR		
W2.01	Casement, semi-circular window head	<p>Follow minimum requirements repairs plan.</p>

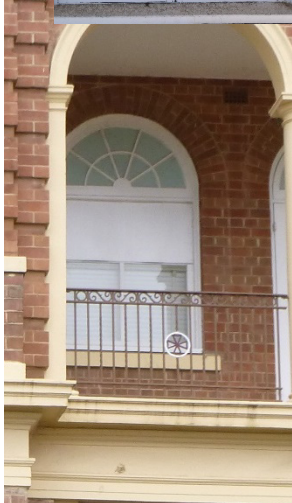
<p>Carefully remove window and window head if required.</p> <p>Reconstruct window frame and casement window to match the profiles, details and materials of W2.01.</p>

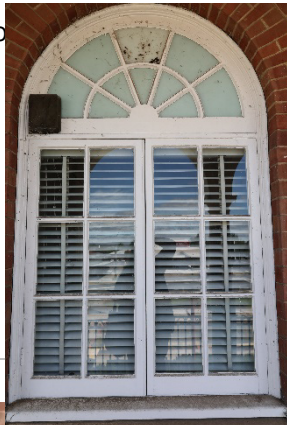
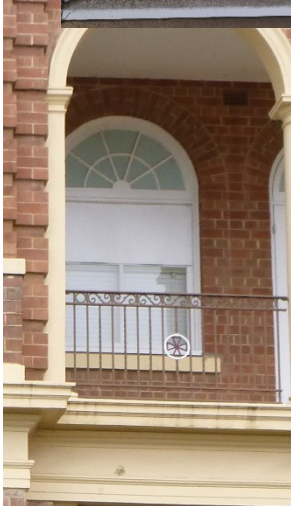
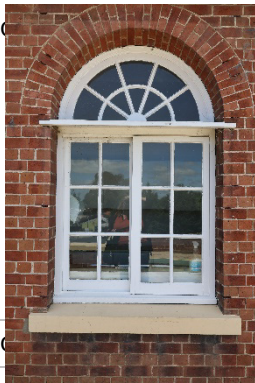
W2.03	Casement, semi-circular window head	Follow [Image] elements repairs plan.
W2.04	Casement, semi-circular window head	Follow [Image] minimum requirements repairs plan.
W2.05	Casement, semi-circular window head	Follow [Image] elements repairs plan.
W2.06	Double hung	Follow [Image] elements repairs plan.
W2.07	Double hung	Follow minimum requirements repairs plan.
W2.08	Double hung	Follow minimum requirements repairs plan.
W2.09	Double hung	Follow minimum requirements repairs plan.

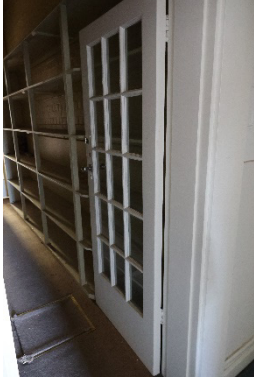
<p>Follow minimum requirements repairs plan.</p>
D1.08	Single leaf timber door.	Follow minimum requirements repairs plan.
D1.09	Modern panel door.	Follow minimum requirements repairs plan.
D1.10	French doors, framed glass panels (x 10 per leaf)	  <p>Follow minimum requirements repairs plan.</p>
D1.11	Single framed glass panel door (x 15 per leaf)

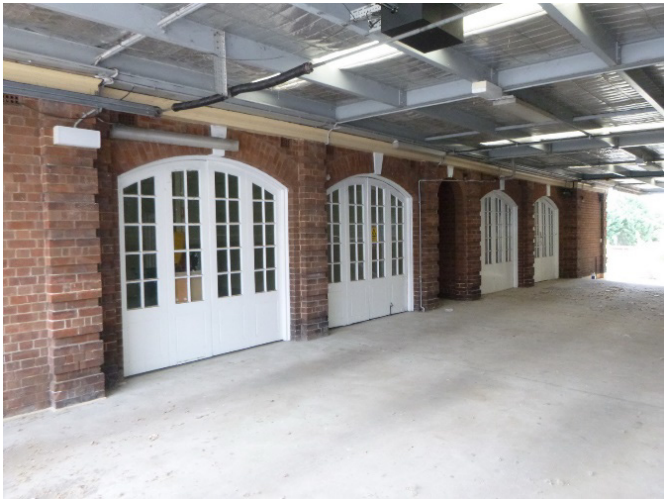
<p>D1.13 D1.14 D1.15 D1.16</p>	<p>Bifold garage door, Framed timber doors with glass panels (x 10 per leaf), 1929</p>

<p>Follow minimum requirements repairs plan. Maintenance for these doors should be a priority and be undertaken by a suitably qualified tradesperson experienced in repair of heritage assets.</p>
<p>D1.17</p>	<p>Modern garage door.</p>

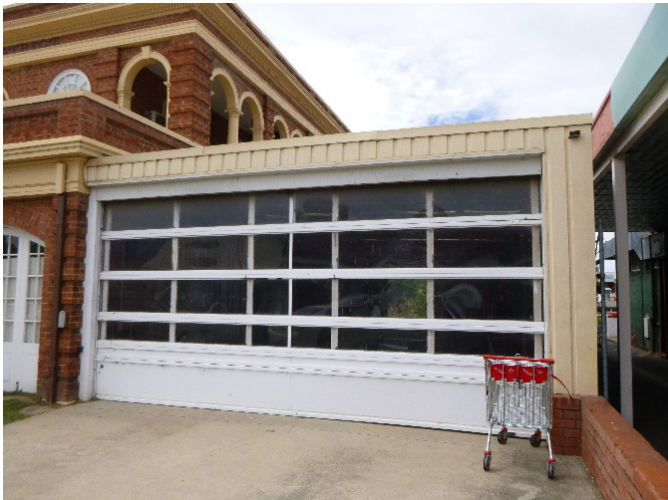
<p>Remove and dispose of off-site.</p>
<p>D1.18 D1.19</p>	<p>Bifold garage door, 1929</p>

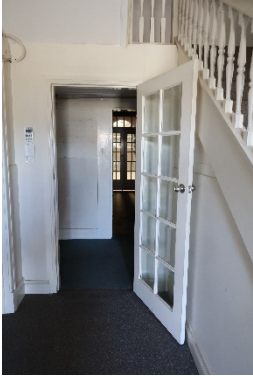
D1.26	Single leaf framed timber door with 10 glass panels (2 wide x 5 high)

Follow minimum requirements repairs plan.
-------	-----------------------------------------------------------------------	------------------------------------------------------------------------------------	-------------------------------------------

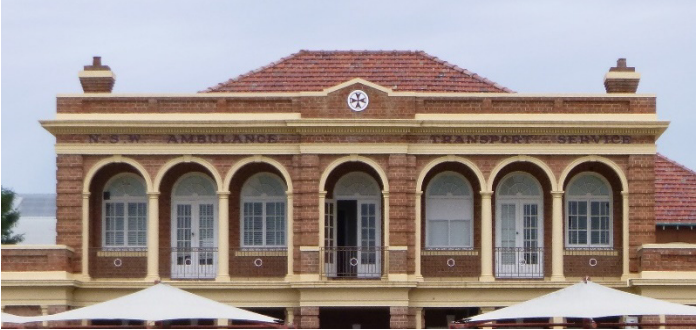
D2.01 D2.02 D2.03 D2.04 D2.05 D2.06 D2.07 D2.08	External doors. French doors with semi-circular fanlight, 1929. Framed glass panel (x 10 per leaf)

<p>Follow minimum requirements repairs plan.</p>
----------------------------------------------------------------------	----------------------------------------------------------------------------------------------------------	-------------------------------------------------------------------------------------------------------------------------------------

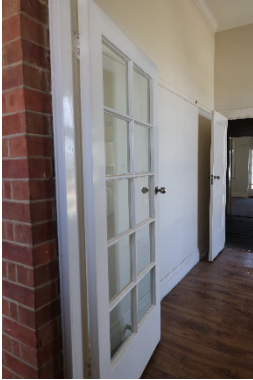
D2.09	Single leaf framed timber door with 10 glass panels (2 wide x 5 high)

Follow minimum requirements repairs plan.
-------	-----------------------------------------------------------------------	--------------------------------------------------------------------------------------	-------------------------------------------

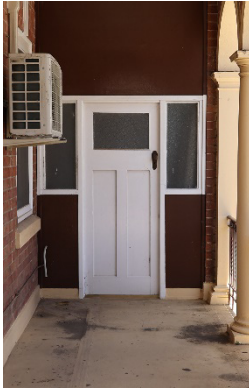
Remove infill panel, door, door frame and windows, and fixings. Patch repair brick finishes. Co-ordinate with floor repairs.
-------	-----------------------------------------------------------------------------------------------------------------	--------------------------------------------------------------------------------------	---------------------------------------------------------------------------------------------------------------------------------
