Bridges Conservation Management Plan

Authors: Barbara Hickson, Heritage Advisor &
Nicholas Murphy, Senior Strategic Planner, Bathurst Regional Council

October 2010

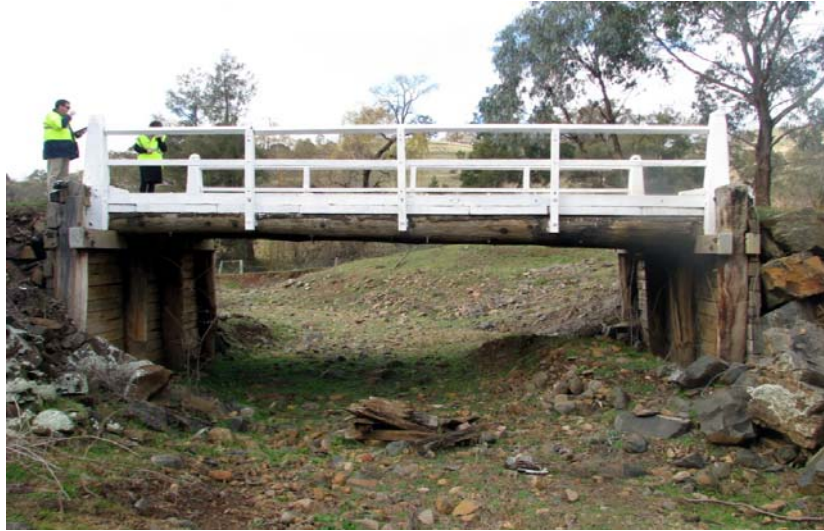
Figure 4: F97 Single span bridge on Red Hill Road

The timber bridge in **Figure 4** below is on the Red Hill Road leading to the Upper Turon which is now only lightly trafficked. The bridge, picturesquely positioned over a dry creek, is an excellent example of the bush craft and local materials used in such a structure. It spans almost 8.2 metres and features timber slab abutments, locally gathered dry stone wing walls and timber railings. The bridge possibly dates back to the late Victorian period.

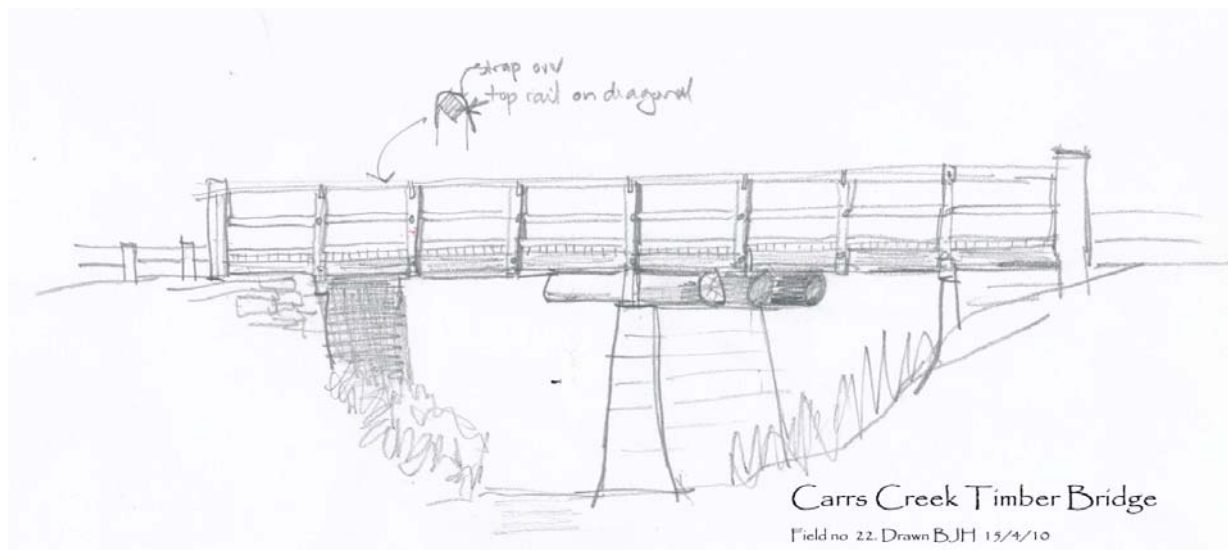
The Carr's Creek Bridge (F22) a two span timber bridge, serves to illustrate many of the principal features, though the end span posts are missing.

Figure 5: F22 Sketch of Carr's Creek Bridge

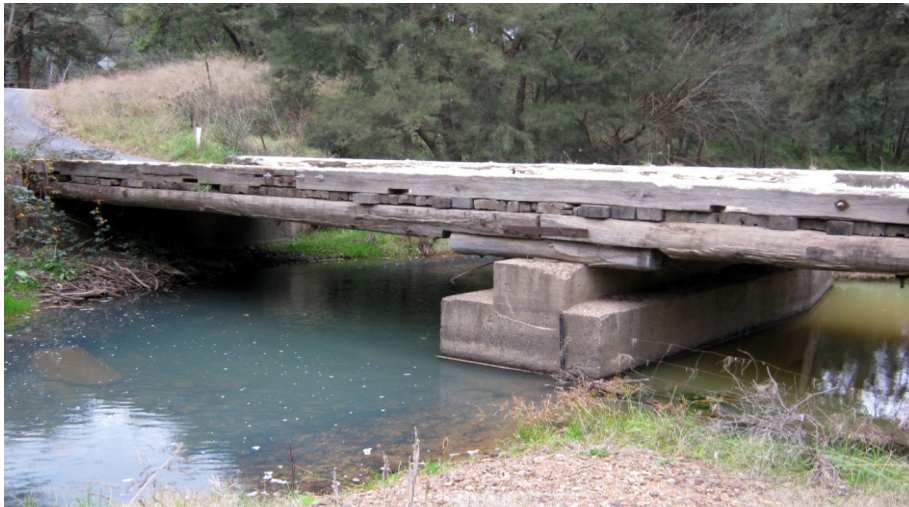
Figure 6: F127 Winburndale Rivulet low level crossing timber bridge

and the low level crossing timber bridge over Winburndale Rivulet (F127) which is 27 metres long and divided into just spans.

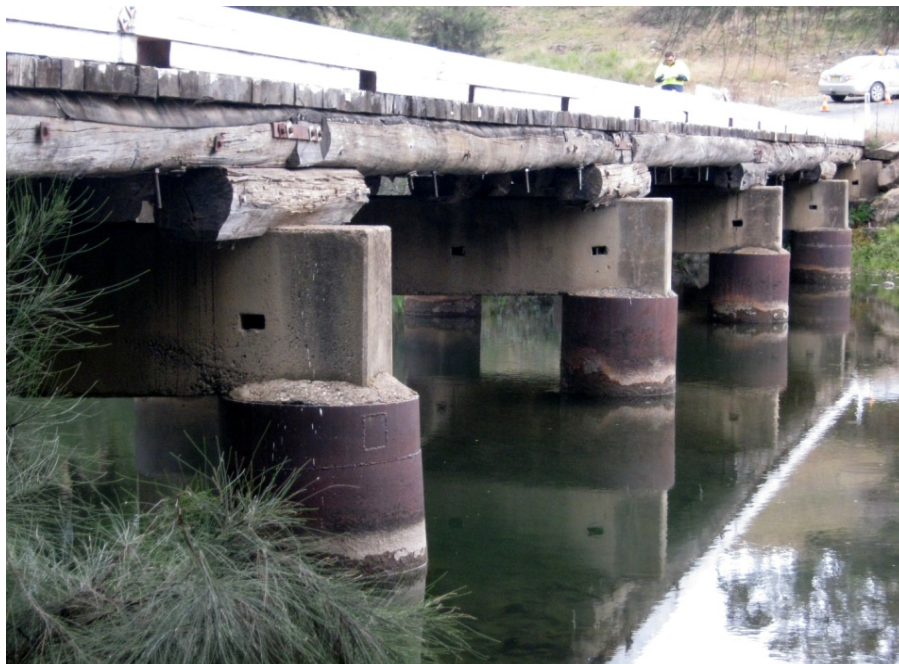
Figure 7: F117 Coles low level bridge over the Turon River

When single spans could not suffice, multiple spans were introduced to break up the total distance. Two good examples of simple log bridges of multiple spans in Bathurst are the Coles Bridge (F117), over the Turon River which is 53 metres long and divided into 5 spans,

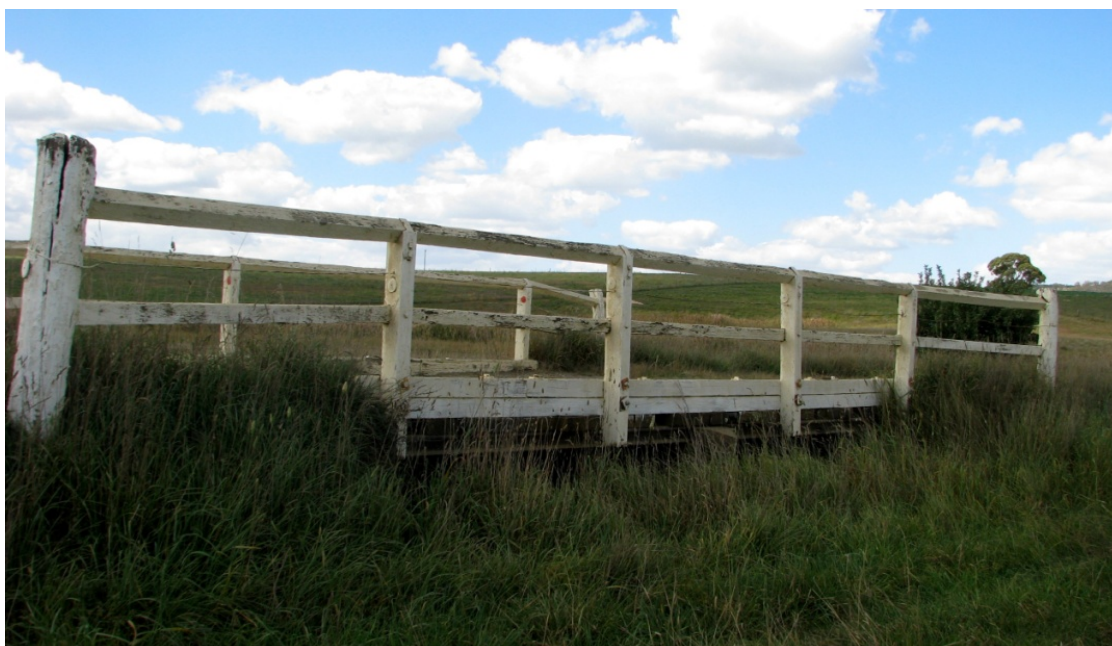
Figure 8: F30 Schumacher's Road, a timber and steel bridge

Towards the end of the 19th Century the use of steel as a structural component became more popular locally. A number of the bridges that used steel beams in lieu of timber give the appearance of simple timber structures from road level but are evident when viewed from beneath. Steel beams and sometimes railway track line are used as the main support for the road deck. Examples in the inventory with this construction method include a timber bridge on Schumachers Road (F30) and McGeorges Creek Bridge (F39).

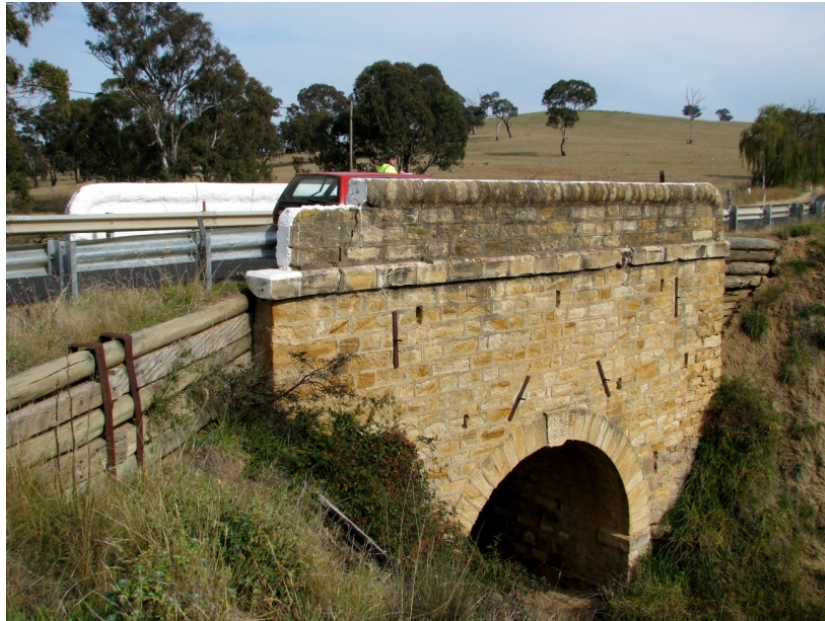
Figure 14: F75 Brewongle stone arch bridge

The Brewongle bridge was probably built by public works, possibly in conjunction with the rail work that was occurring at that time. Its quality dimensioned stones must have been brought to the area especially for the purpose. Cross braced with tie rods and with deep weep holes for drainage, its overall detail suggest a public works design. The granite stone for the Kellosheil Bridge is more likely to have been won locally. It would be more difficult to work, but is a very durable stone.

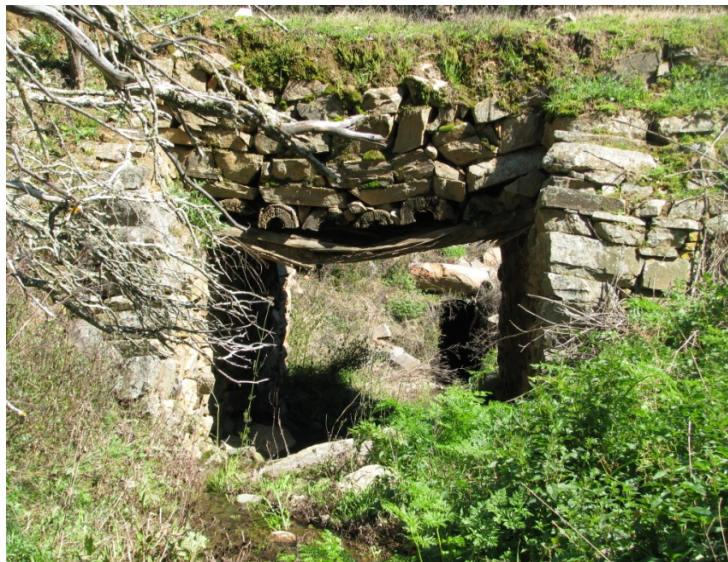
Figure 17: Disused Bridle Track stone bridge

On The Bridle Track two more exemplar bridges of this style remain. They too have raised stone wall balustrades with rotating ends but much more rustic in character having been constructed from local stone which appears to be a type of slaty, sedimentary, stone very prevalent in the rocky landscape. These are not a true arch bridge either and their simple single span is supported by timbers in the round. Probably the local stone being so varied in shape precluded it being used for such an accurate masonry structure as an arch.

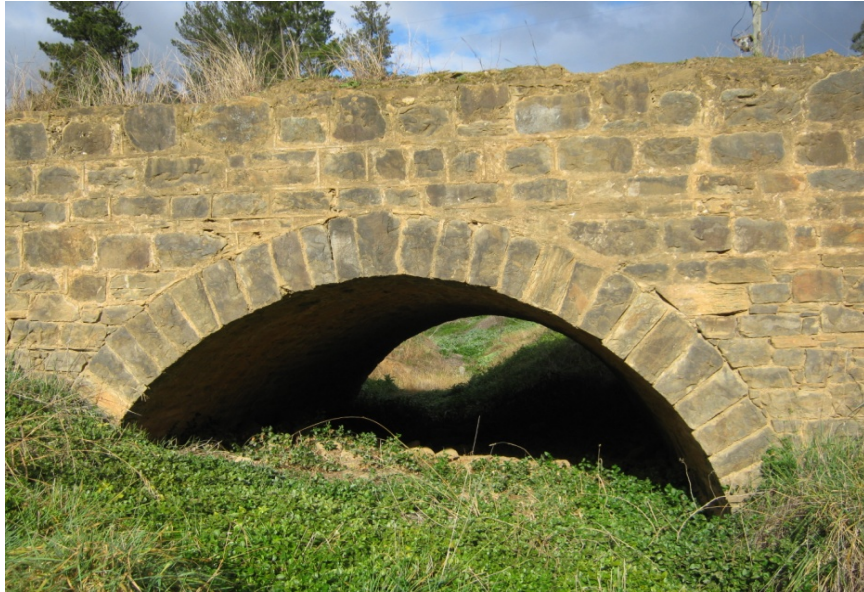
Figure 18: F109 Stone bridge 1887 Hill End Road

Another four good stone arched bridges are located along the Hill End Road between Sofala and Hill End. Three of these bridges are dated with engraved stones, being 1887, Jan 1888, and 1890 travelling from Sofala towards Hill End. They are stone arched bridges with joints raised, struck and expressed. There is some physical evidence that each originally had stone balustrades that rose above the road level, but which are now generally missing or partially retained below existing built up road levels. These bridges are difficult to see from the road. The best opportunity to view the bridges is from within their associated water courses looking directly onto the side elevations.

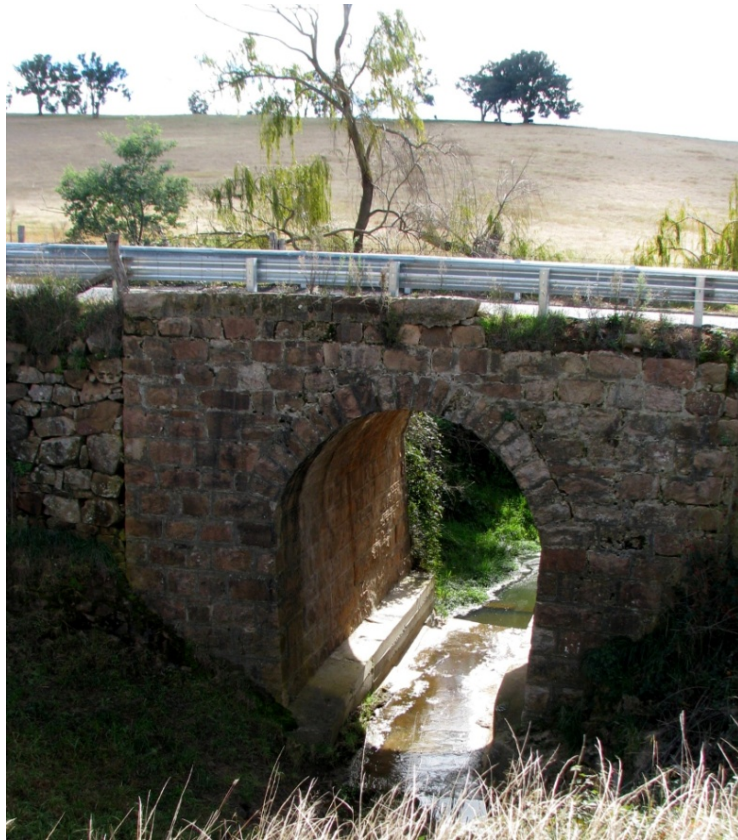
Figure 20: F52 Deep Creek stone bridge, The Lagoon

Another stone arch bridge over Deep Creek at The Lagoon is the tallest of the region's examples. An attractive sandstone arch, built around 1890, over Deep Creek (refer to **Figure 20**) its aesthetics have been spoilt in that the top courses have been removed and Armco railings now dominate the upper line of the bridge.

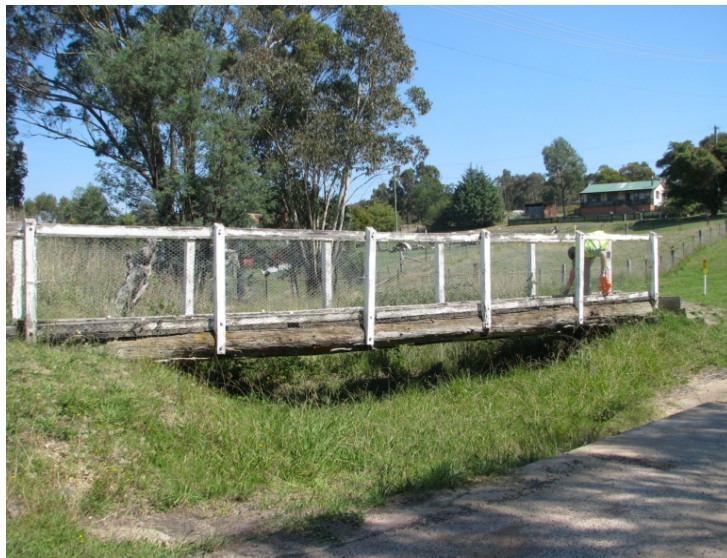
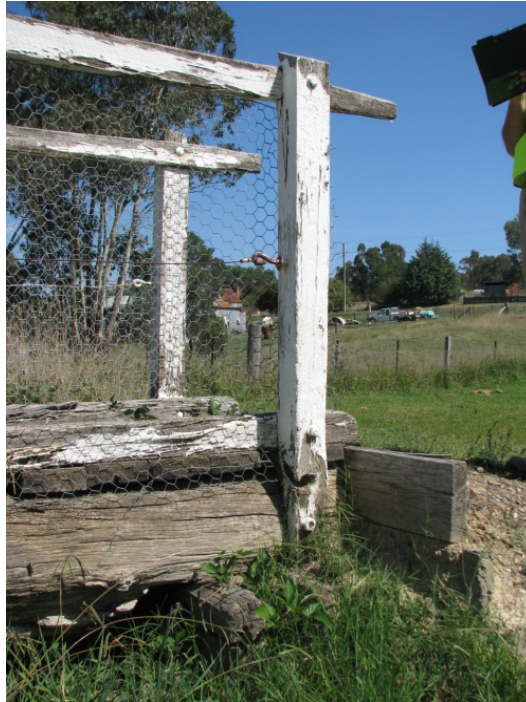
Figure 21: F15 Long view of Trunkey Creek Primary School Footbridge

Eleven footbridges were recorded as part of this study. Most are still in use today and generally serve as pedestrian access over watercourses to schools or sportsgrounds. A good example is the Trunkey Creek Primary School (F15) timber log footbridge that enables children to reach school when Trunkey Creek rises.

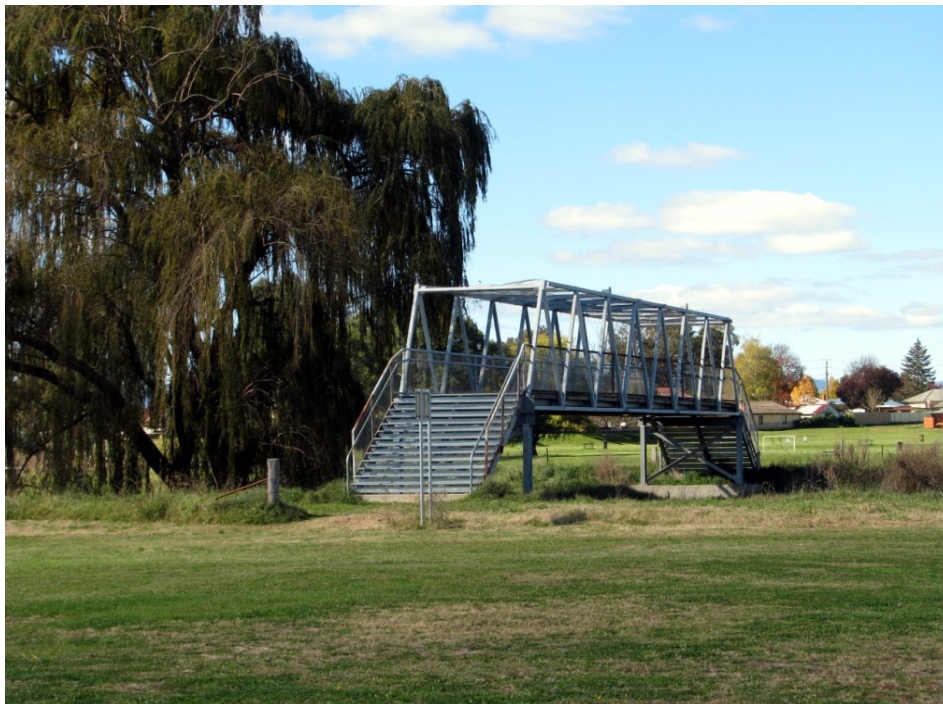
Figure 23: F60 Proctor Park footbridge Bathurst

A good example of a sports bridge is at Proctor Park (F60) where an all weather crossing over Raglan Creek is afforded by a steel truss structure constructed in recent years. This bridge was originally used as part of the Sydney 2000 Olympics and later purchased by Bathurst Regional Council and placed within Proctor Park.

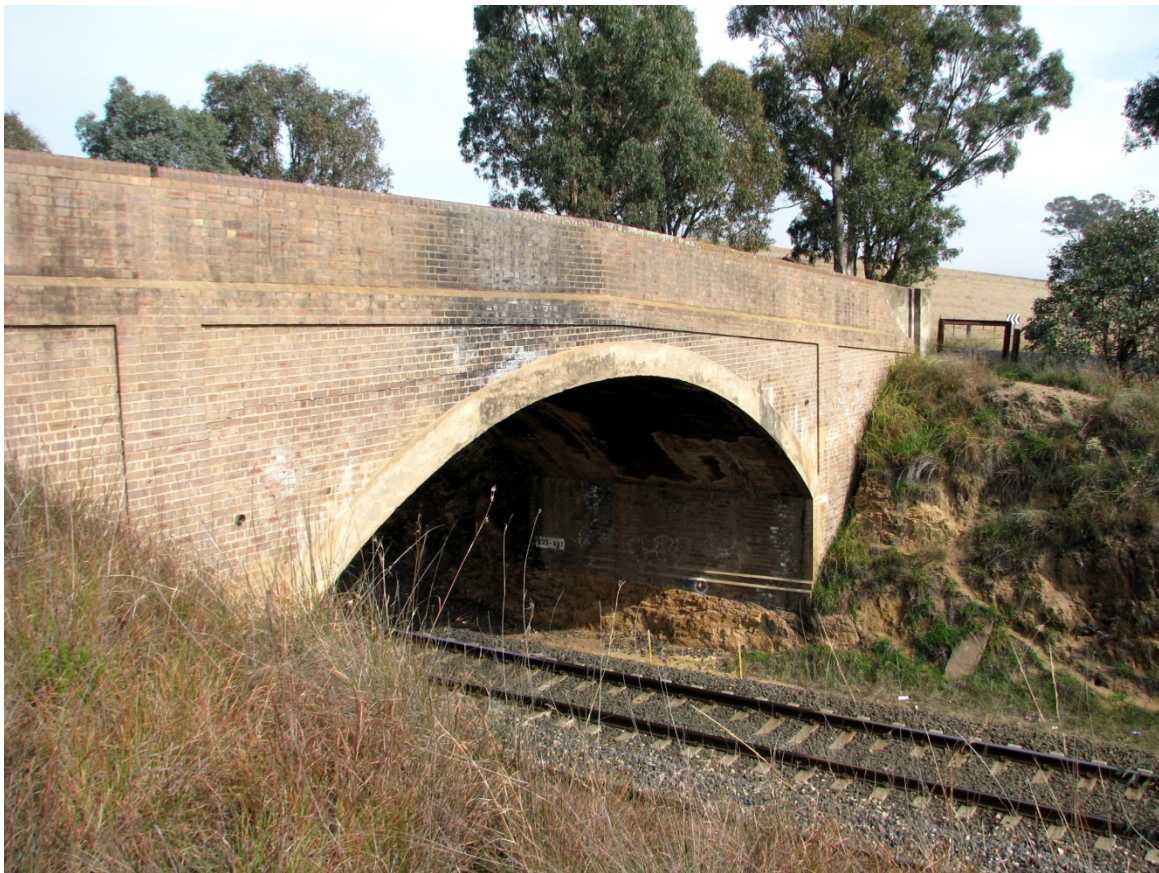
Another example is built in brickwork, F73, and located near Brewongle. The bridge displays a long and elegant single low arch. This may be a concrete arch bridge within an otherwise brick structure, or rendered masonry. Because of the length and flatness of the arch it is not surviving well. Long horizontal cracking has appeared in the structure.

Figure 29: F73 Brewongle long single arched brick and possibly concrete bridge

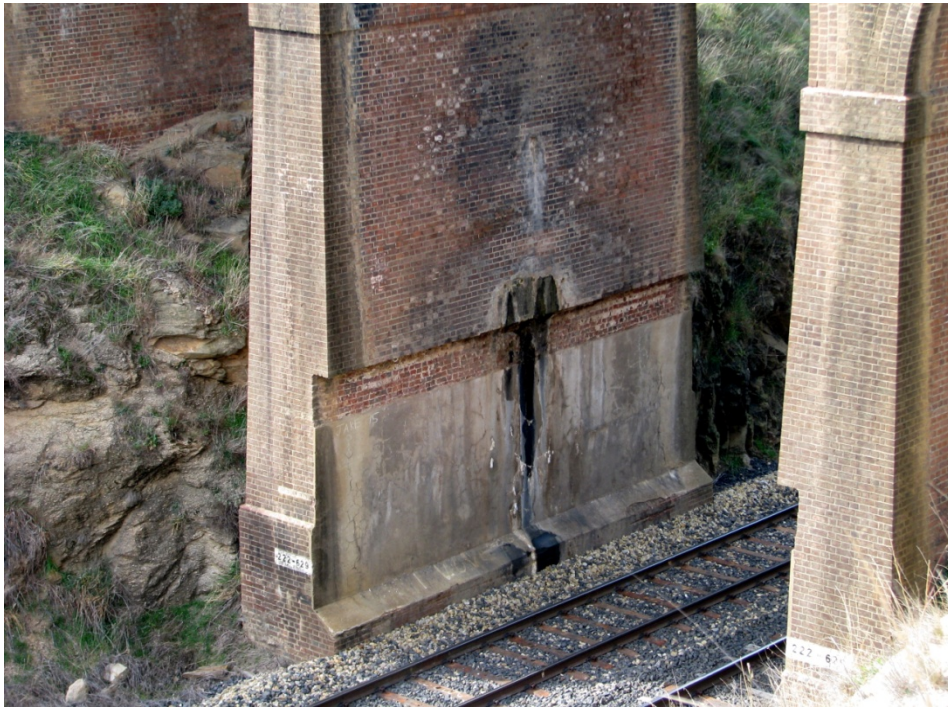
At track level, and for a height of approximately 5.2 metres, a skin of brickwork has been removed. It is two bricks wide at the base, tapering to 1 brick or 230mm at the top. This new face was rendered over, although the upper section of nine courses has not been, indicating that this probably occurred at a later date.

Figure 30: F74 Track side detail showing brick removal to widen the space for the second rail line

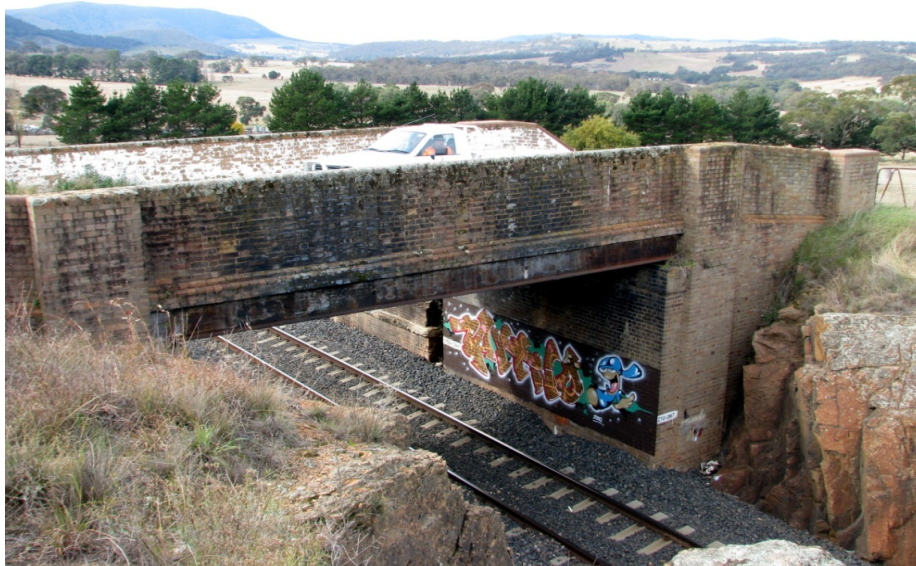
The brick bridge over rail on Kinghorne Falls Road (F82) is an example of a bridge which was abandoned, partially demolished and replaced. This is a strange bridge which is constructed with a light weight structure of steel to span over the rail line while the bridge structure was loaded up with brick balustrades.

Figure 32: F82 A replacement bridge with steel frame and brick balustrade

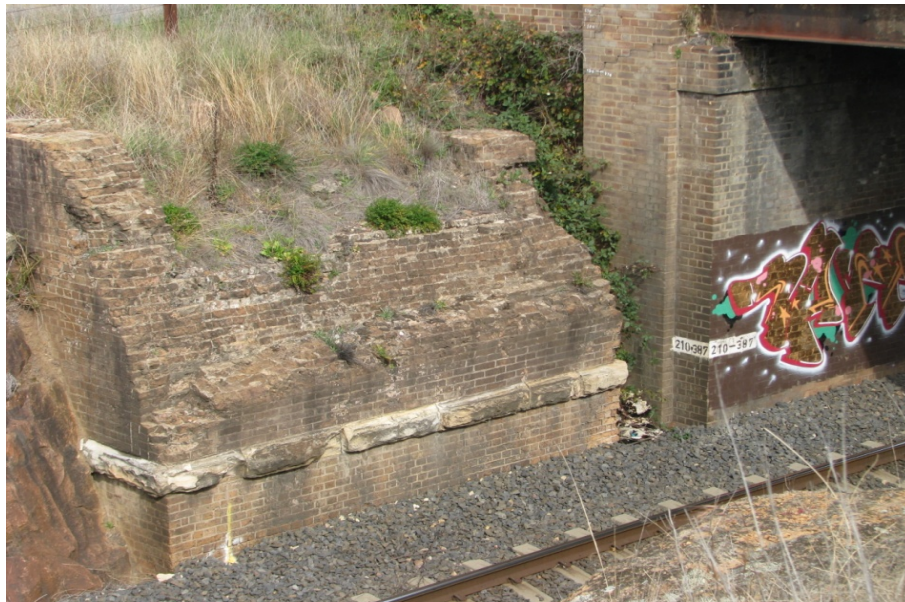
Next to this bridge are the remains of the former arched brick structure with stone trim. Possibly bricks were salvaged from the demolished structure and used in the new bridge balustrade.

Figure 33: F82 The remains of the demolished bridge, most probably an arched brick structure

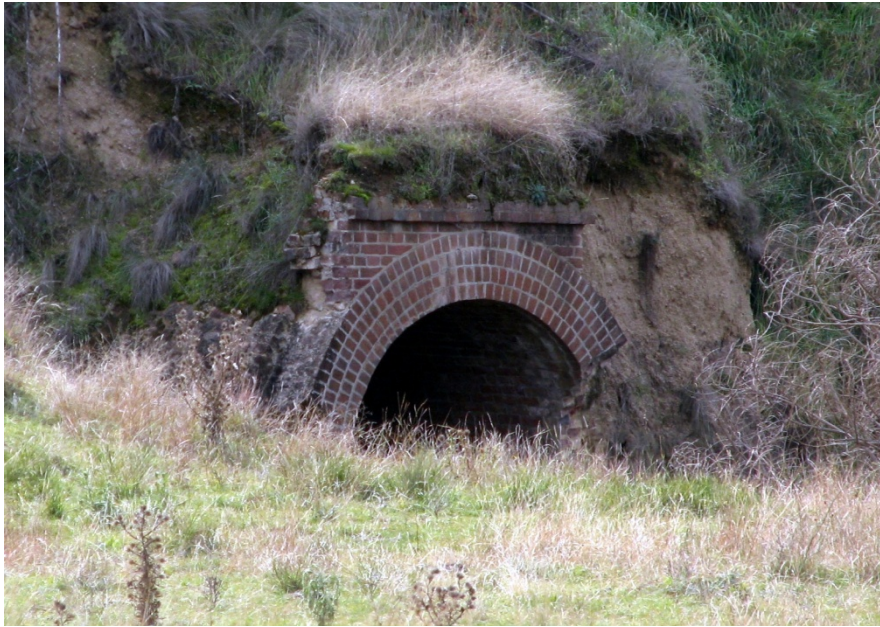
Figure 34: F76 Abandoned brick tunnel - drainage culvert

There are some brick structures that remain as part of the abandoned rail line. In particular brick drainage tunnels to allow for drainage under the elevated tracks remains in situ. F76 below is such an example. It formed part of the earlier rail line that was abandoned when the deviations of the mid 1890s were built near Brewongle. Presumably this high rail line on top of a levy bank structure could not be easily widened to accommodate a second track.

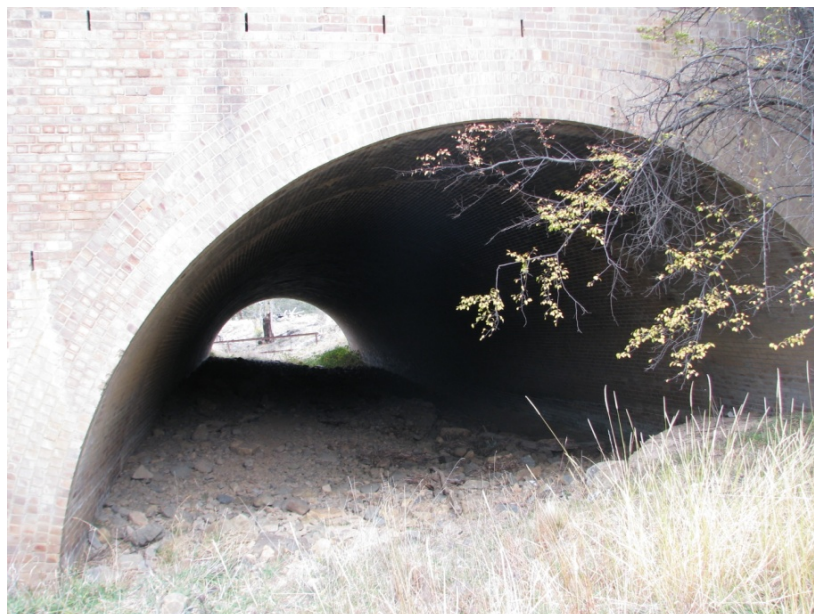
Figure 35: F84 Brick tunnel

The scale of the drainage tunnels is quite impressive and the workmanship even more so. Examples include over Eusdale Creek on Tarana Road (F84) and a double arch bridge on Tarana Road (F86). It was possible to walk right through the tunnel of F84 as the ground surface was dry. The tunnel is 47 metres long and in excellent condition inside with all brickwork fully tuck-pointed.

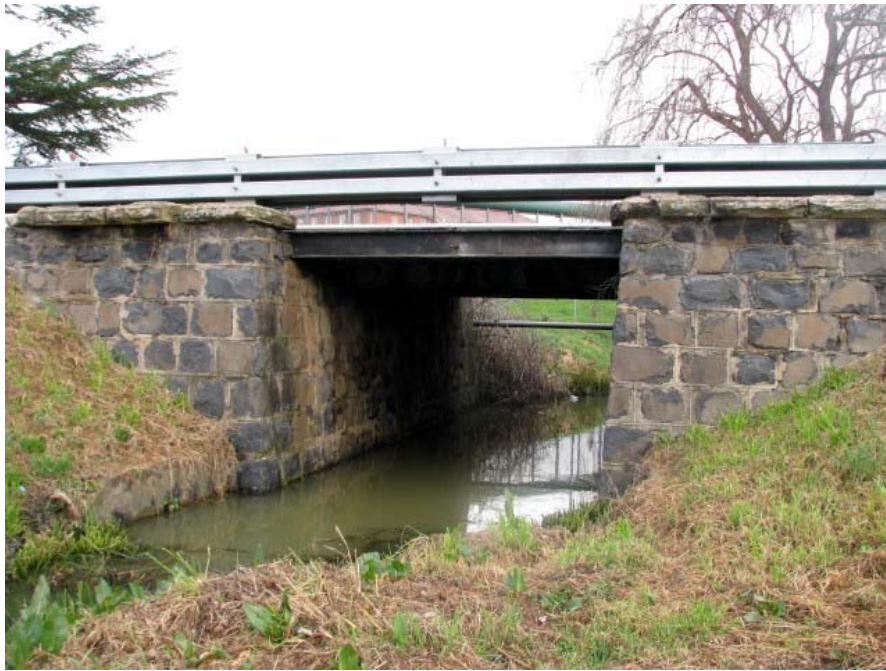
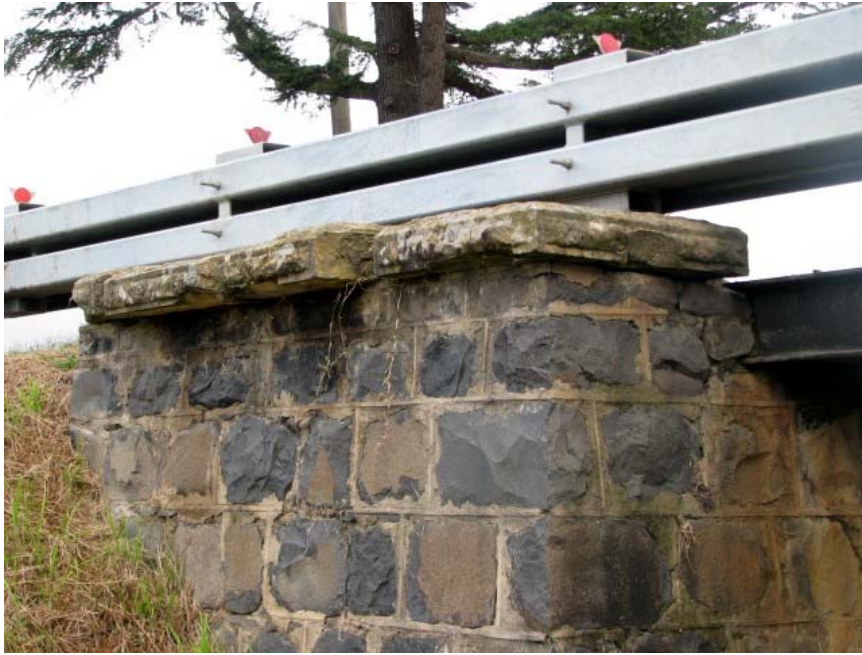
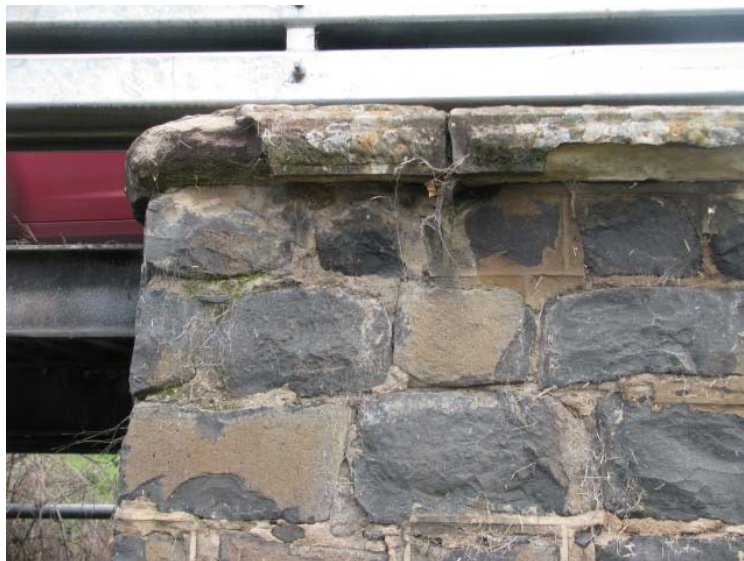
Figure 37: F141 Steel and stone ridge over Jordan Creek near Bathurst Gaol

Generally, the stone abutments vary in type depending on the type of local stone available. In the above case (F141) attractive bluestone was used. In other instances sandstone is the material used. The workmanship is generally consistent with the stonemason using an expressed raised mortar joint where the joint is initially flushed up, then cut or struck away to produce a raised even line of mortar. This enables the stonemason to produce an attractive, consistent, appearance even if the stones used vary considerably.

Most of these bridges are generally in good, serviceable, condition. Some have the addition of later balustrades of Armco railings or similar. Possibly F141, near Bathurst Gaol, is the best example remaining. Its span is small, and it is in good condition and is easily accessible for viewing.

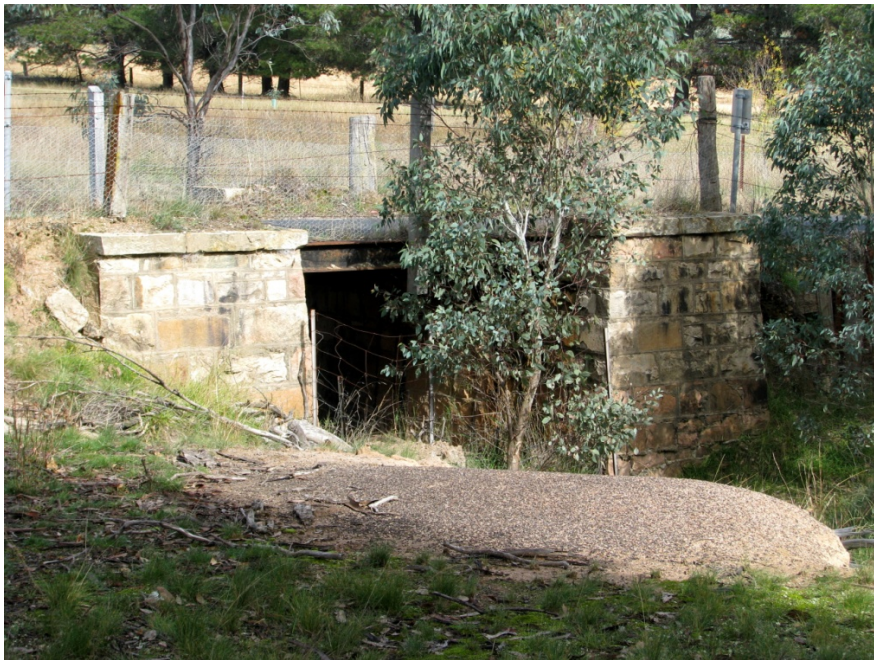
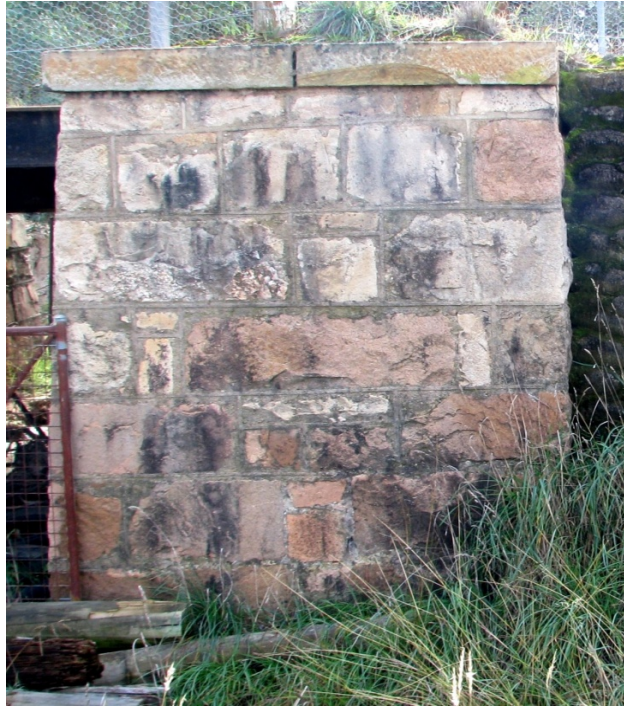
Figure 39: F51 Steel and stone bridge, Sandy Creek

Figure 40: F51 Sandy Creek detail in sandstone

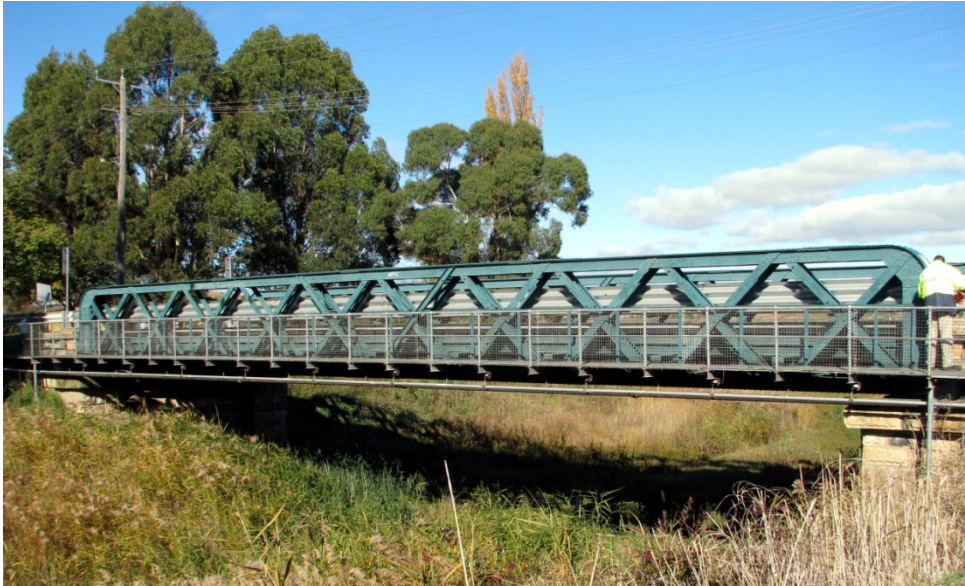
Figure 42: F49 The Queen Charlotte Vale Creek Lattice Girder Bridge at Perthville

A single span bolted lattice truss structure over the Queen Charlotte Vale Creek at Perthville, F49, a crossing of such commercial significance that it was designed and built by the National Government of the day and was the second of only two of its type.

In many ways it could be mistaken for a much more modern structure than its date of 1892. It was considered a 'state of the art' bridge of its day. Although the science was not new, the materials were. The Romans used timber lattice truss bridges over the Danube and many followed their example although it is most unlikely that they understood the science behind the structure. A Mr. Howard Carroll built the first completely engineered wrought-iron lattice truss bridge in New York in 1859. This example in Perthville is of great local significance especially as it spanned the creek in a single long span (over 28 metres) and was constructed in a relatively remote location.

This bridge is included in the Evans Shire Bridge Register with notes about its maintenance. It was scraped and repainted in 1895 using red hematite paint (Dampreys 90% oxide of iron). Its reference in the register is included in **Figure 44** below.

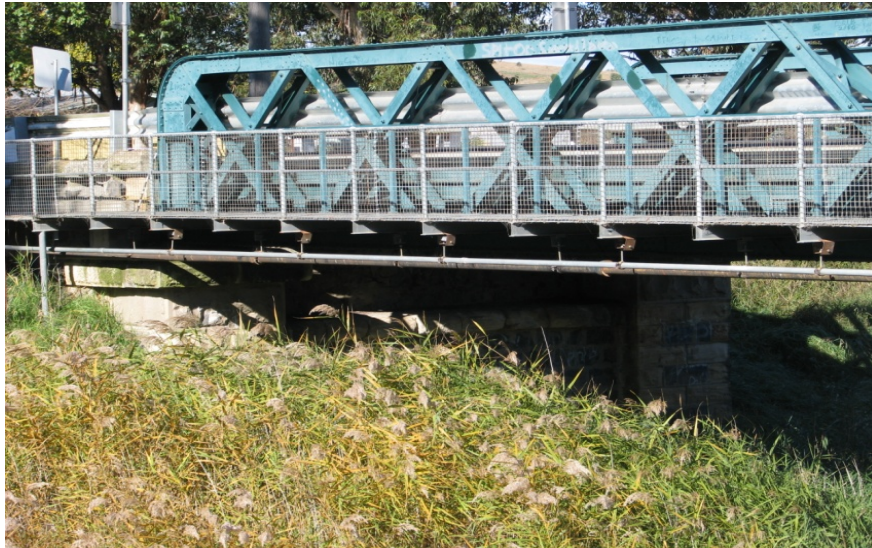
Figure 43: F49 This image illustrates the sandstone and blue stone abutments

The sandstone abutments are typical dimensioned sandstone blocks and projected capping used as the bridge supports. Interestingly this sandstone does not appear to be local stone, but the local bluestone, for which Perthville is well known is used in the approach walls and the retaining wall between the sandstone supports.

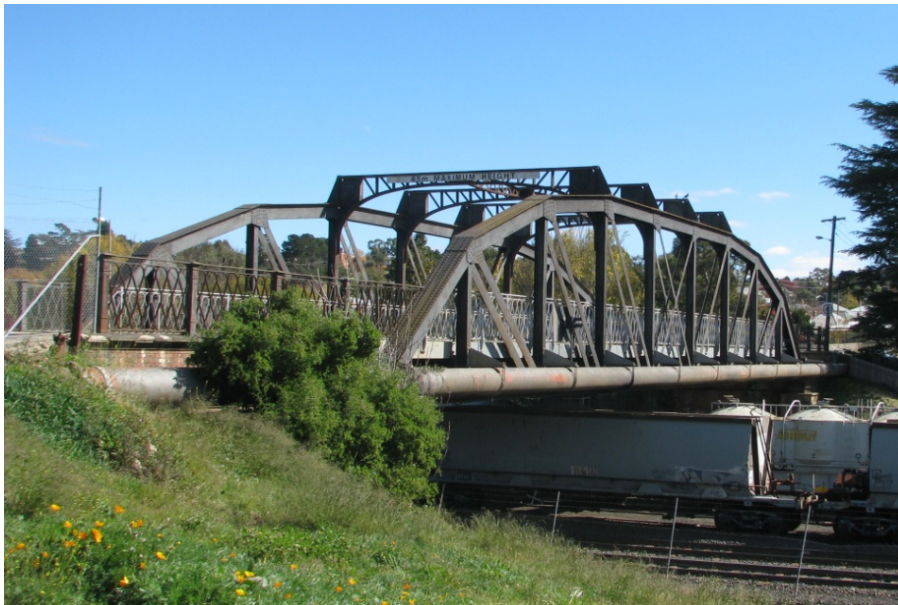
Figure 45: F59 Rocket Street Bridge

The shaped upper chord of the trusses make the bridge unique amongst other Pratt Truss designs, with materials kept to a minimum, over a maximum single long span.

'Even the NSWGR got into the act of erecting adventurous road bridges, building a Schweidler iron truss with a single span of no less than a clear 135ft (41.2m) for a road across the railway yard at Bathurst in 1888. It is still in service.'

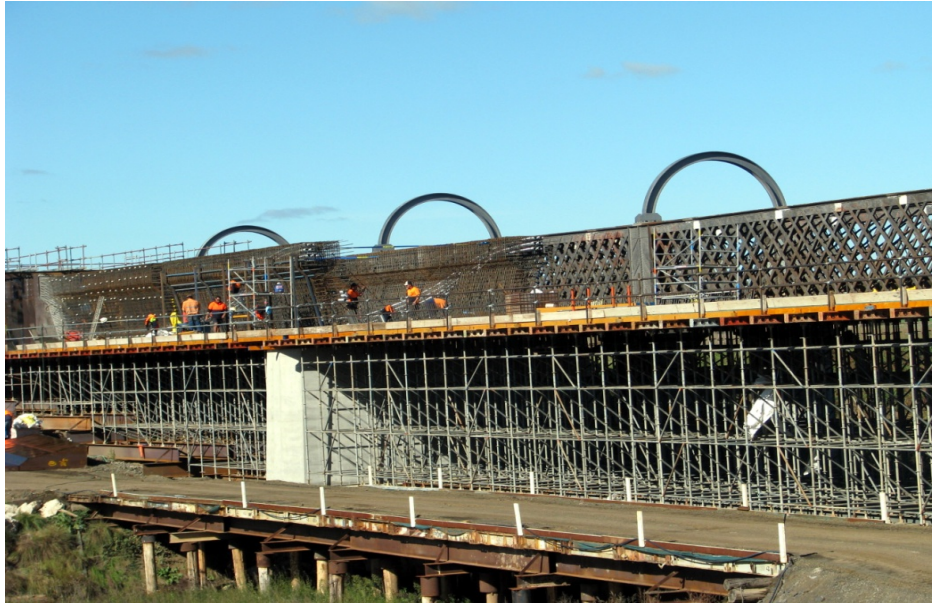
Figure 46: F63 The steel lattice girder rail bridge over the Macquarie River with a new concrete bridge under construction in the foreground (image 7 May 2010)

The third bridge in this group, and no less impressive, is the 1876 English steel lattice rail bridge over the Macquarie River. It is presently being replaced by a deep concrete girder bridge which may all but remove the girder bridge from view to the north.

While not unique, it is one of only 11 such rail truss structures in NSW². The whole group of this style of truss bridge is generally under threat as they are progressively replaced by bridges suitable for today's faster and longer trains. In its location over the Macquarie River the Bathurst lattice bridge offered a special aesthetic addition to the river scene.

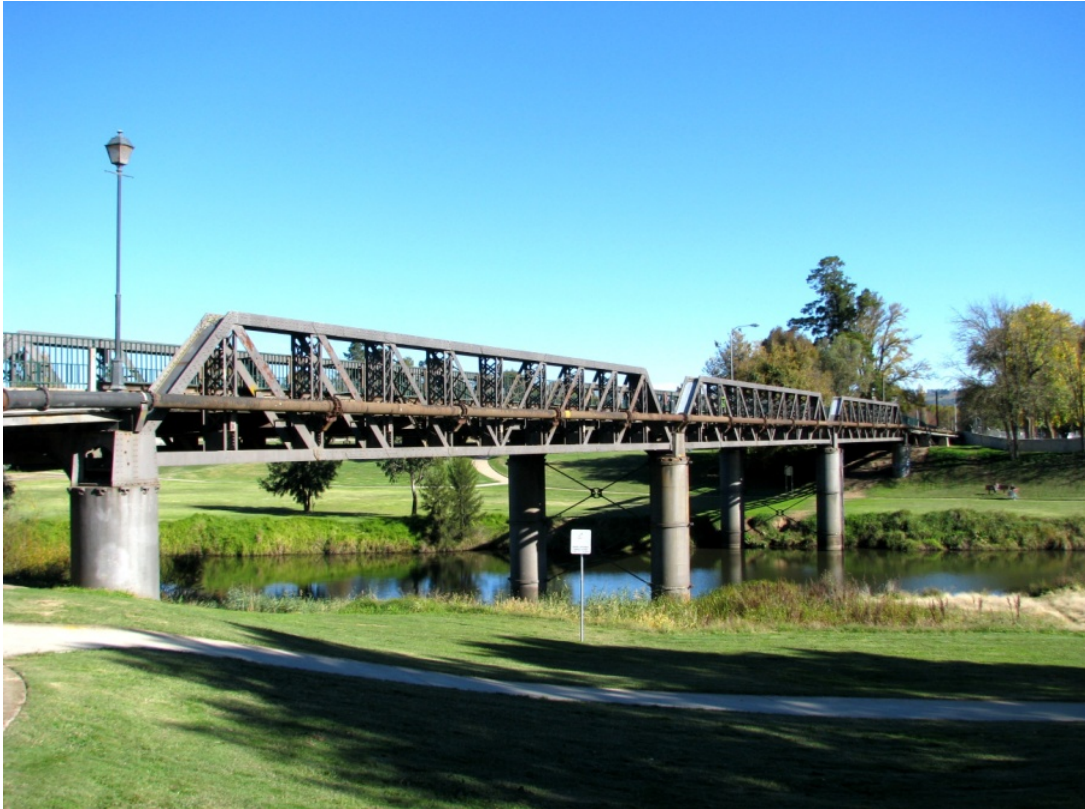
Figure 47: F64 the Denison Bridge

The bridge's advanced design was a major engineering achievement at the time and represented the maximum achievable in span with the river section divided into three spans, supported on large round concrete piers or pylons. The approach spans are more primitive with timber slab abutments and timber supports of large trestle frames which are cross braced.

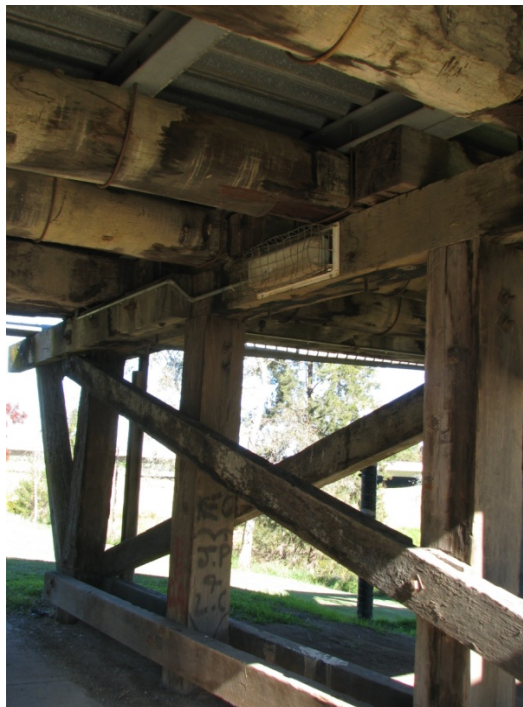
Figure 48: F64 The timber under structure of the Denison Bridge

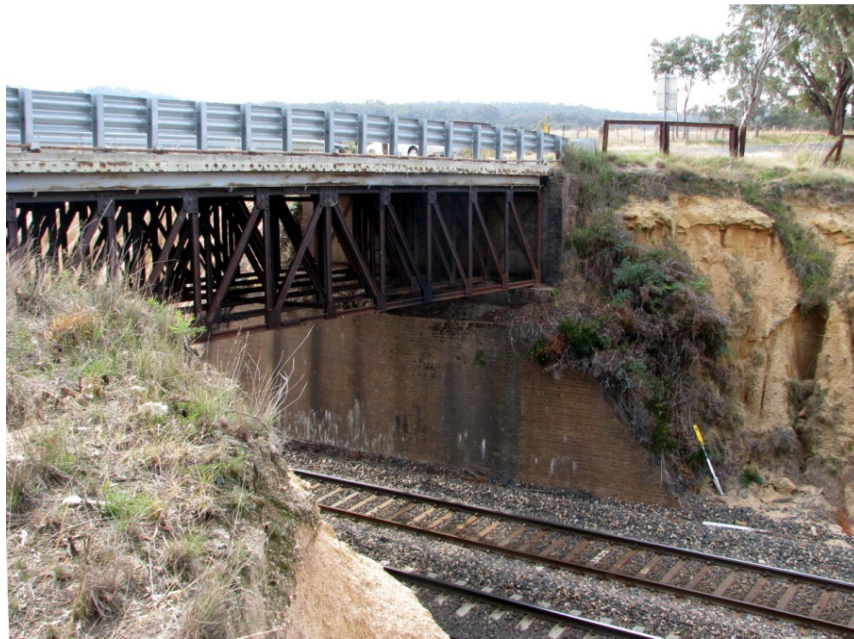
Figure 49: F77 Steel truss railway bridge over the new dual track line in 1898

The final two steel truss bridges in the region are over the rail line in the Wambool area, F77 and F78. These are interesting components in the second stage of rail transport in the Bathurst Region. The bridges were constructed when the second rail line or duplication occurred in about 1898.

Their construction is also of interest as they are constructed of six (6) light weight trusses made up of rail line. Rail line was used in diverse situations such as fencing, simple bridges and building foundations, but this use is truly an 'in house' railway solution and shows the diversity and usefulness of the rail line steel section. Presumably there were economic benefits to the rail department in using their own materials.

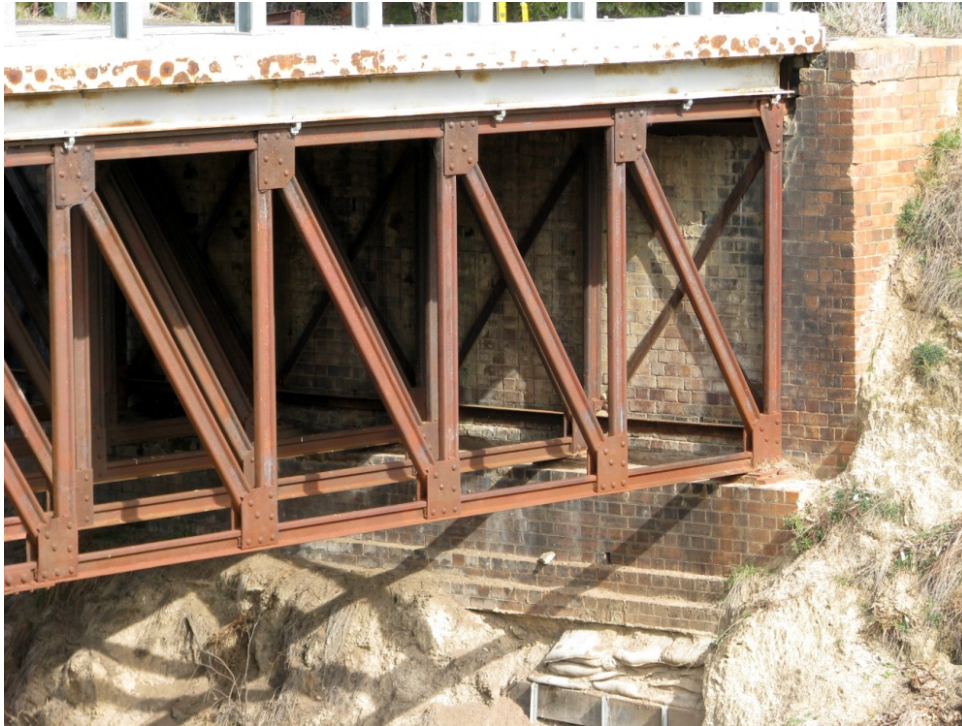
Figure 50: Detail of the 'rail line' steel sections used in the construction of the bridge (F77), using simple king post trusses

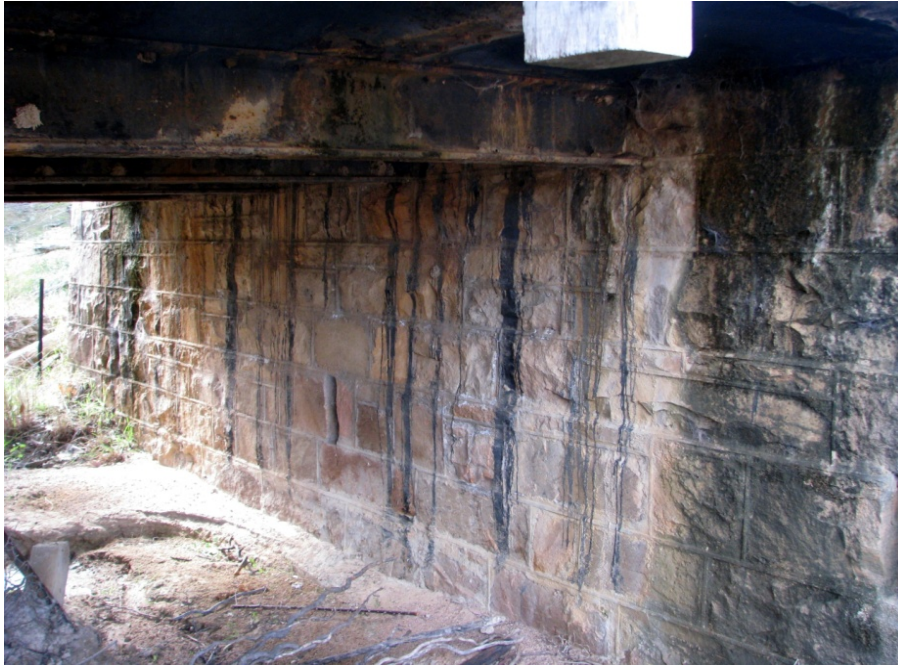
Concrete was initially used in conjunction with other materials. Generally this was un-reinforced and used for example to line the floor of bridges to prevent erosion and assist extending the life of bridges.

Figure 51: Sandy Creek, Ryans Road (F51) Under this stone and steel bridge 'bush' concrete material was used to seal the floor

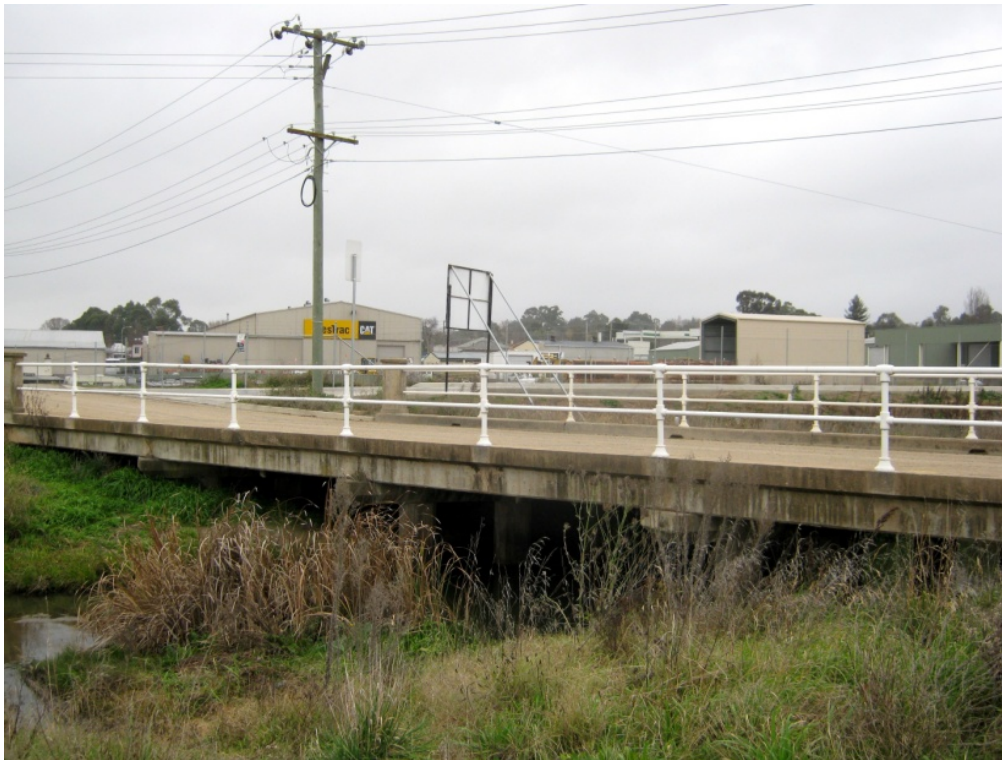
Figure 52: F128 Lee Street concrete bridge

One of the most significant concrete bridges in Bathurst is located in Lee Street, now an industrial area in Kelso. This road was then a 'main road' of Bathurst. This reinforced concrete bridge (F128) was constructed by the MRB in 1930.

Lee Street was formerly a 'main road' of Bathurst and this bridge was possibly the first reinforced concrete bridge constructed in Bathurst. It was constructed by the Main Roads Board (forerunner to the Main Roads Dept) in 1930 during a period of labour works to relieve unemployment during the Great Depression. It still retains the original plaque on its end post, and original flanged pipe handrails. Lightly trafficked, it is generally in good and original condition.
