Bridges Conservation Management Plan

Authors: Barbara Hickson, Heritage Advisor &
Nicholas Murphy, Senior Strategic Planner, Bathurst Regional Council

October 2010

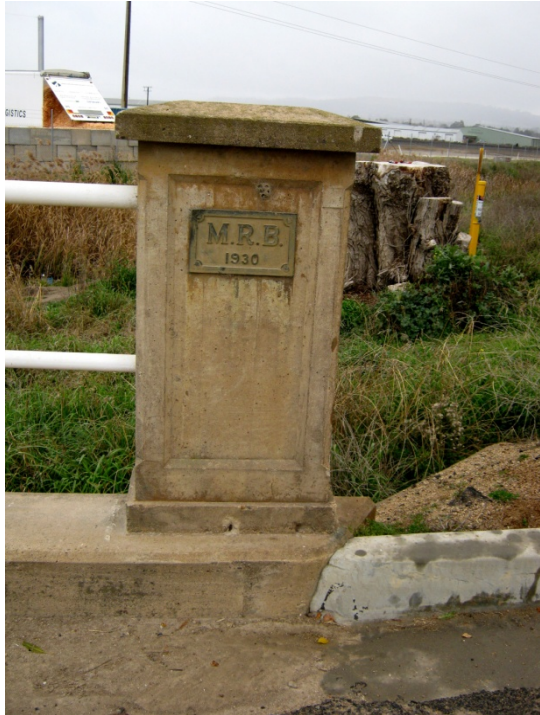
Figure 53: F128 Lee Street bridge end post with plaque

The bridge still retains the plaque on its end post. This feature of affixing plaques to end posts was carried out for many decades by the MRB and later the DMR but unfortunately very few remain in place today.

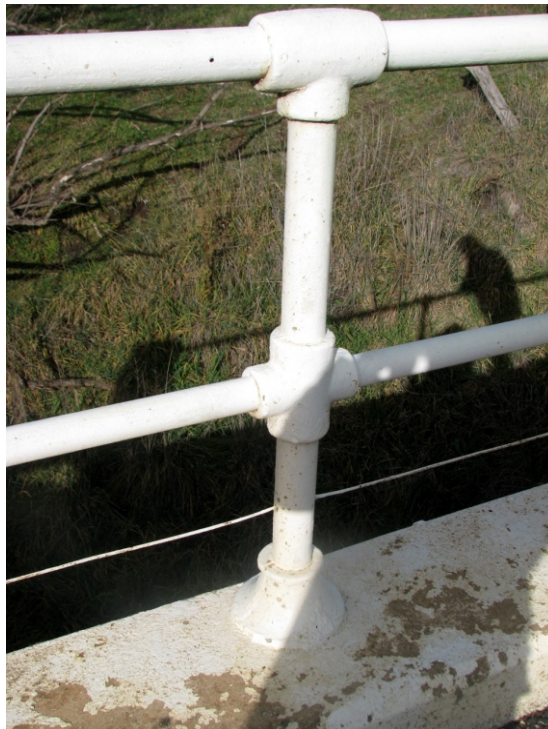
Figure 54: F128 Detail of pipe handrails

Another detail of this bridge, the white painted steel pipe handrails with their flanged post bases and ball joints between members, were easily assembled in situ. End posts were invariably stout rectangular concrete posts. The pipe balustrades serve as a visual guide to other reinforced concrete bridges of the 1930s and 1940s period.

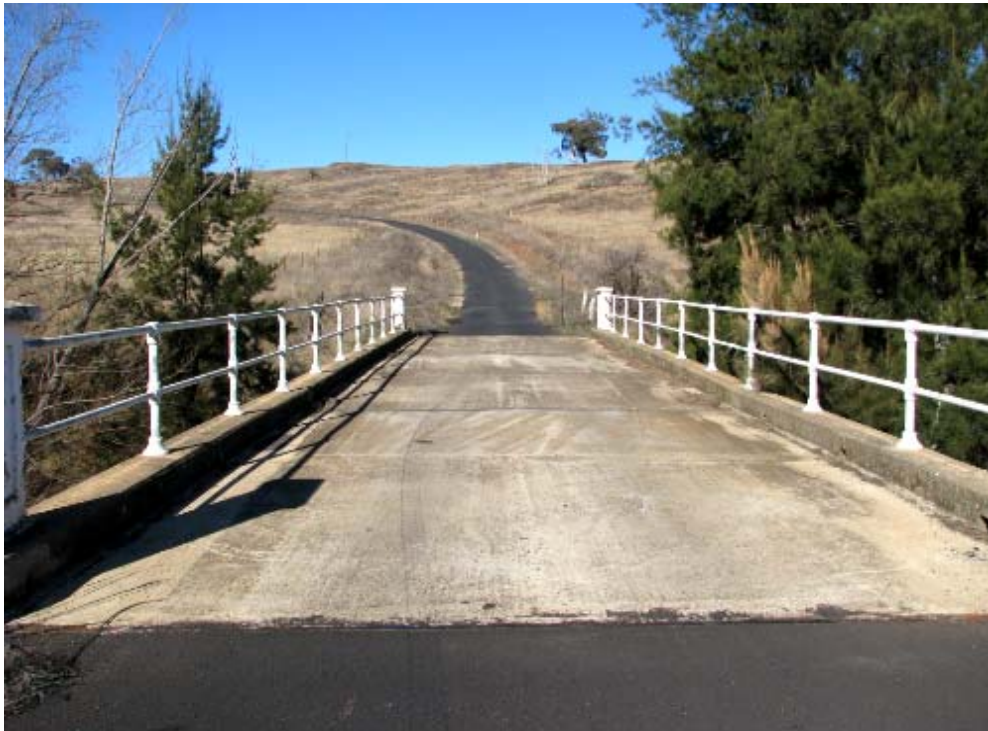
Figure 55: F150 The cement bridge on the Bridle Track

Another bridge constructed in this important period was the 'cement' bridge over Stony Creek on The Bridle Track (F150). It again displays the white pipe handrails of the first concrete bridge in Bathurst. It was most likely constructed in the mid 1930s providing labour opportunities during the Depression period.

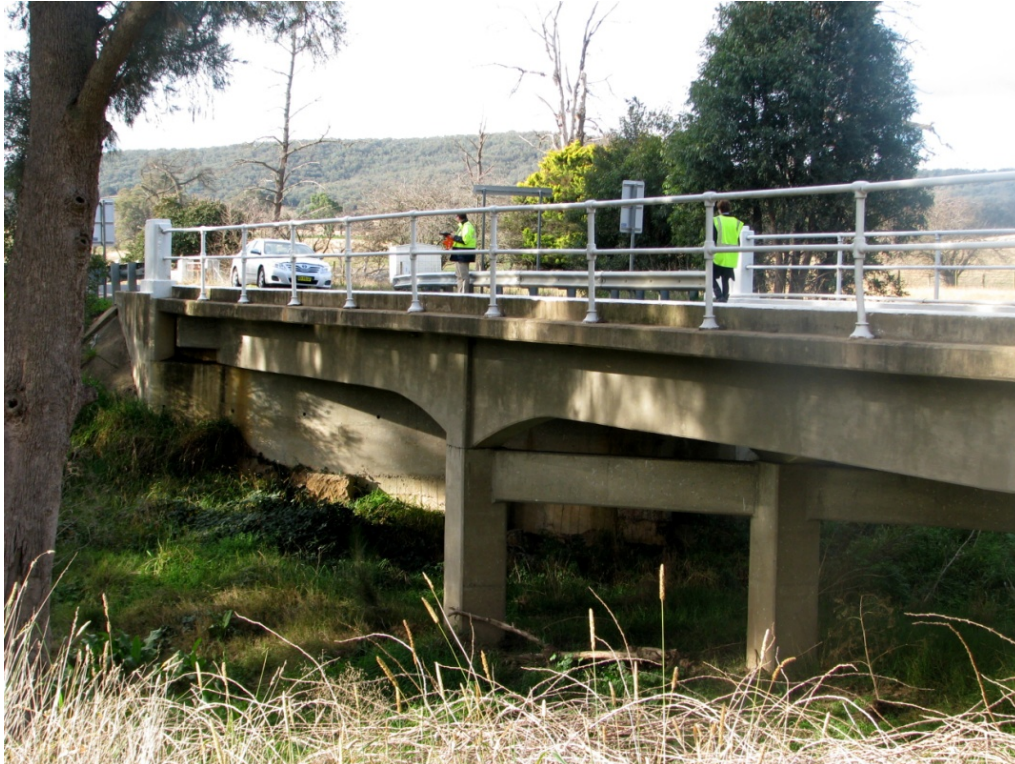
Figure 56: F106 Bridge over Winburndale Rivulet

Within the Bathurst Region there are another three good examples of reinforced concrete bridges of this era built over Clear Creek, Cheshire Creek and Winburndale Rivulet (F106) on the Sofala Road probably between 1935 and 1937. They each display the characteristic white painted steel pipe handrails with flanged bases and heavy set end posts, though none now bear the DMR plaque. Each also has a modified design below the road level to suit the particular locality with support columns and beams designed to offer the least resistance to the passing stream. Close examination reveals details such as the formwork style, usually timber boards or plywood sheets.

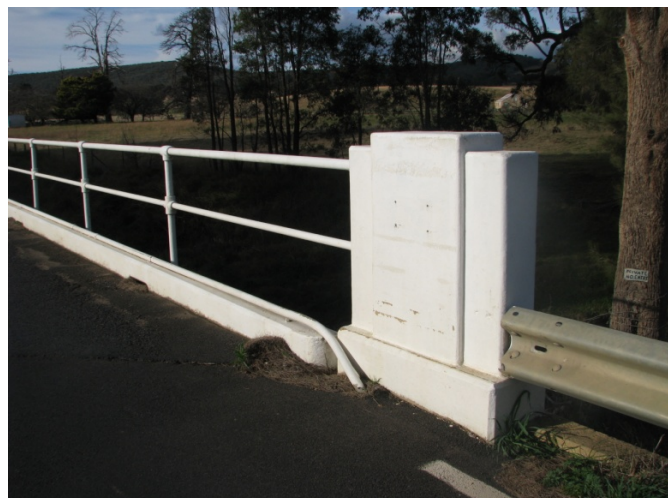
Figure 57: F106 End post with plaque removed

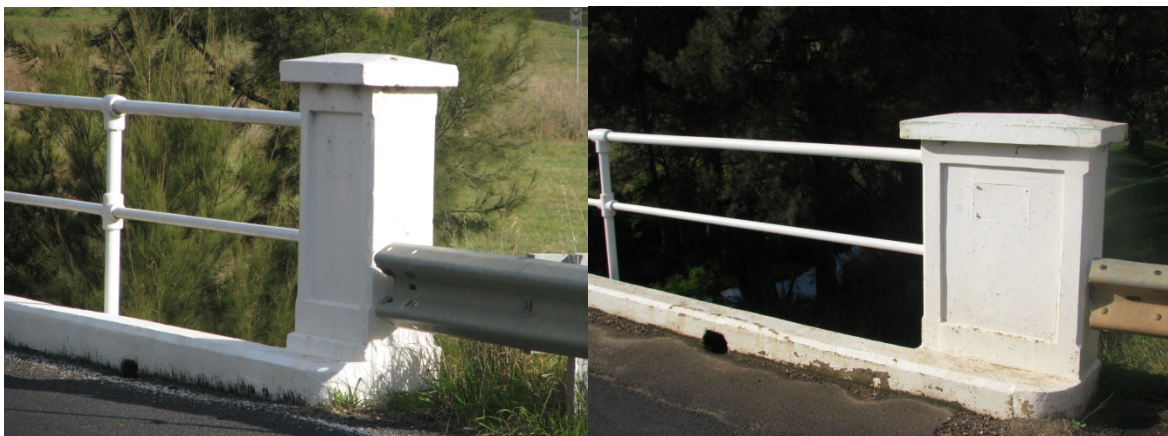
Figure 59: Examples of plainer end posts

Designs were heavily standardised but each still had to be modified to suit the conditions of the particular location, including the length of span, the direction of the river flow and the road line, (sometimes not at a right angle to the water course), and the depth of the river. Individual designers' stamped the bridge with their own particular choice of end post.

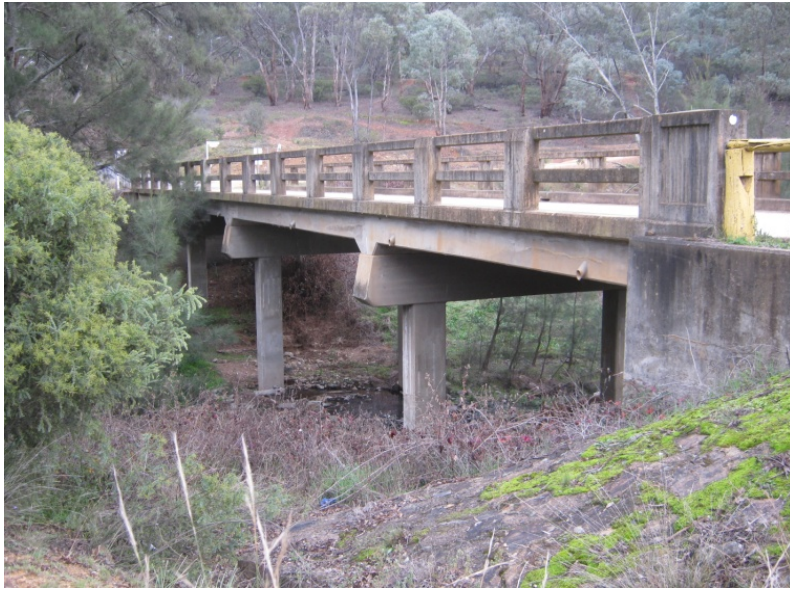
Figure 60: F112 Bell Creek Bridge constructed in 1954

After World War II and over the next two decades the DMR designed and constructed a number of reinforced concrete bridges in the Bathurst Region for the most important main roads of the period. Examples include the bridge over Pepper's Creek at Rockley, (1956) F33, over the Bells Creek on the Hill End to Sofala road near Chesleigh, (1954) F112, and a series of bridges across the region to Georges Plains and Cow Flat Road, (1965) F48.

Strong common characteristics of these bridges are what appear to be prefabricated balustrades of heavy concrete posts and rails, often set upon a deep concrete kerb and wide flat end posts that occasionally still carry the DMR plaque.

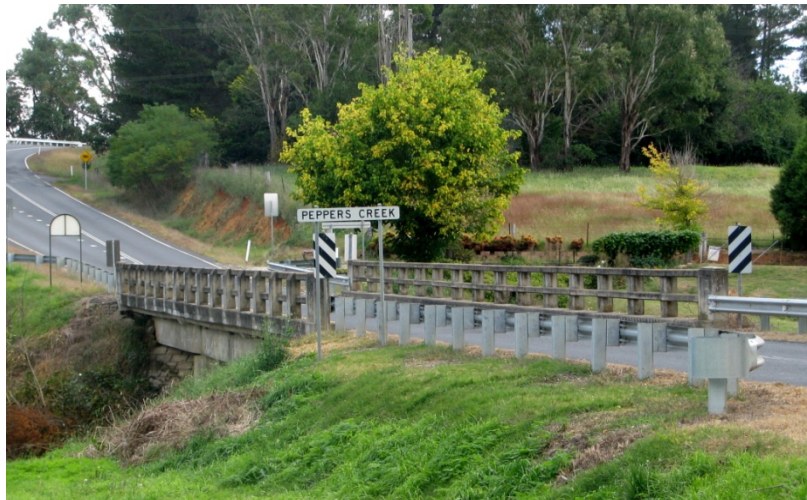
Figure 61: F33 Peppers Creek Bridge at Rockley constructed in 1956

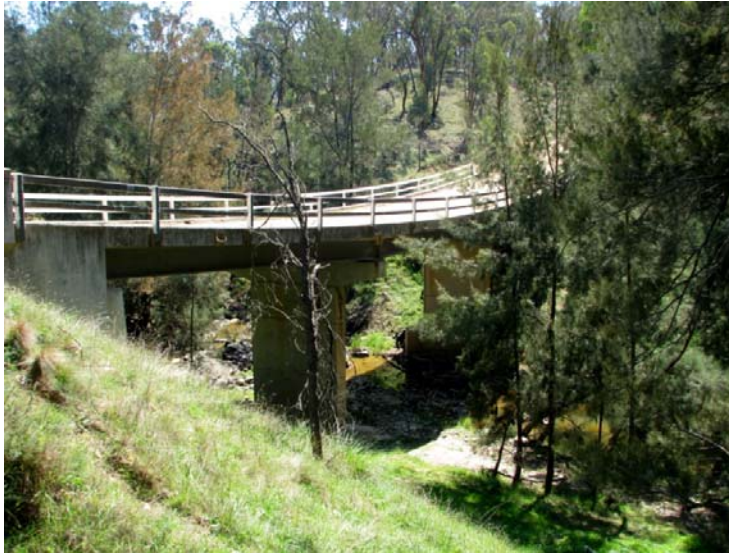
Figure 63: F10 The graceful curve of the bridge over Grove Creek

By setting the steel beams at different pitches underneath the deck allowed the cast to be curved. The off form concrete markings are clearly visible on the stanchions and underside of the deck.

The materials and design were fairly versatile allowing some changes in span and direction. The bridge over Grove Creek, F10, is aesthetically pleasing, being an unusual curved bridge. By setting the support beams at differing pitches from span to span the bridge deck has been able to be cast in a long curve over the deep ravine, making it possible to reduce the overall height of the bridge's concrete stanchions. It is difficult to imagine a better way of achieving this particular goal.

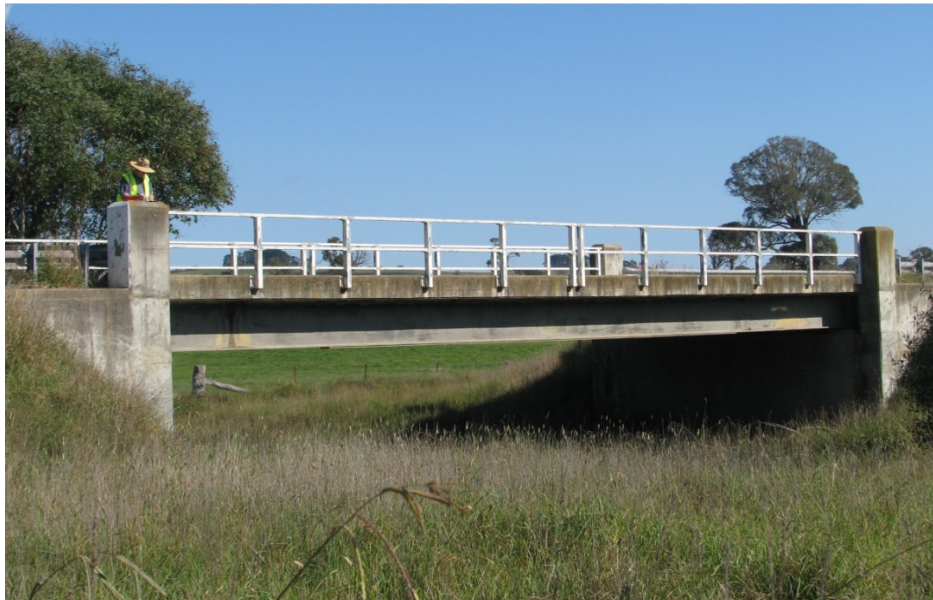
Figure 64: F20 Steel beam and concrete bridge over Caloola Creek on the Lachlan Road

Generally, this group of bridges is all constructed in a similar way. The concrete abutments and any central pier supports or stanchions were first constructed. Then a series of steel I beams, four or more, were installed and formwork placed over them. The reinforced concrete slab or deck was then poured. The earliest of these bridges in Bathurst was probably F20 over Caloola Creek and F53 at The Lagoon over Deep Creek. The feature that makes them slightly older in appearance is their squat concrete end posts and light steel rails.

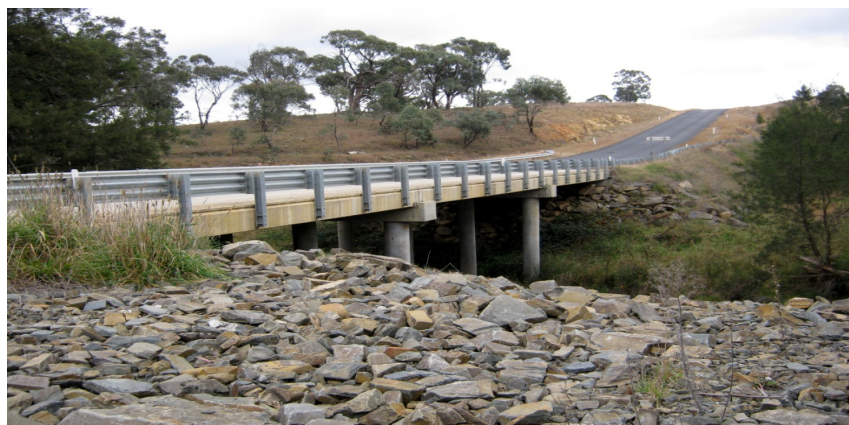
Figure 66: F123 The present day pre-stressed concrete bridge over Cheshire Creek

An example includes the pre-stressed concrete bridge over the Cheshire Creek (F123) which represents a state of the art bridge constructed in minimalist, functional, concrete. A three span concrete bridge, its central supports are sets of four round columns with a cantilevered beam over. These support the integral concrete deck. Side rails consist of simple Armco railings. The span of the bridge is a long 39 metres.

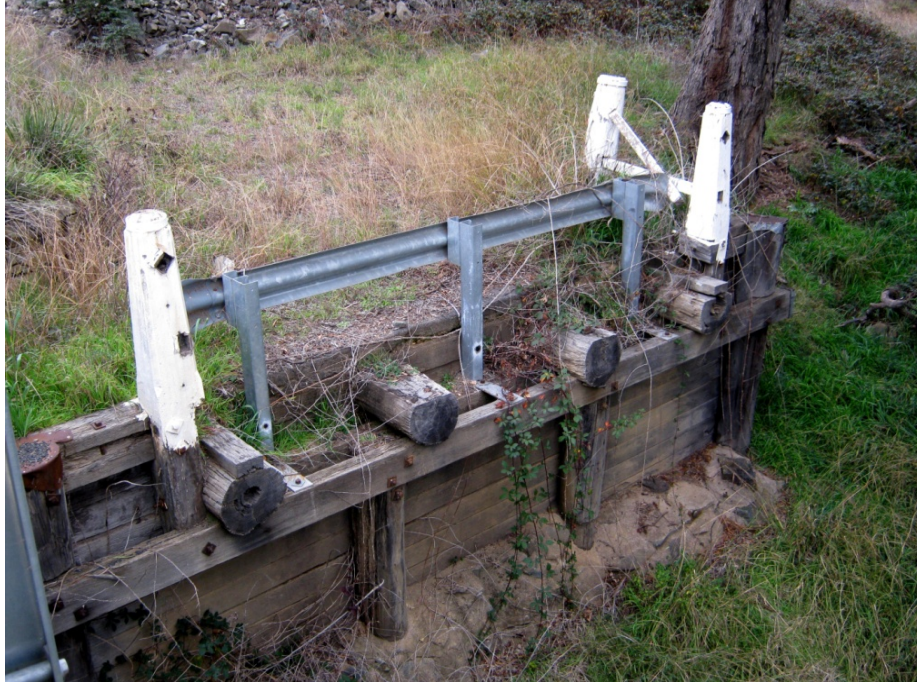
Figure 67: F123 Original timber plan abutments and shaped timber posts from a former timber bridge at Cheshire Creek

To one side of the bridge are remnants of an earlier timber bridge circa 1880. Timber abutments and original end posts still stand on the bank, and in the creek the base of the original timber posts are still visible. This former timber bridge is listed in the Evans Shire Bridge Register, Folio 73, and was constructed c.1878-1880. It was a three span structure with a total span of 77 feet, or 23 metres.

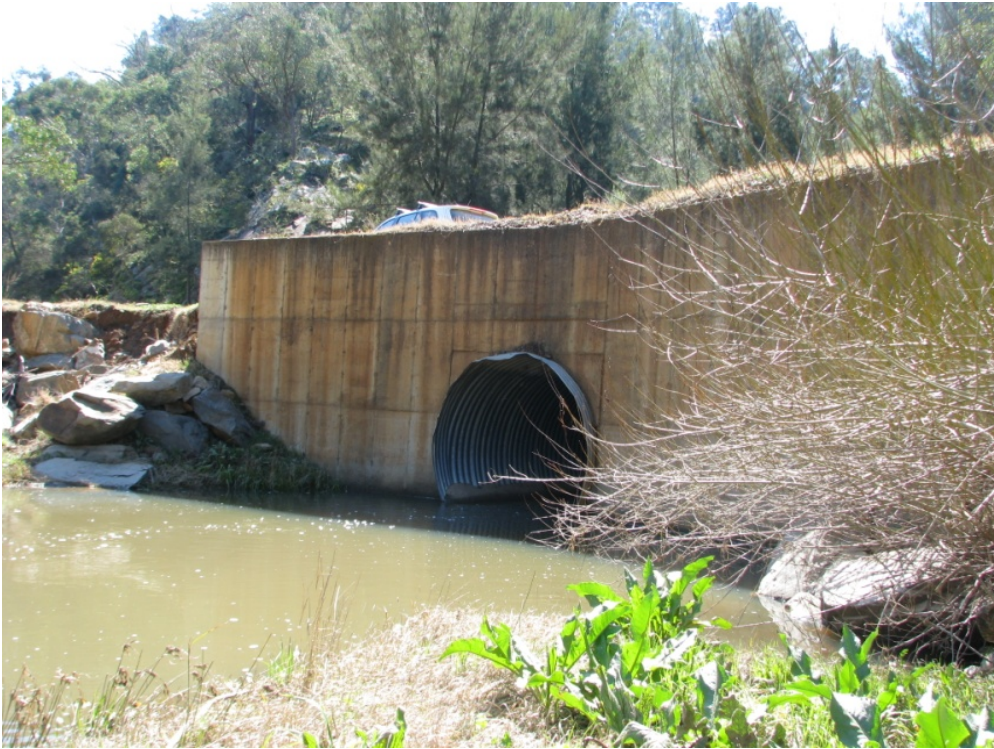
Figure 68: F21 A large pipe culvert formed from corrugated iron formwork and mass concrete on the Lachlan Road

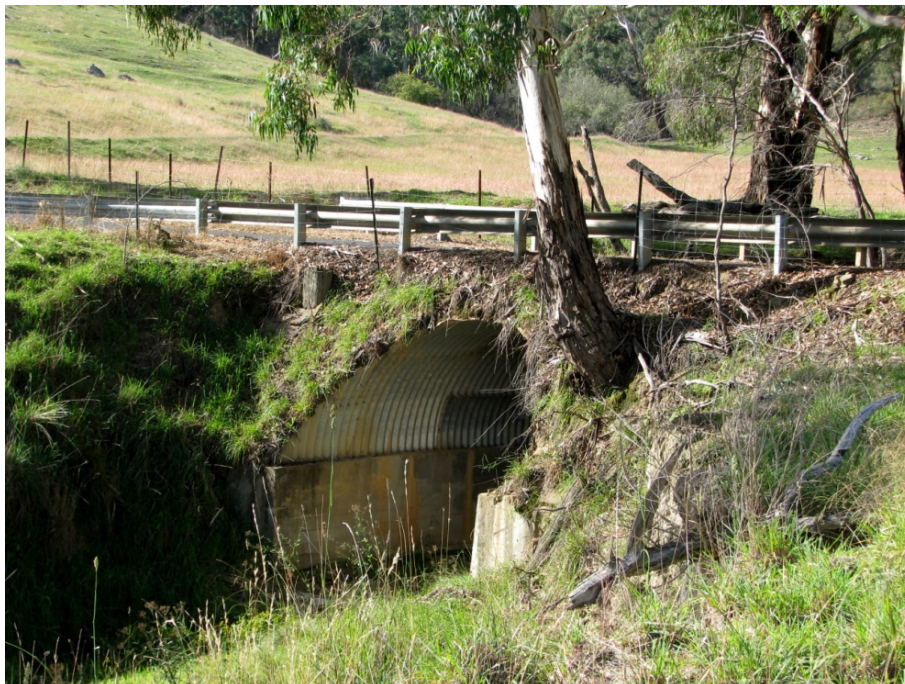
Figure 69: F46 Corrugated iron formwork is used above to form up a mass concrete arch and bridge over a stream

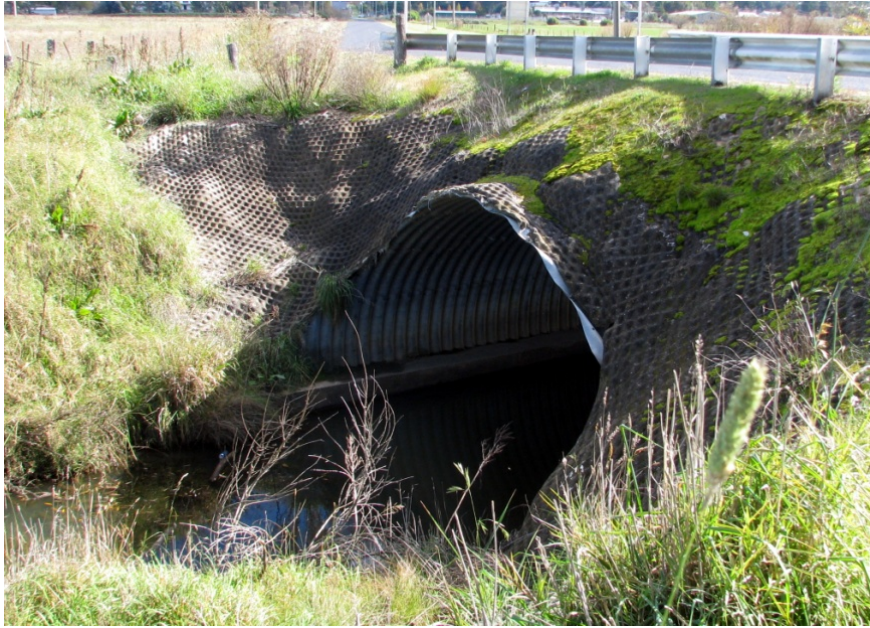
Figure 70: F57 A more recent example of the same technology with corrugated iron formed arch bridging a stream

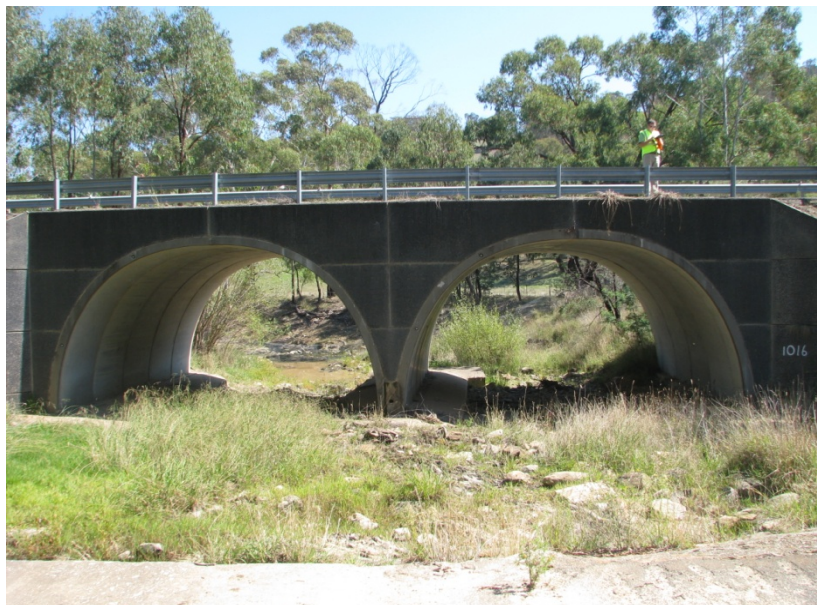
Figure 71: Large culvert technology used to form a double arched bridge on main road near Trunkey Creek (F13)

Some modern culverts are exceptionally large and when used in combination as a double or more, they can be placed where once an engineered bridge would have been a necessity. Exceptionally large examples include F13 a massive double pipe culvert, F28 a triple box culvert and F37 a seven unit box culvert.

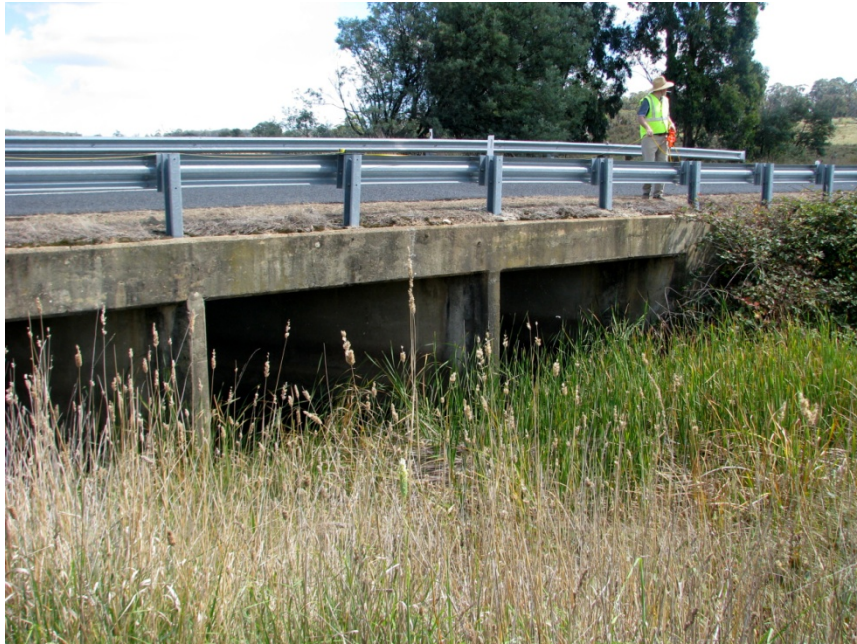
Figure 72: F28 Multiple box culvert over Buck's Creek 10 metres in width and 12 metres long

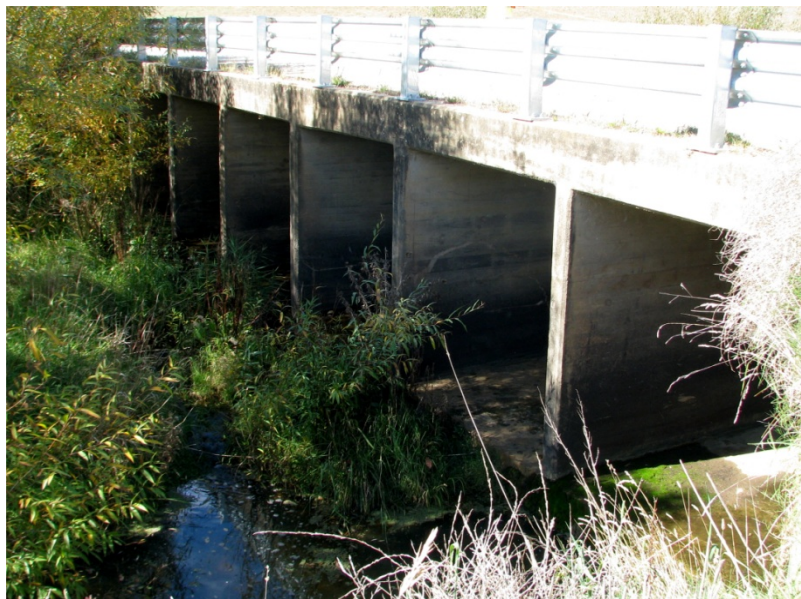
Figure 73: F37 Another multiple box culvert over Evans Creek consisting of seven box openings and an overall length of 18.5 metres, where once a considerable bridge construction would have been required.

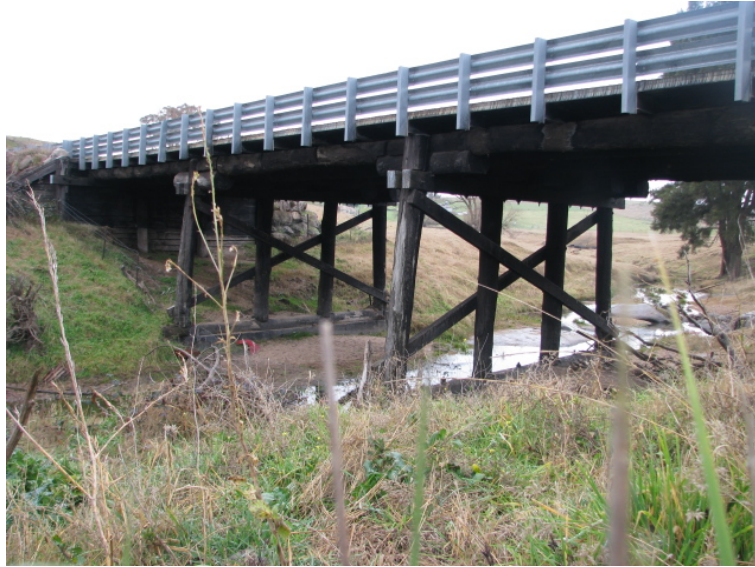
Figure 74: F134 Evans Plains timber bridge

A good example of a multi-span, generally intact, late 19th Century timber bridge and an excellent example of the bush craft and local materials used in such a structure. It spans almost 27.5 metres overall and features timber cross braced trestle style frames with corbels over and timber slab abutments which were once quite common. Its original timber balustrade is missing and a concrete slab forms the deck that would have been a timber deck originally.

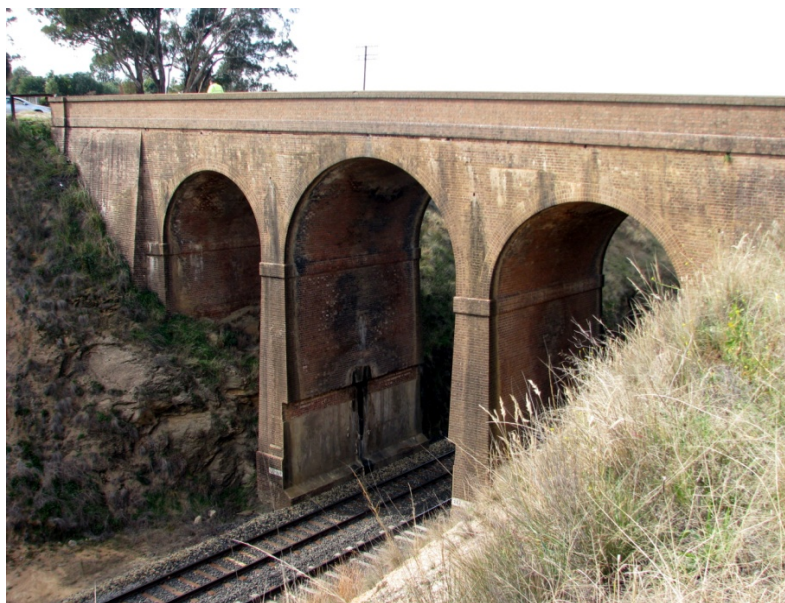
A number of brick structures in the Brewongle area are suffering movement cracks. Some are over 140 years of age and so were not designed for current loads. There is on site evidence that these cracks are being monitored by ARTC.

Figure 75: F74 Cracks on one side of the rail bridge are being monitored by ARTC

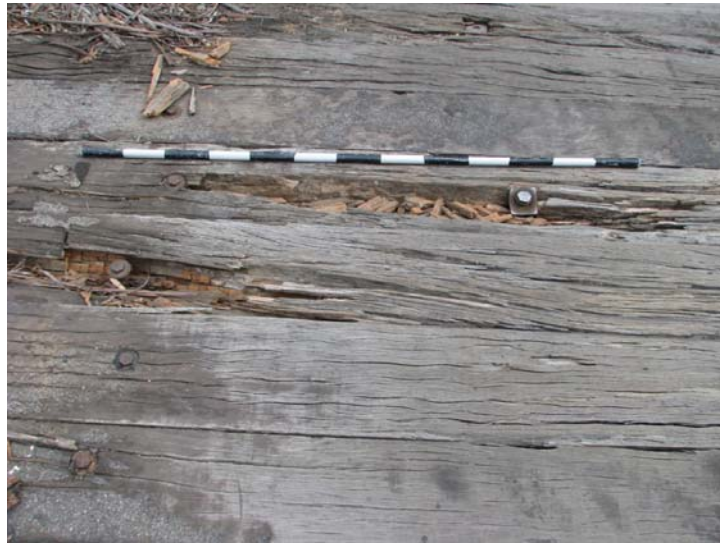
Figure 76: F83 Road deck in need of replacement above

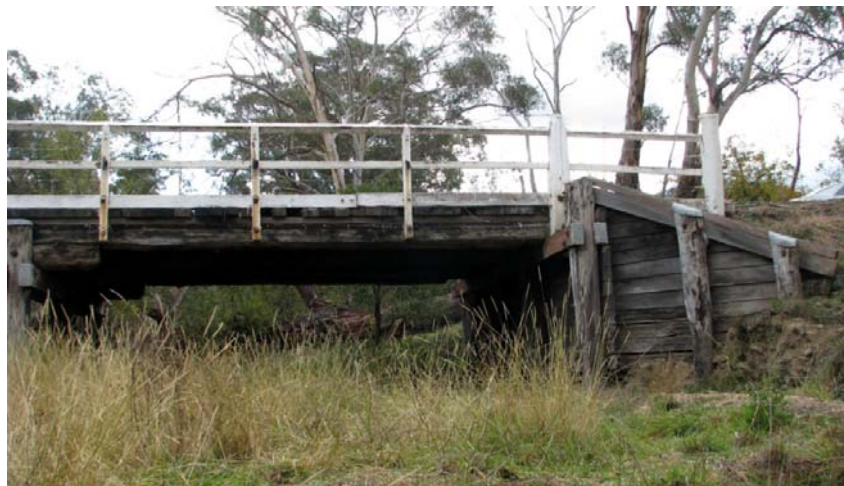
Figure 77: F83 Two span timber bridge illustrating the signs of deterioration

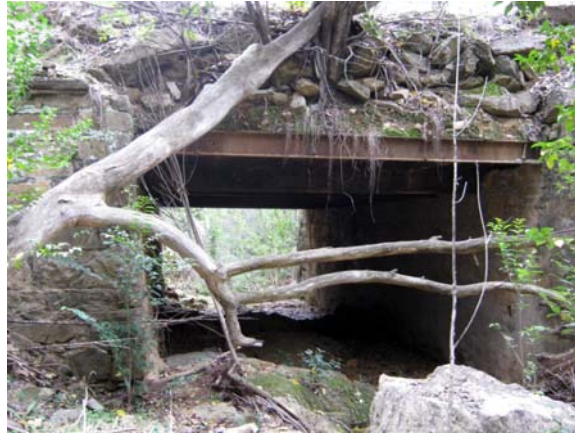
Figure 78: F118 This steel and stone bridge is now well below road level and difficult to inspect

The area of concern may be below the bridge as sometimes road levels are built up well above the original bridge deck.

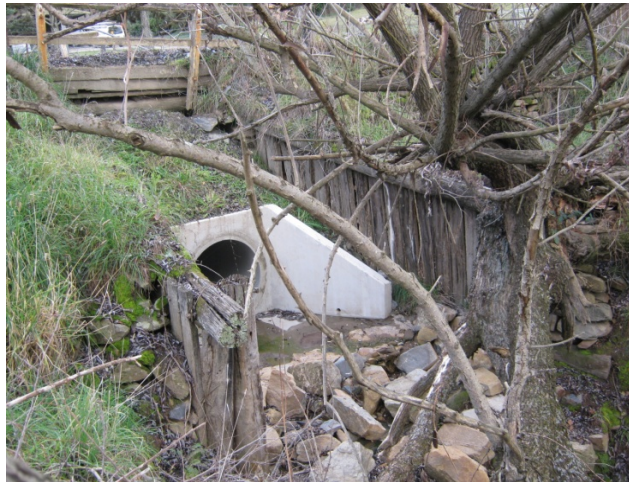
Figure 79: F116 Warry's Road Bridge

The above timber bridge in Hill End shown above was converted to a piped culvert when the spanning structure was determined as not structurally sound. With the alterations, a pipe culvert was inserted and the 'space' around it filled. The bridge is no longer in danger of collapse, but the white end wall of the pipe work is a visual distraction. It could have been screened by stone or timber walls or coloured to blend into its surrounds. In time it will colour and blend in better.

Some timber bridges have been converted from a bridge to a culvert, thus retaining much of the original fabric, but changing the structure significantly. This is an interesting solution, though it affects the aesthetics of the structure.

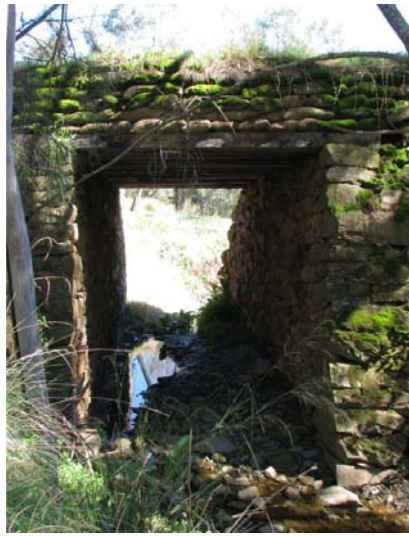
Figure 80: A typical Bridle Track small stone bridge

This small bridge shown above is located on the Bridle Track, was repaired using cement bags raising the level of the road. They were used to retain the sides of the road and are now covered with green moss and blend in quite well with the original dry stone walls. In time many alterations that are unsympathetic initially will blend in better compliment the structure they relate to.

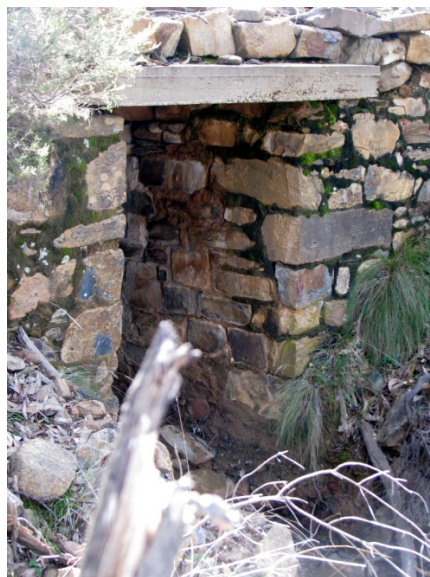
In other examples on the Bridle Track, concrete slabs were cast over the abutments to provide a sound spanning bridge in place of former timber structure. These slabs allow the load on the bridge to be better distributed and while there is some loss of significant fabric, the replacement slabs in time will not detract from the retained historic fabric - the stone abutments. In some cases the slab can be cast slightly wider than the present bridge allowing for future road widening.

Figure 81: Cast slab over small stone bridge on the Bridle Track

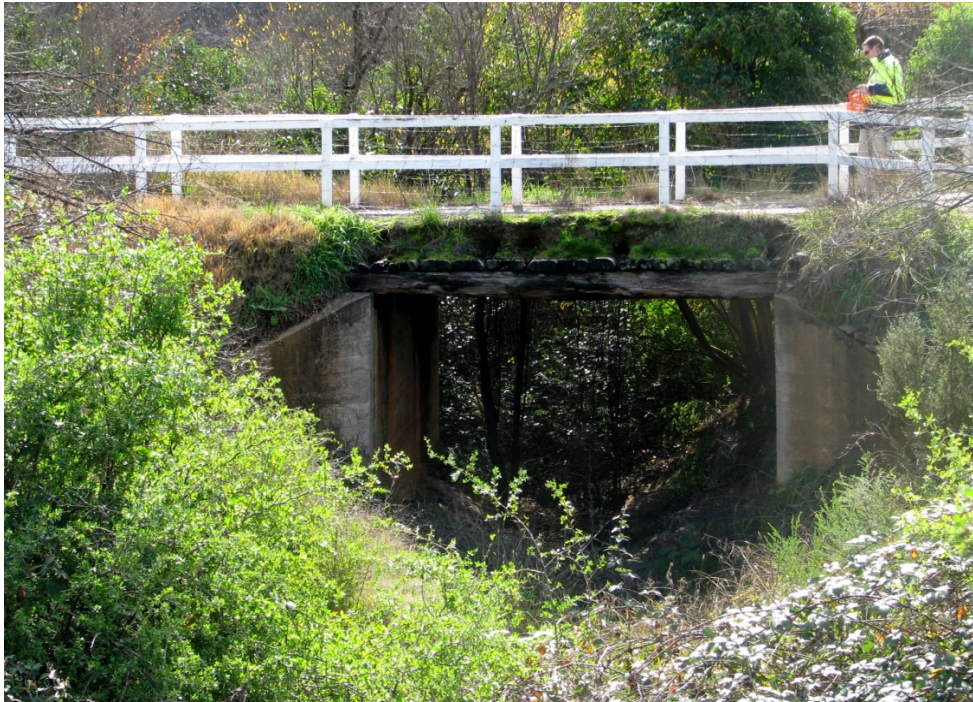
Figure 83: F99 Former road bridge and now retained as a footbridge in Sofala

Policy 21: Where possible allow for the continued use of the bridge as a road bridge or, if not possible, as a footbridge and/or if historically relevant, to carry services.

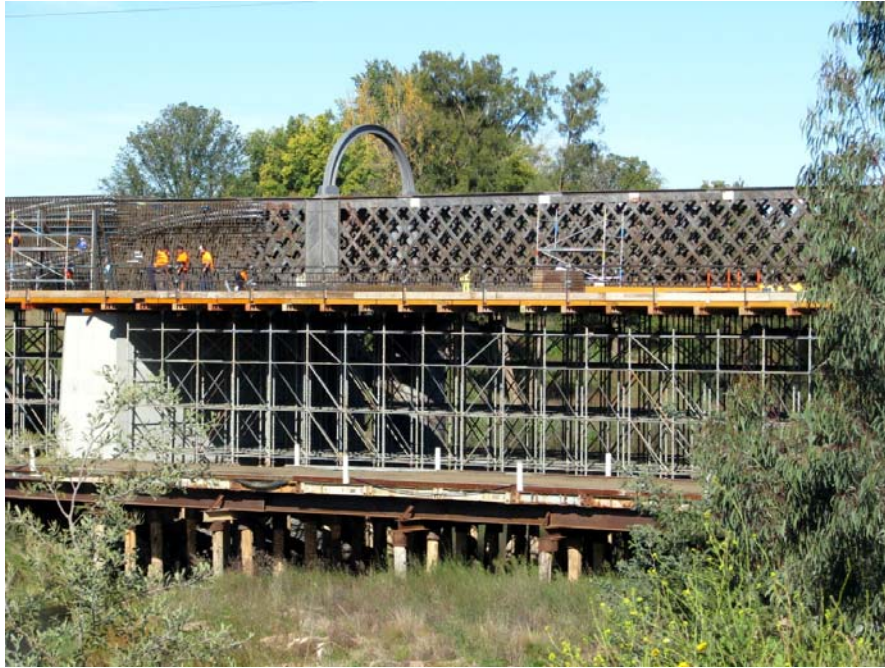
Figure 84: F63 Formwork in front of the original steel lattice bridge (20 May 2010)

Another State listed bridge, the Lattice Rail Bridge (F63) over the Macquarie River, has also been retained and yet will soon be replaced by a new concrete bridge. While no longer visible from the north or east sides it is nevertheless a bridge of considerable significance and it is hoped that it will be made accessible in the future to pedestrians and cyclists. It is important that the bridge retain some function as it is difficult in the long term to justify expenditure on maintenance of an asset that cannot be used, seen or appreciated.

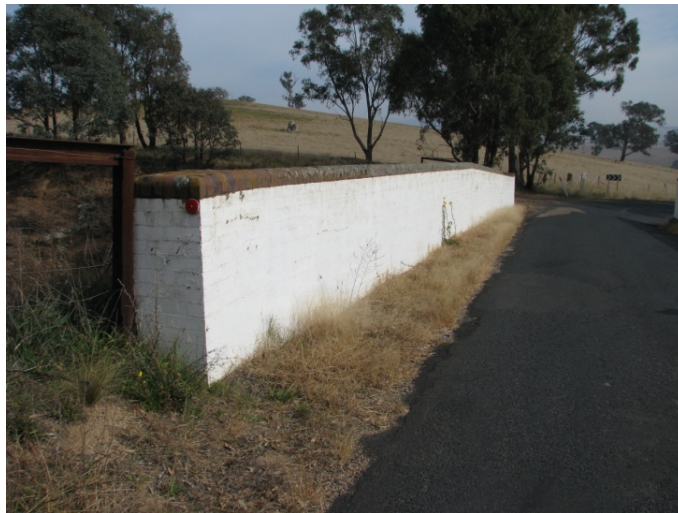
Figure 85: F73 Typical painted bridge balustrade. This bridge is a rail overpass bridge in Brewongle

Paintings of the inside face of masonry bridge balustrades is carried out to make structures more visible and safer for night driving. There are a number of examples in the LGA. Such paint should be water soluble and not more detrimental to the masonry surface than possible. In particular the paint should be able to breath, that is allowing soluble salts to pass through the coating.

It is preferable if such paint work is limited to the extent necessary to make the structure safely seen and not covering the entire surface down to the ground. As a rule of thumb it is recommended that such paint work be limited to the area 5 or 6 brick courses above ground, or two stone courses. Paint will not extend the life of masonry.

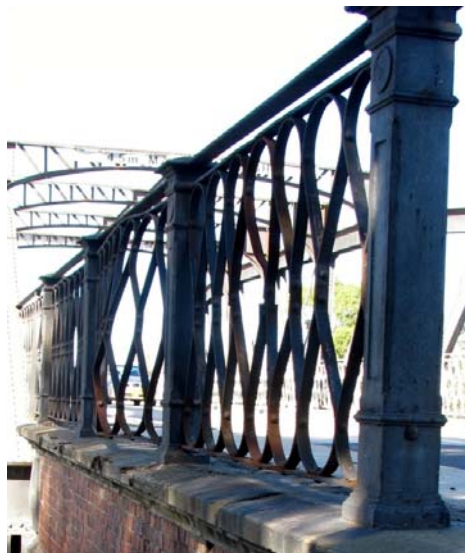
Figure 86: F59 Corroding steel balustrade on the Rocket Street bridge

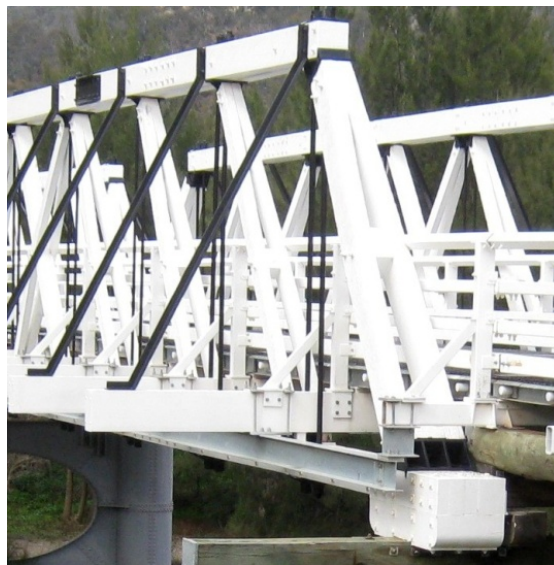
Figure 87: F144 Details of timber and steel work of the bridge over the Turon River

For example the timber and steel bridge over the Turon River at Wallaby Rocks, F144, has been significantly upgraded. Some timber members such as handrails have been replaced with steel sections of a similar shape and geometry to the original. Additional steel straps have been added and the whole bridge re-painted. There has been some loss of original materials and of integrity. However on balance the result is a bridge visually similar to the original and retaining most of the original design intent, yet able to support modern traffic loads.

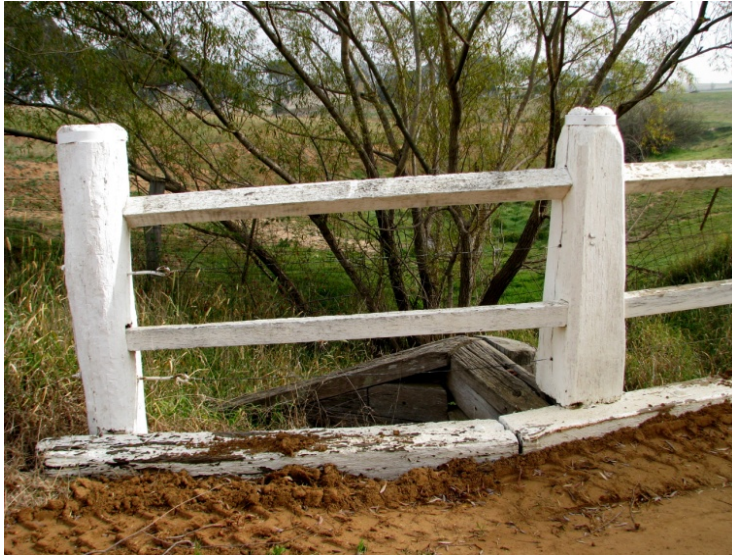
Figure 88: F72 Timber bridge in Brewongle

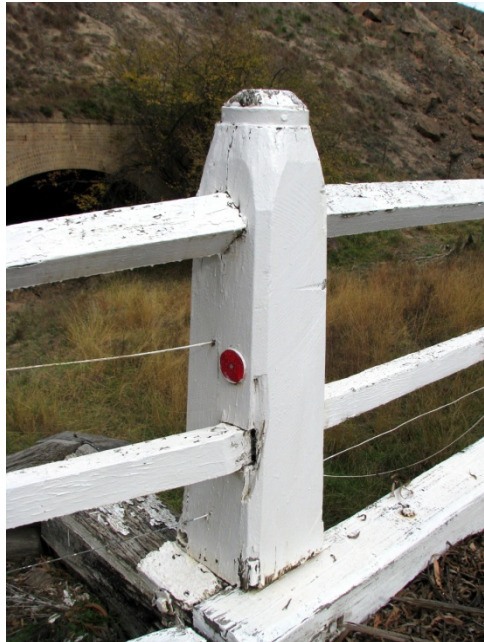
Figure 89: F85 Timber bridge post detail typical of six bridges in the LGA

Most timber posts were originally capped with galvanised iron sheet, cut, bent, strapped and clouted into place. These caps prolonged the life of the posts and where they are missing they should be replaced in similar fashion.
