**Bathurst Regional Council**  
Chifley Dam Pipeline Routes Terrestrial Flora and Fauna  
Study  
Additional threatened fauna surveys

April 2014

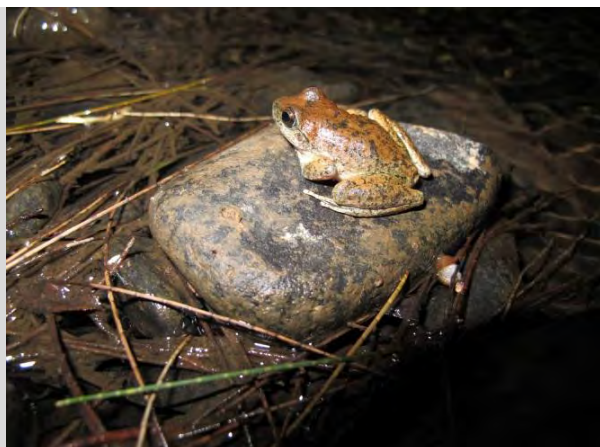
Photograph 1: Booroolong Frog observed in adjacent stream and rock habitat shown in photo 2.

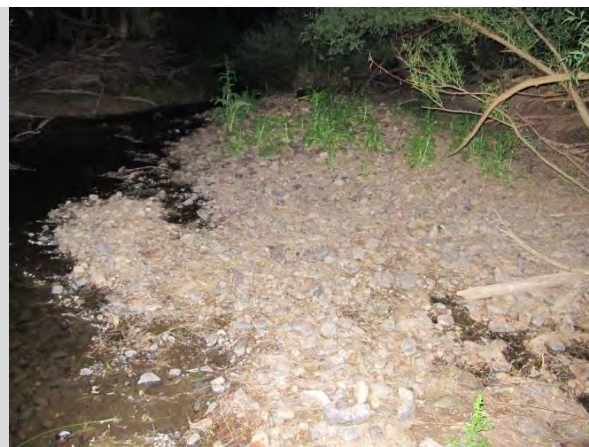
Photograph 2: Rock outcrop where Booroolong Frogs were observed.

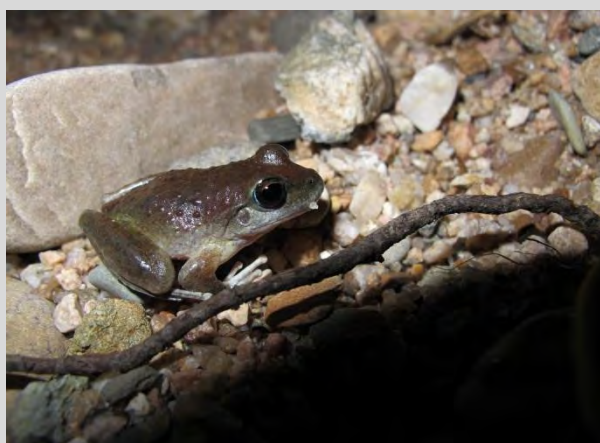
Photo 3: Booroolong Frog observed in rock habitat shown in photo 4.

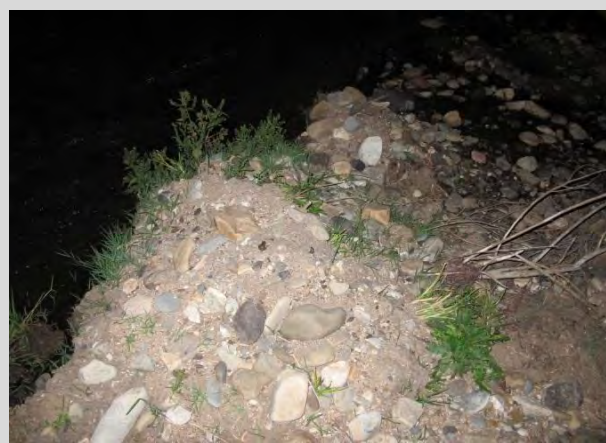
Photo 4: Rock outcrop where Booroolong Frogs were observed.

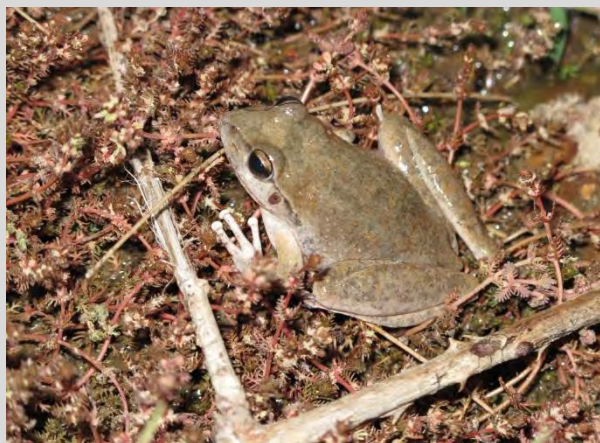
Photo 5: Booroolong Frog observed on aquatic macrophytes amongst large emergent boulders as shown in photograph 6

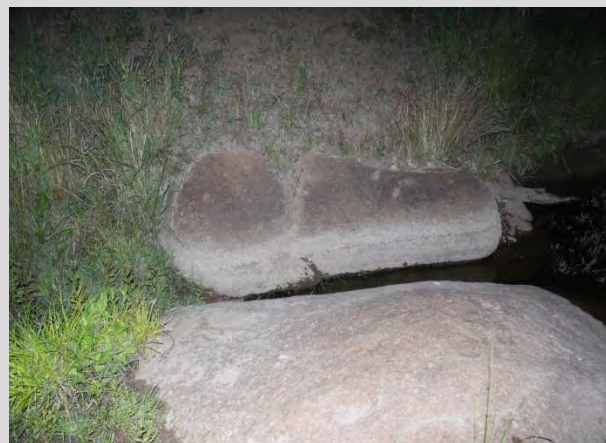
Photograph 6: Boulder (rocky) habitat where a Booroolong Frog was observed.

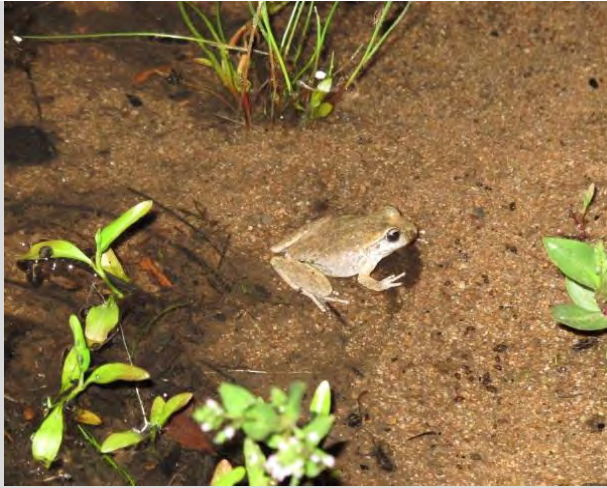
Photograph 7: Booroolong Frog observed within a stagnant pool within a sand bank. Larger area shown in photograph 8. Area was heavily infested with weeds and dense mid-storey vegetation.

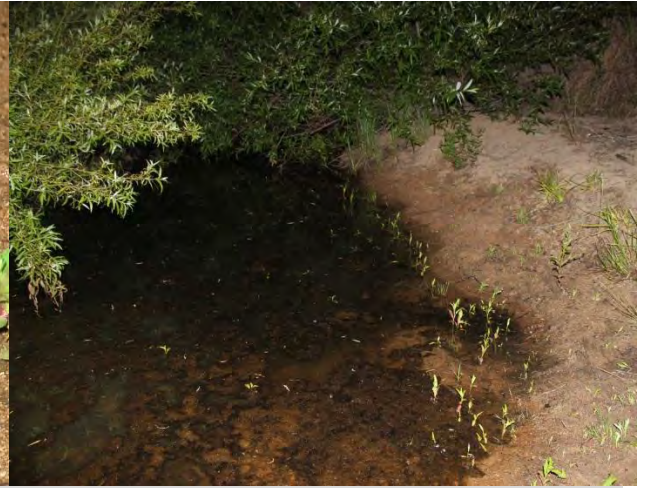
Photograph 8: Stagnant pool where a Booroolong Frog was observed.

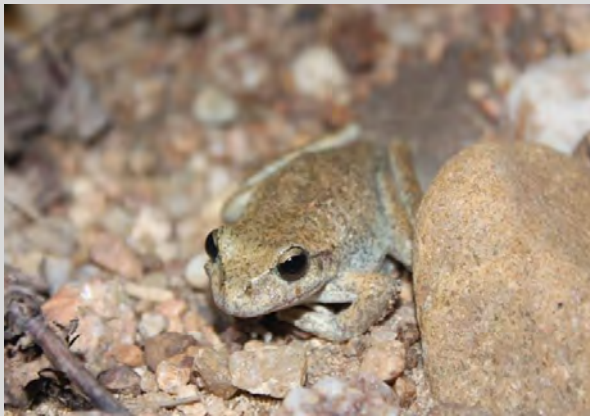
Photograph 9: Booroolong frog observed traversing sand bank with sparse rocky cover as shown in photograph 10.

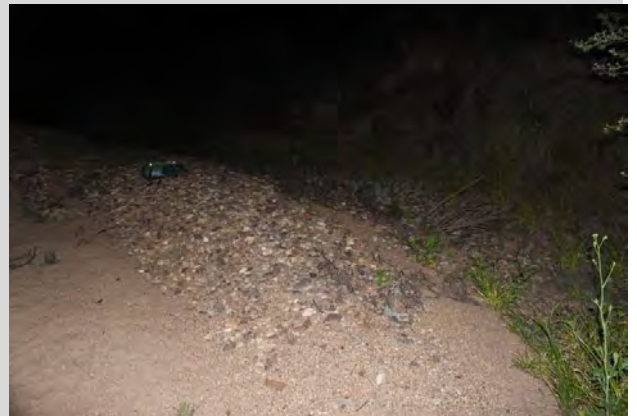
Photograph 10: Sand bar with sparse rock cover.

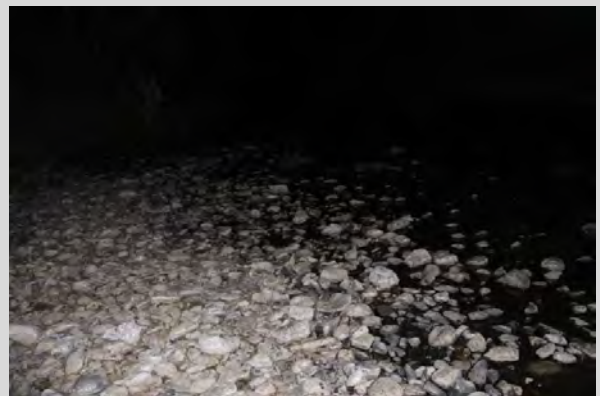
Photograph 12: Densely cobbled habitat adjacent to stream (to the right).
