ROCKLEY MILL

Budden Street, Rockley

CONSERVATION MANAGEMENT PLAN

Final
19 July 2006

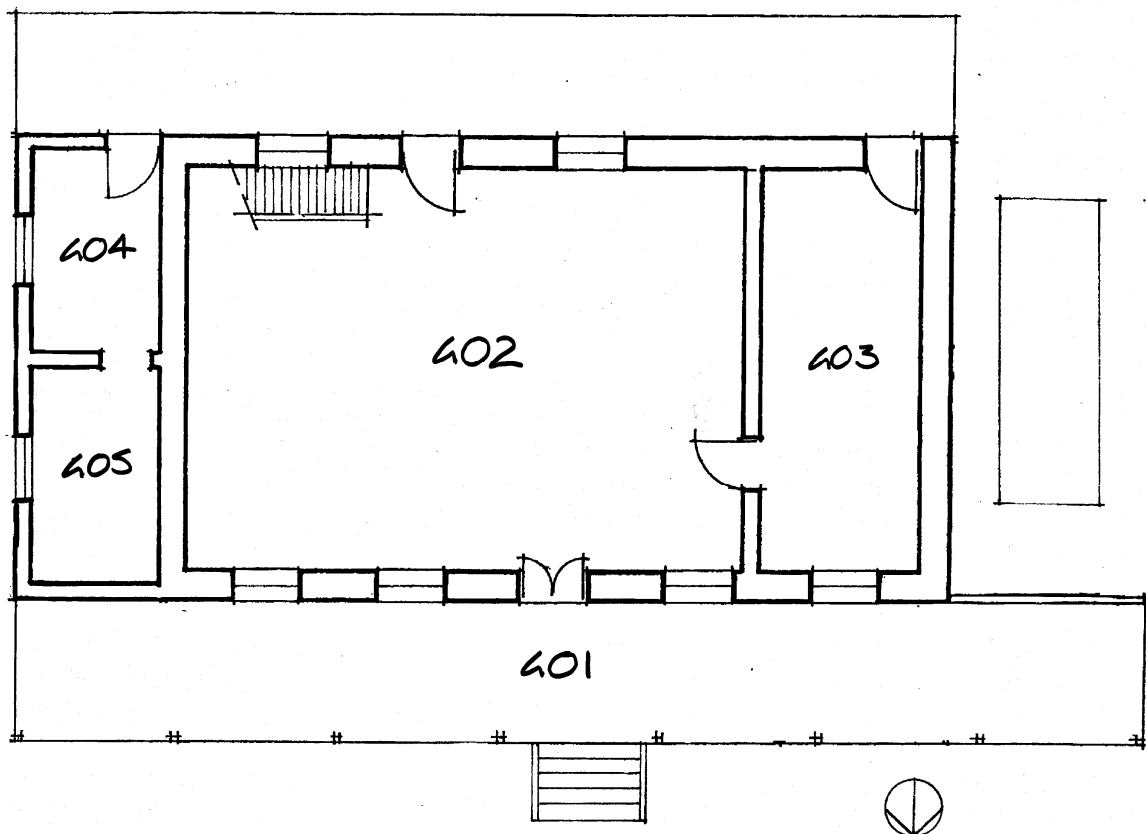
Figure 10

Ground floor plan of Rockley Mill (not to scale)
Based on drawing by Brian Costello

The building has a simple plan with the main part of the building having a large room on each floor. On the ground and first floor, a machine room is located at the west end. The third floor has a loft accessed by a simple timber ladder. The eastern single storey addition has two rooms lined with plaster and with the laths remaining of a lathe and plaster ceiling.

Plans included below as Figures 10-12 show the layout of the building.

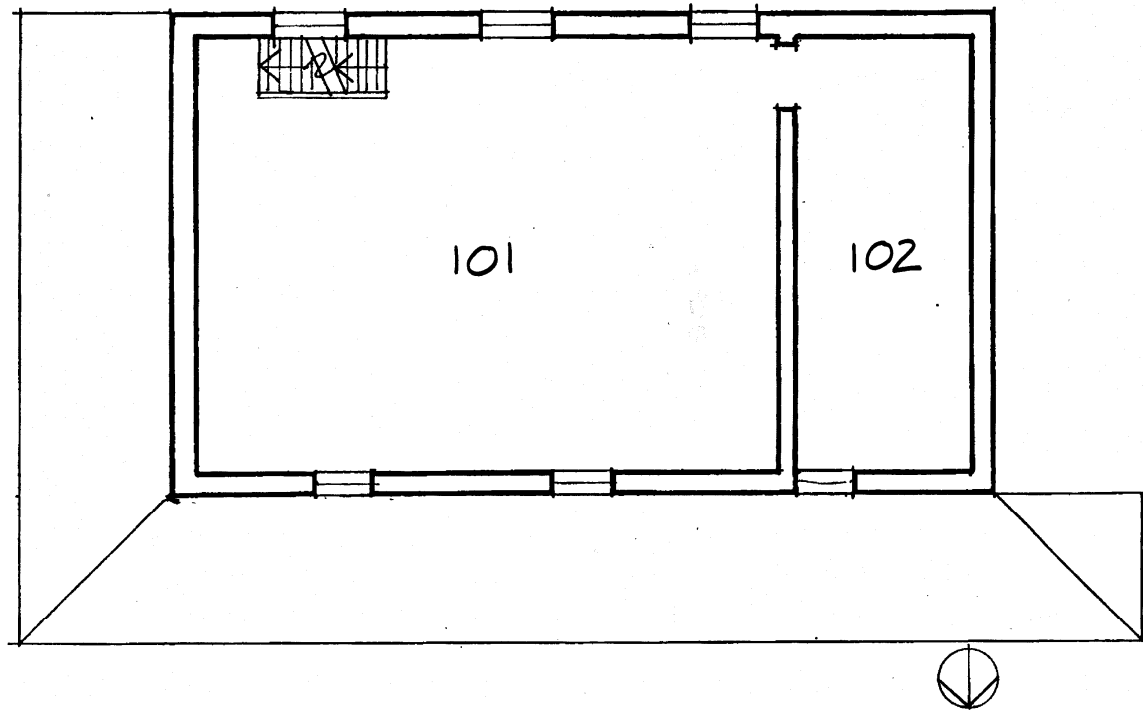
Figure 11

First floor plan of Rockley Mill (not to scale)
Based on drawing by Brian Costello

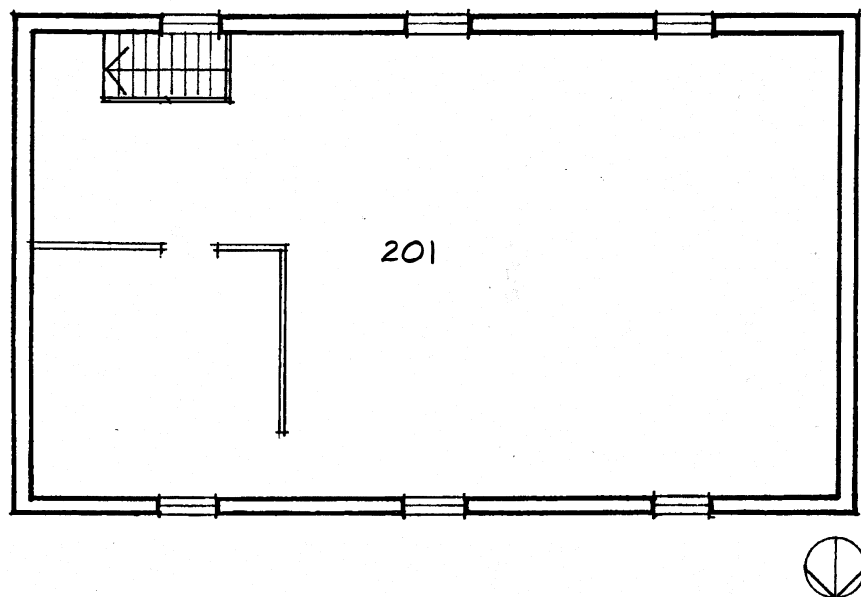
Figure 12

Second floor plan of Rockley Mill
Based on drawing by Brian Costello

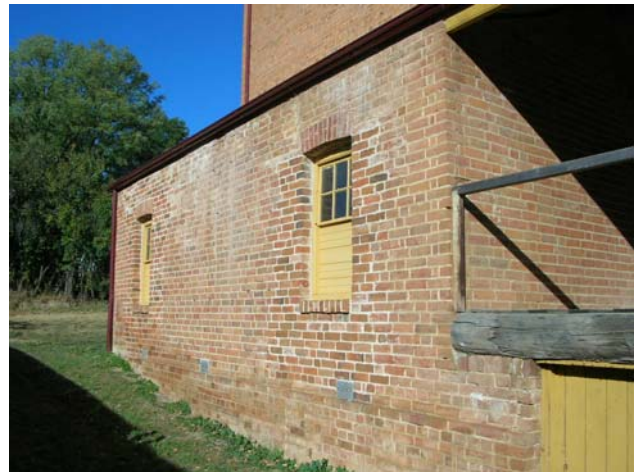
Figure 14

East wall of single storey section. The window openings were reconstructed in 1990

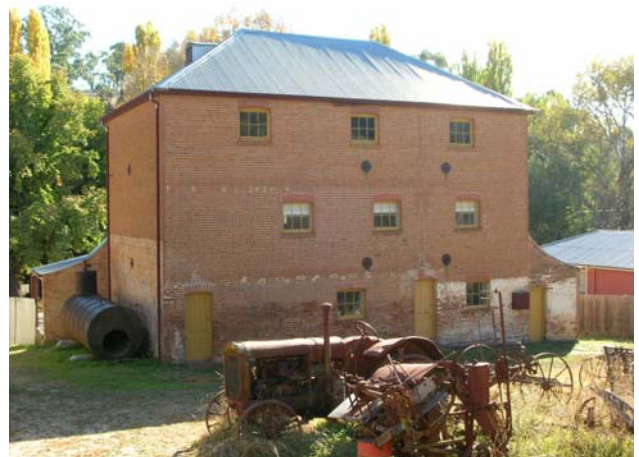
Figure 15

Rockley Mill from southwest. There is evidence of structures at ground and first floor level built against the south wall.

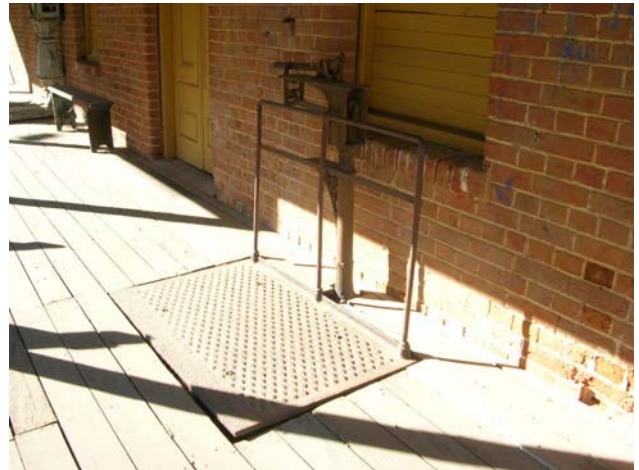
Figure 18

Scales built into the verandah. These are assumed to be original or early.

- Floor (F): Original framing,
1990 floor boards
Original or early 300 x 300
hardwood bearers to
perimeter.
- Skirting (Sk): N/A
- Walls (W): Original face brick
1990 reconstructed verandah
posts
- Cornice (Co): N/A
- Ceiling (C): 1990 verandah framing
reconstructed
1990 corrugated galvanised steel
roof sheeting
- Joinery (J): Original windows with timber
boards to bottom sash
Original front door and frame
(east leaf reconstructed 1990)
- Other (O): Original or early scales set into
verandah

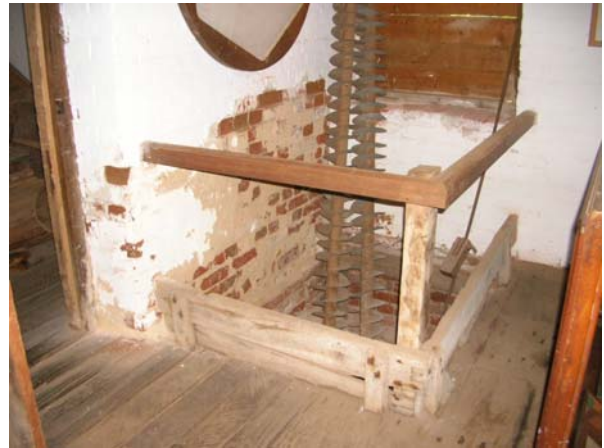
Figure 21

Northwest corner of space G01 where salt is said to have been stored. This and a well that has been infilled on the opposite side of the wall have contributed to spalling of the brickwork. Sacrificial render applied in 1990 has largely been lost.

W: Painted brick
Openings in the west wall relate to milling machinery.
Fretting of brickwork on western side, particularly in northwest corner. This has been attributed to the storage of salt in the corner and also to the infill of a well below the machine room. Considering the concentration of the problem in the area where salt was stored, salt is likely to be the major contributing factor to the condition of the brickwork.

A problem with damp and salt damage to the brickwork, particularly at the west end of the building, was obvious in 1988 when works were recommended to improve drainage and to apply sacrificial render to the worst areas of damage. The sacrificial plaster has now fallen away. At the time the work was scheduled, it was suggested that the worst area of damage, in the northwest corner of the main milling space at ground floor, was the area where salt had been stored when the building was used for storage associated with the adjacent store. If this has left higher than normal salt levels in the soil, this needs to be confirmed so that a strategy for dealing with the problem can be developed. Salt levels also need to be checked in the wall to see if the brickwork has higher levels of salt in that area. Other suggestions for the cause of the problem include the filling in of a well at the north end of the machine room.

Priority should be given to attending to problems in the western end of the building due to rising damp and salt damage. This work should include

- 1. Testing of salt levels in the wall and foundation material to ascertain whether some areas have unusually high salt levels.*
- 2. Depending on the results of salt testing, developing a strategy for desalination of the soil.*

- 3. Drilling a bore hole near the east and west boundaries of the site to determine the level of the water table. If the water table is noticeably higher on the western side near the mill, investigate the likely cause of this and instigate appropriate measures to locally reduce the water table in that area.*

- 4. Repair of the brickwork including repointing and turning/ replacement of bricks where necessary (after salt levels and damp problems have been stabilised).*

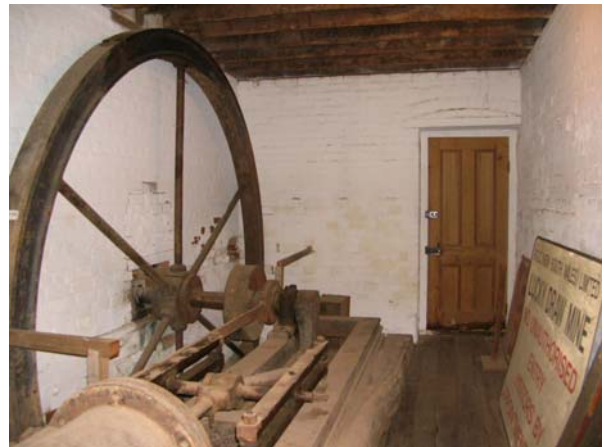
Figure 22

Machine room from north. The door at the south end of this space is reconstructed.

- F: Original timber framing and boards
- Sk: N/A
- W: Painted brick.
Fretting of brickwork on walls, particularly in nothwest corner.
- Co: N/A
- C: Soffit of timber floor above.
- J: Reconstructed door leaf in south wall
Original window in north wall with with pivot sash above horizontal timber boarding.
- O: Milling machine restored 19??
Well below floor infilled 19??

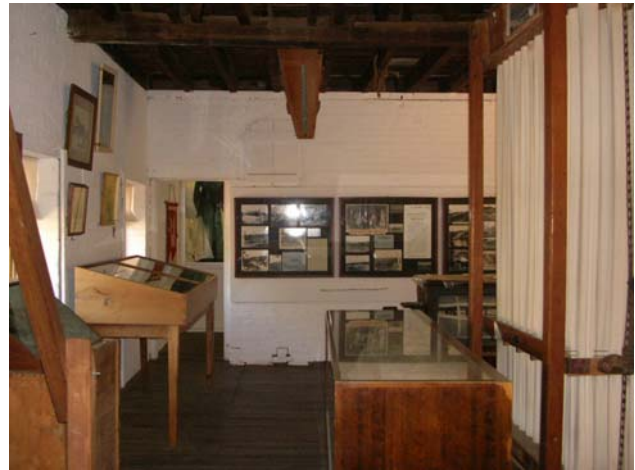
Figure 28

Space 101 from east. The chute for feeding grain from the top floor is visible.

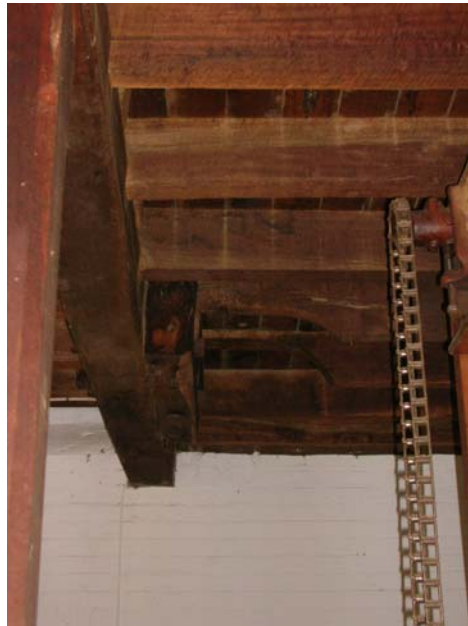
Figure 30

Detail of the floor structure showing joists that have been tapered, presumably to accommodate machinery for the mill.

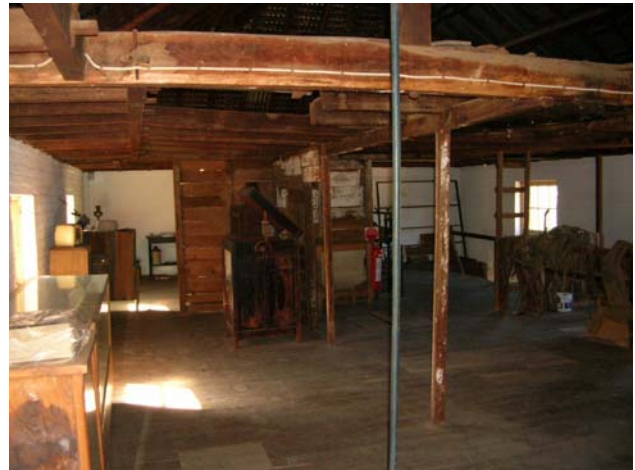
Figure 35

Space 201 from northwest. Note the tusk tenoned joints of the roof and loft framing above.

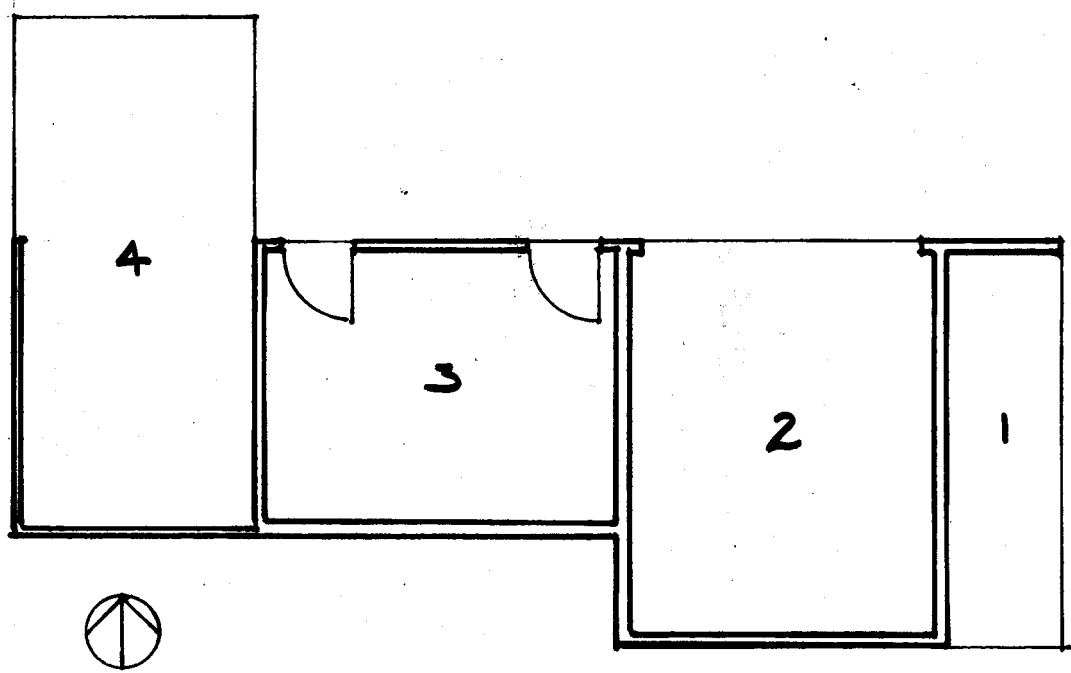
Figure 36

Plan of former coach house and stables (not to scale)

The building has a mixture of construction types, reflecting various repairs and changes. The floor to the coach house is concrete and the east and north walls are timber slabs. The skillion at the south side is an addition with concrete at the base of the walls and timber slabs above. The roof is constructed of bush poles with timber battens. The battens to the main gabled roof are closely spaced suggesting the roof was originally shingled. The skillion at the rear of the coach house has wider spaced battens for corrugated steel sheeting.

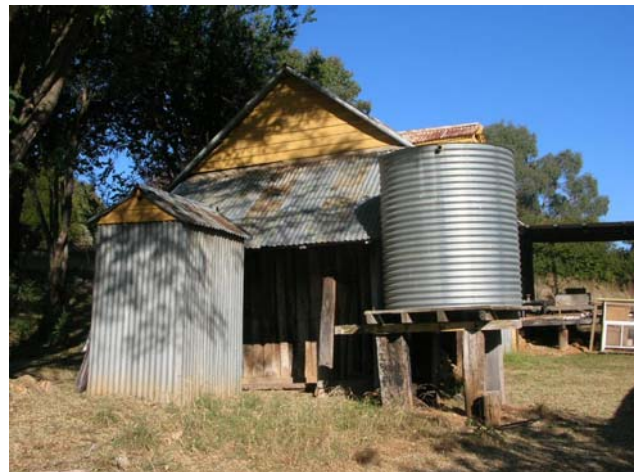
Figure 39

East end of stables showing outhouse and tank stand

A tank stand and corrugated steel tank is located at the northeast corner of the coach house and stables (Refer figure 39).

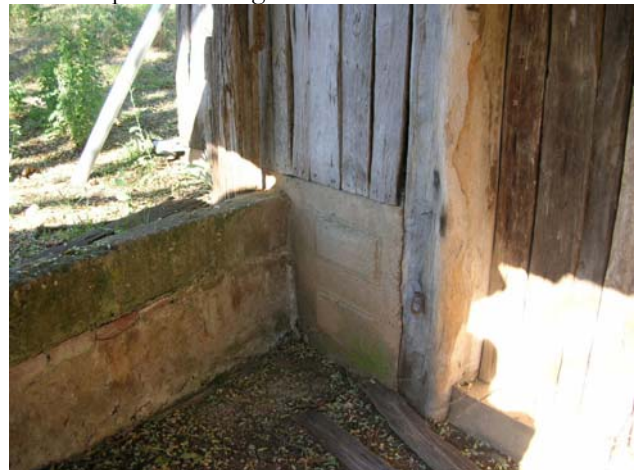
Figure 42

Concrete plinth for wall of south skillion built with a paneled door as formwork.

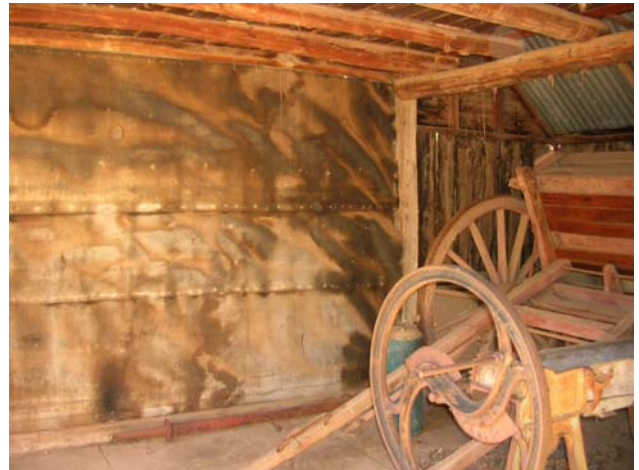
Figure 43

Coach house from northwest. Walls have been partly sheeted with sarking paper.

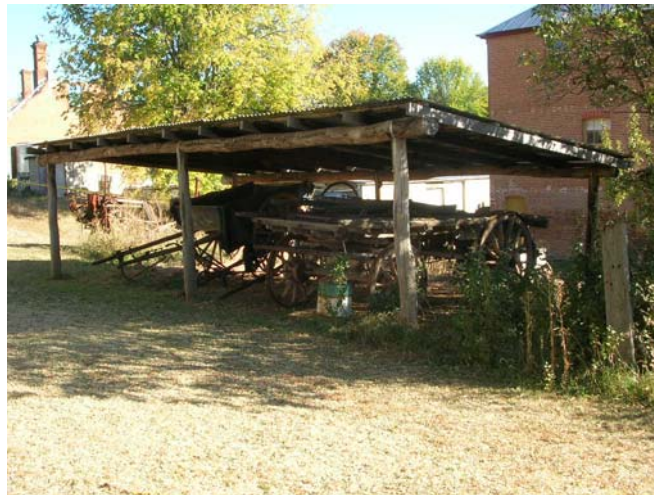
Figure 45

Skillion shed from southeast

The skillion shed is a 1970s structure of hardwood poles with a skillion roof of corrugated steel.

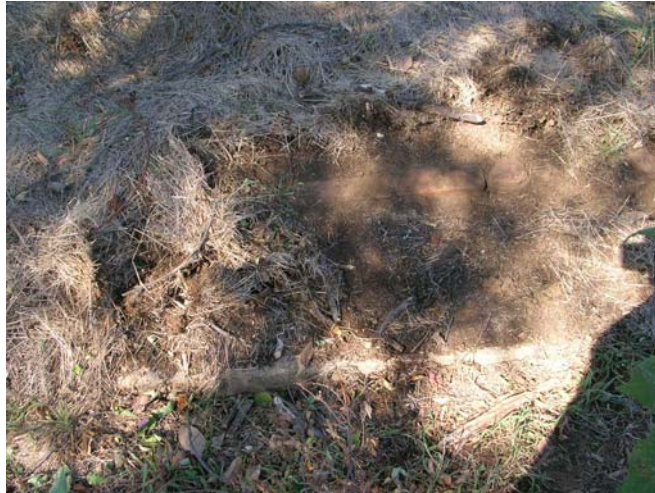
Figure 46

Brick footings south of coach house

A line of footings are apparent behind the coach house and stables. Brick footings survive to the south, partly covered with metal strips. Some local stone flagging survives on the south side of the footings.

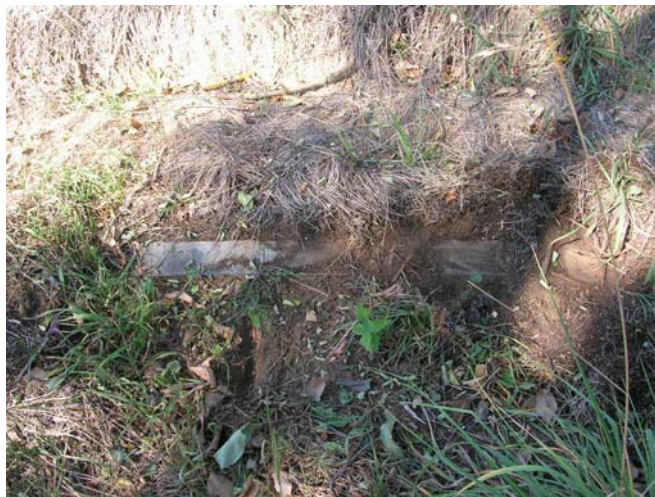
Figure 47

Metal strip over footings south of coach house
