CONSERVATION AND MANAGEMENT PLAN

SCHOOL OF ARTS HALL THE LAGOON, BATHURST

JUNE 2007

1011 Lagoon Road, Bathurst

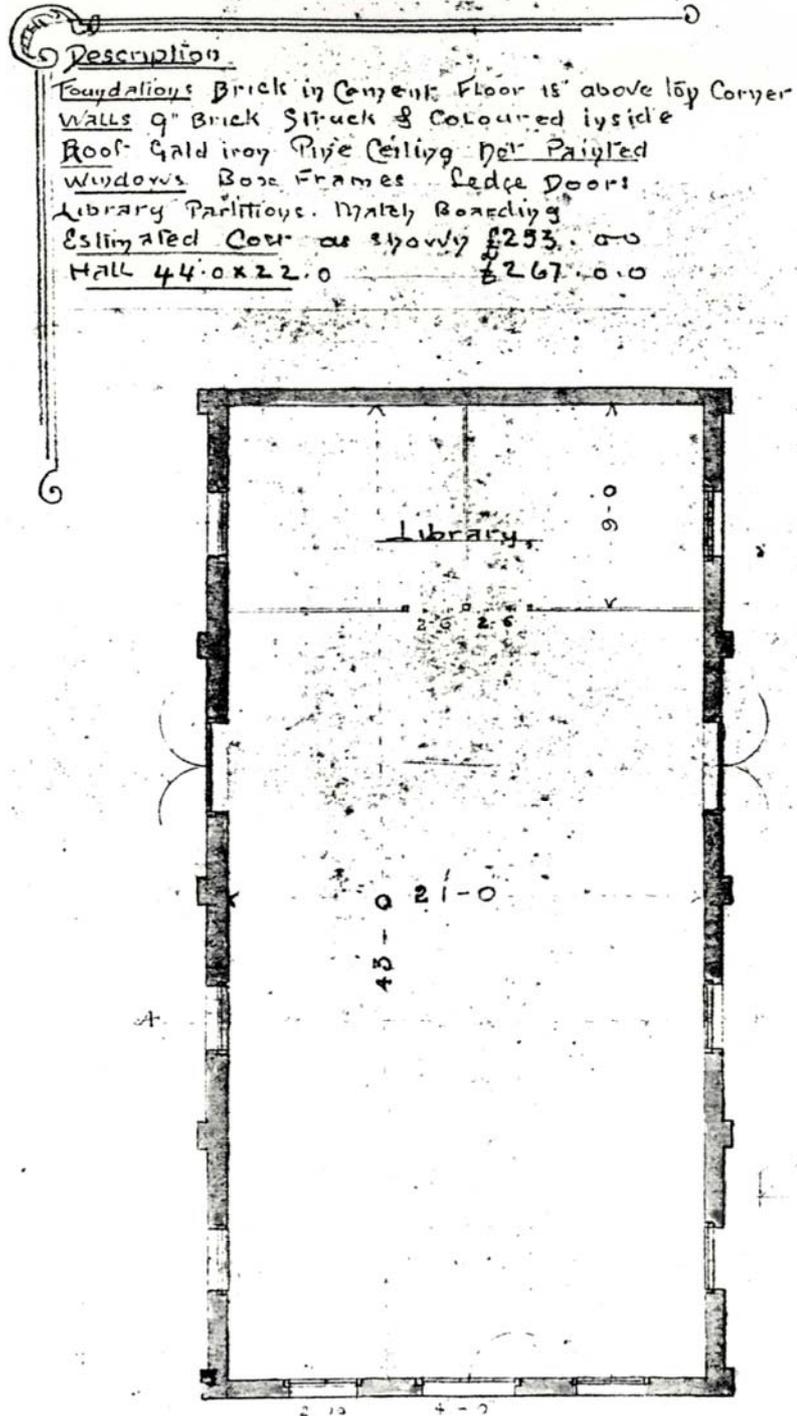
**FIGURES 8 - Floor Plan of Original Copeman Design
 Indicating Library Section**

The Lagoon School of Arts reflected this movement, as is indicated in the original John Copeman plans which indicated a library section where the stage is.

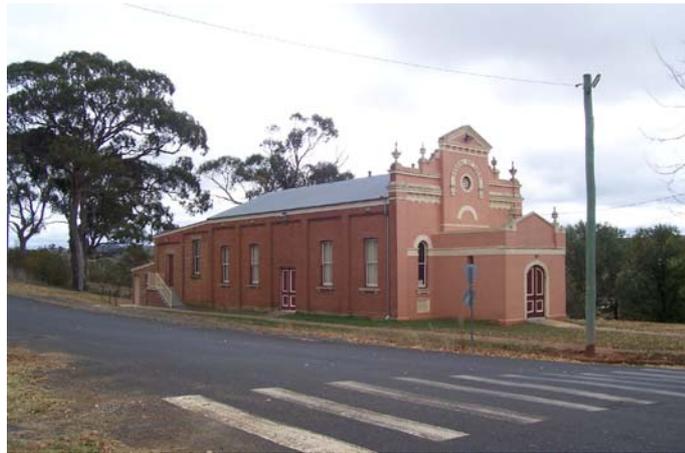
**FIGURE 10 - Rockley School of Arts by J.J. Copeman 1890
(Note corbelled brick bays)**

One of J.J. Copeman's early buildings was the Rockley School of Arts in 1890, which incorporated on a much grander and intricate scale a number of the details found in the Lagoon School of Arts including the Brick corbelled structural bays. In addition the use of pediments, and brick features show the influence of his Architectural Teacher at Bathurst technical College James Hine.

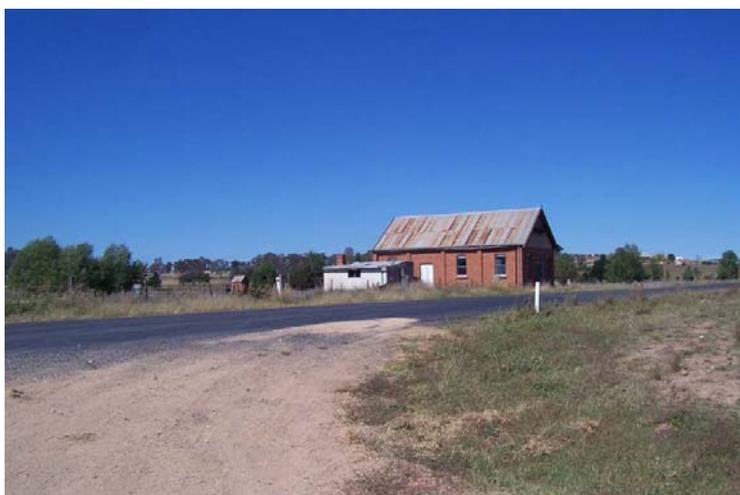
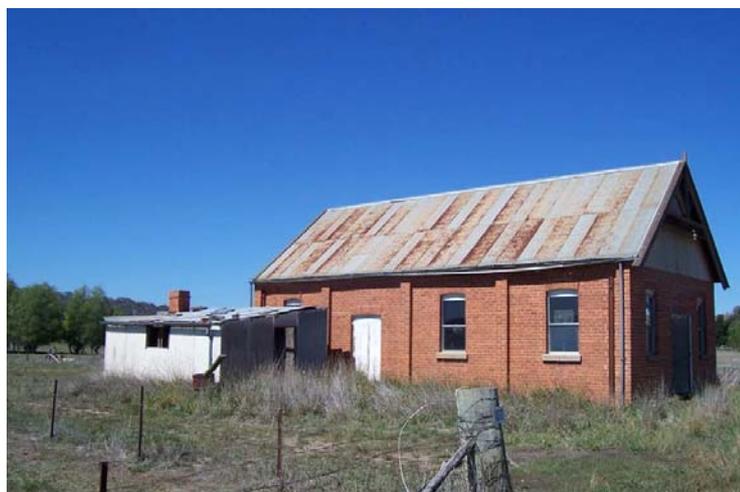
FIGURE 15 - HALL FROM NORTH x 2

The structural bays of the building are expressed externally with corbelled panels and piers. There is substantial cracking apparent in the north and south walls emanating from movement of the front and rear gables. This problem has been occurring for some time, as is evidenced by steel bracing beams that were placed in the 1940's. These beams are connected with bracing rods which run north south, and suffice to hold the north and south walls vertically in place, but appear not to have eased the cracking problem.

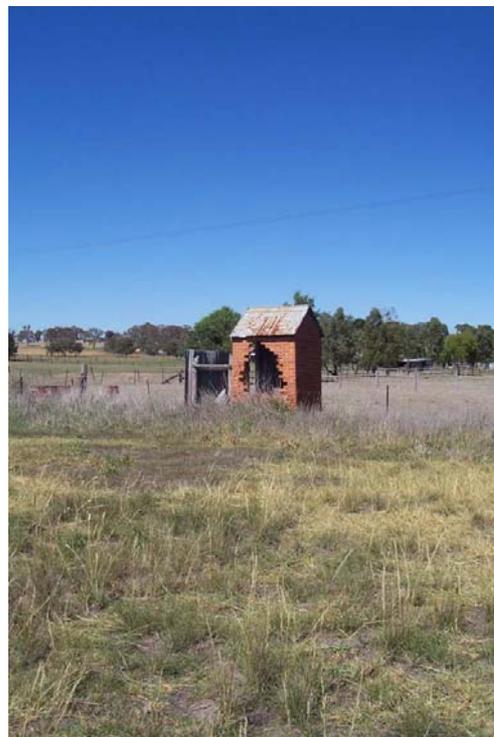
**FIGURE 17 - MALE TOILET
(Section of brickwork lost in Willy Willy)**

The toilets have been damaged in recent years by a freak wind storm, which demolished one toilet and knocked out a wall from the other. The remaining toilet has sufficient remains for repair and reconstruction as a safe visual structure and building. However it is unlikely that under today's standards this can continue to operate as a toilet given the pit nature of the toilet.

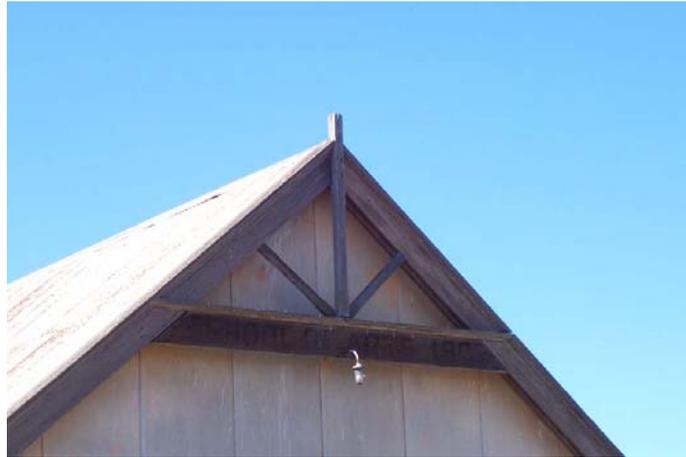
Roofing is corrugated iron in a simple gable form. The frontage gable is lined with fibre cement cladding and a simple gable timber fretwork detail houses the sign "School of Arts 1902". The gutters are in poor condition and are falling off. Downpipes to the roof drain onto the ground at the base of the footings. One rear downpipe is connected to a poor condition water tank (which supplies the kitchen). The timber tank stand is rotting.

FIGURE 18 - ETCHED SCHOOL OF ARTS SIGN

- Reinstating timber double hung windows into the original openings.
- Reinstating original design for timber gable fretwork as outlined on the J.J . Copeman Plans.
- Reinstall awnings over windows.
- Reinstall WW1 memorial board if site is to remain in community ownership.
- Provision of new gutters and downpipes (galvanised) - quad style gutters and round downpipes.
- Replacement of the roof with corrugated galvanised iron sheeting if roofing on inspection is found to be in too poor a condition for repair. Repair is the preferred option.
- Hat rails to interior.

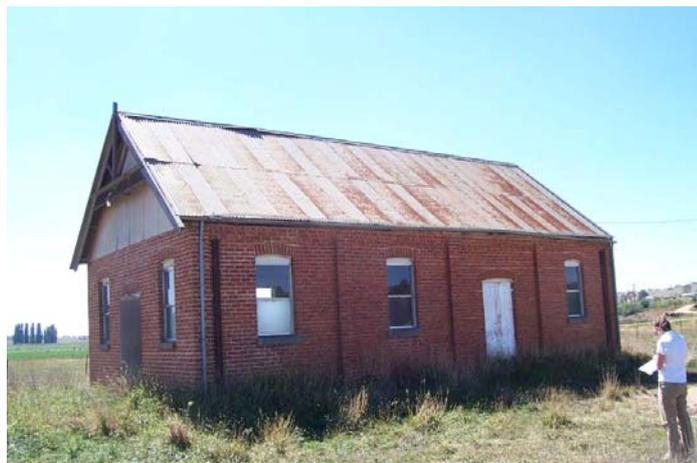
FIGURE 20 - SOUTH ELEVATION

Cracking is likely to be exacerbated by the fact that the downpipes shed water at the foundation of the building, and also the fact that the footings are likely to be brick rather than reinforced concrete, which in a such a flood prone area are likely to move.

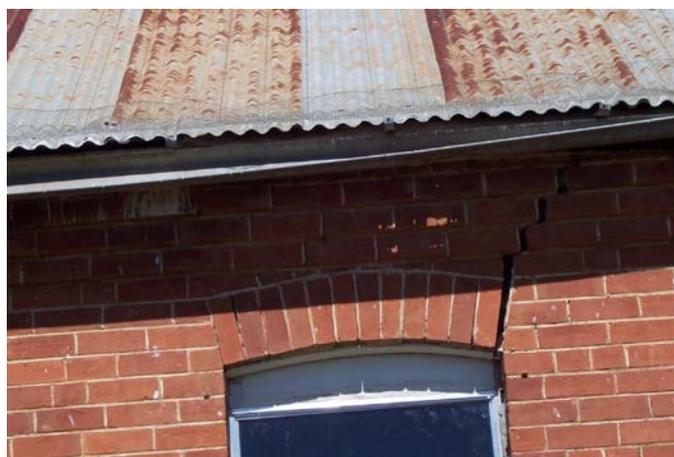
FIGURE 22 - NORTH WINDOW DETAILING CRACKING

Cracking in this area appears to have occurred after the installation of the bracing indicating the footing movement is likely to remain active and may become more pronounced with a return of moisture to the soil when the site next floods.

- 1 Hall Building to be inspected by Structural Engineer and recommendations provided regarding the works required to stabilise the building.
- 2 Repair / replace gutters and downpipes and provide drainage to downpipes to an absorption trench away from the building.
- 3 Repair exist doors and provide new latches and security to building.
- 4 Cut grass around the site and provide a gravel set down around the base of the hall to ensure air flow to under floor ventilation.
- 5 Provide fencing to the site (as per conservation recommendations).

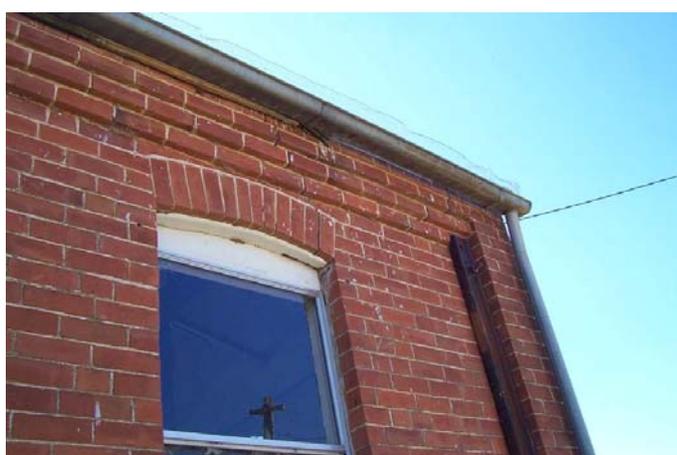
FIGURE 23 - SOUTHERN WINDOW SHOWING BRACING AND BRICK CORBELL

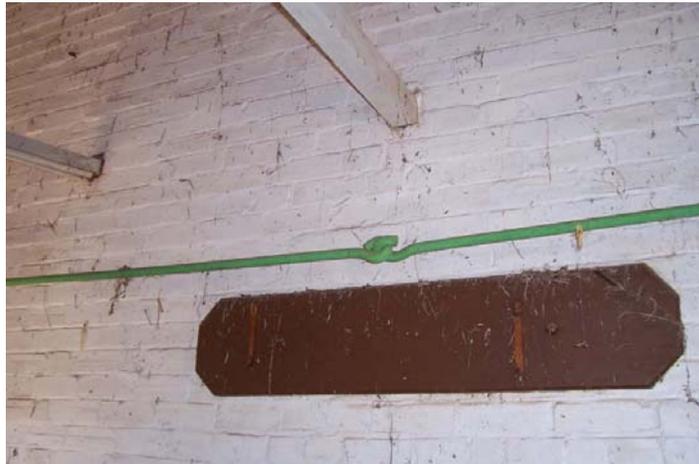
There are the remains of wall mounted hat and coat racks which were made of cedar and originally ran around the full extent of the hall walls. These are said to have been progressively stolen over the past 10 - 15 years, as the building has not been secure.

FIGURE 26 - HAT RAIL

Failure to upgrade the building also leaves the building and the site insecure and accessible to vandals and unauthorised use. This has already resulted in the loss of significant fabric including hat racks and furniture.

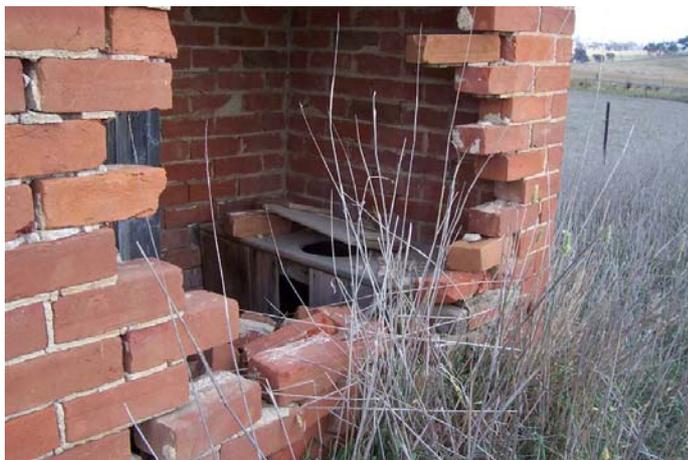
FIGURE 28 - TIMBER PIT TOILET

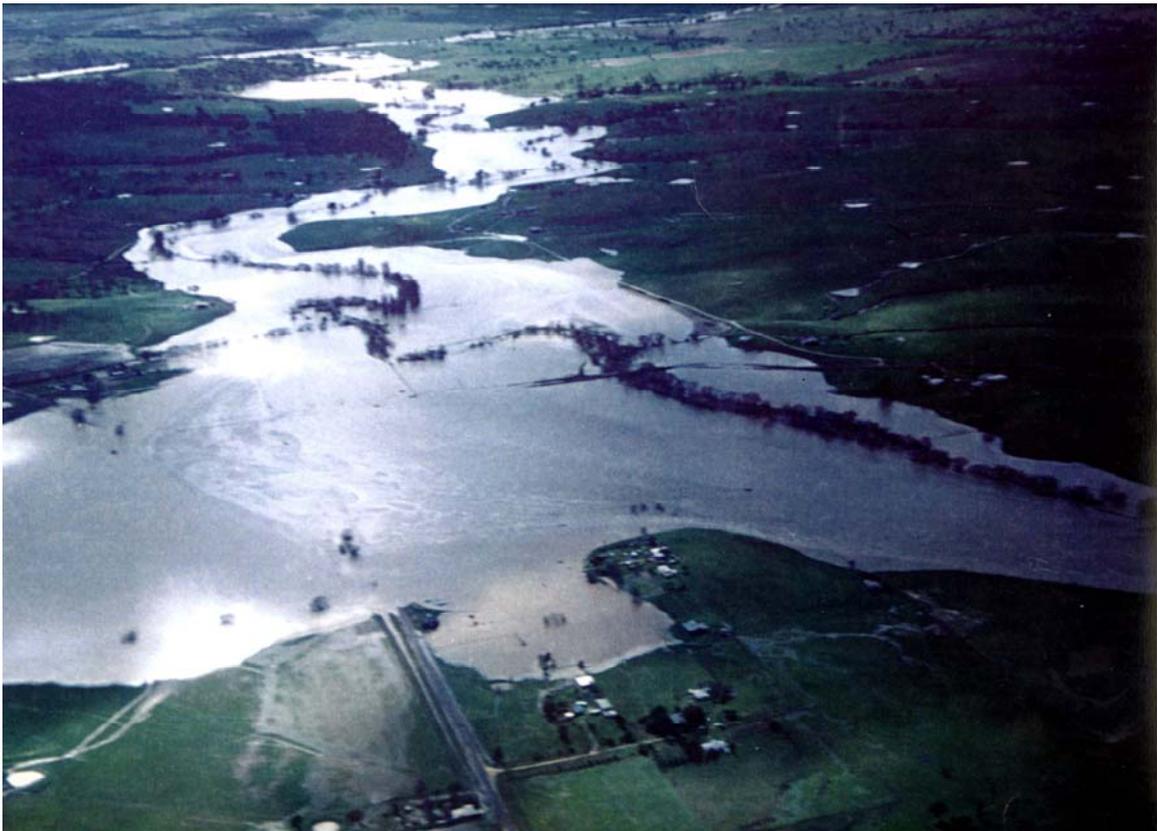
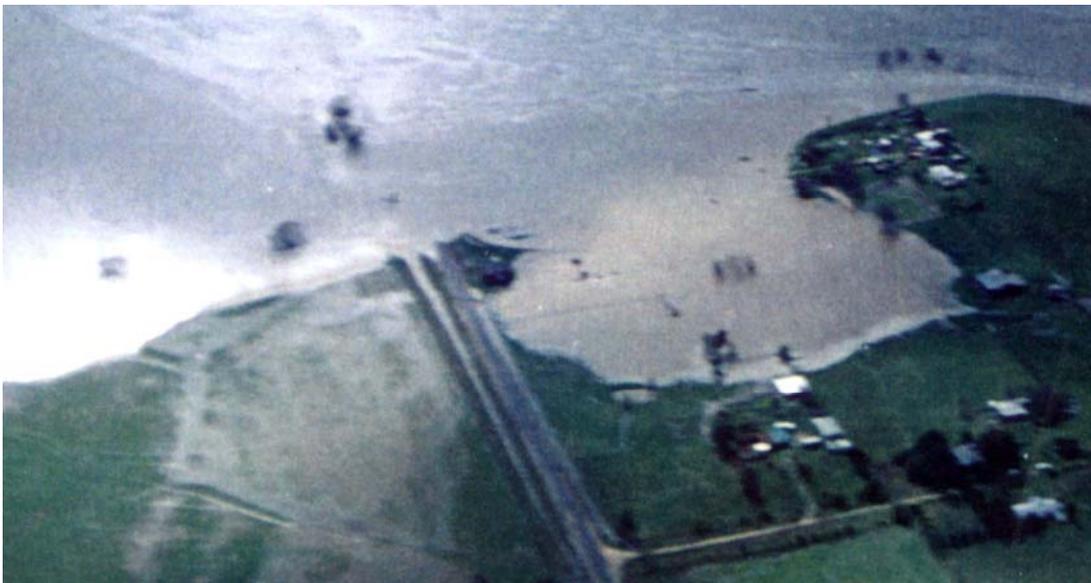
While the site is in a flood prone area, the height of the building itself has protected the building in the past from flood damage, although parts of the site have been subject to flooding.

**FIGURE 34 - 1990'S FLOODING OF THE CAMPBELLS RIVER
(Detail below of flood around the School of Arts Hall)**
