# CONSERVATION MANAGEMENT PLAN

## ST MARTIN'S FORMER ANGLICAN CHURCH

22 Rockley Street Perthville, NSW 2795

Date: 21 June 2020

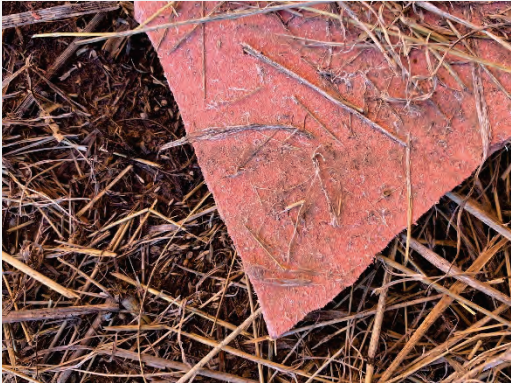
| Element | Description | Schedule | Life Cycle | Response |
|---|---|---|---|---|
| Slate/Tiles | <p>Inspect for slipped, cracked or broken tiles or for tiles that have become porous.</p> <p>Test tiles for asbestos. Tiles appear to be either asbestos or may be concrete fibro replacements.</p> | 7 years | 50+ years | Inspect |

5. Inspect roof tiles for damage and test for asbestos.
6. Investigate the installation of ties or tiebacks to maintain the structural integrity of the building.

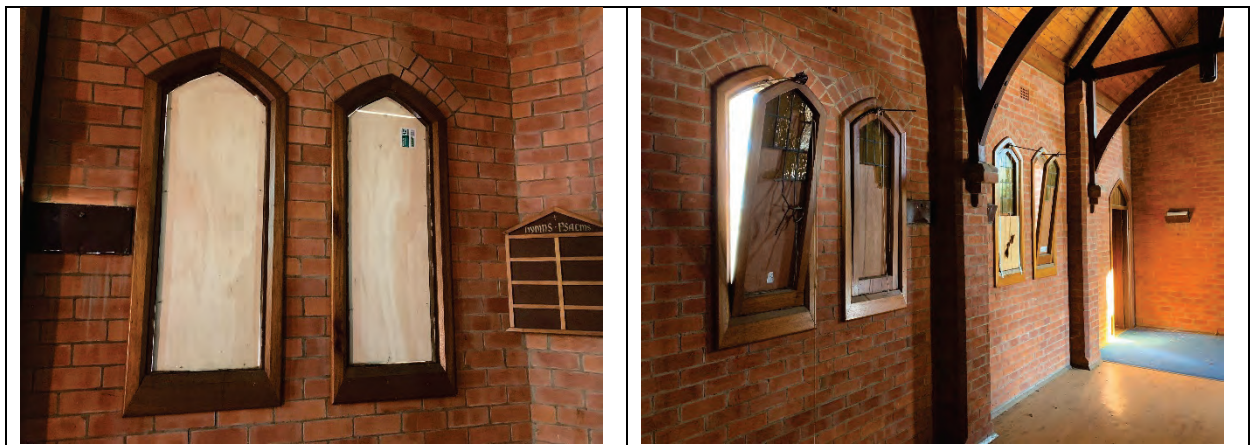
Most of the stained-glass windows have been either damaged or removed from the building. The lead work is failing and all windows are predominantly in need of major repair or total replacement.

It is recommended that when a reuse for the building is proposed, that an assessment be undertaken to determine if the windows should be reinstalled into the building (if inline with the proposed reuse) or if they should be used as an interpretation feature, displayed in an appropriate area that will provide protection for these significant items. The windows should remain with the site to ensure context and continuity of significance is maintained.

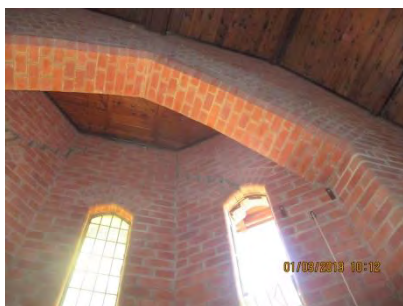
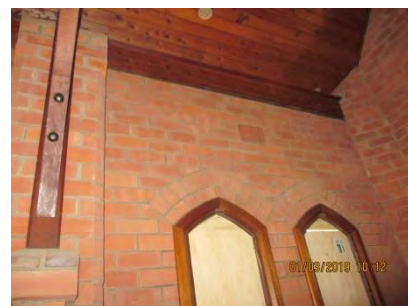
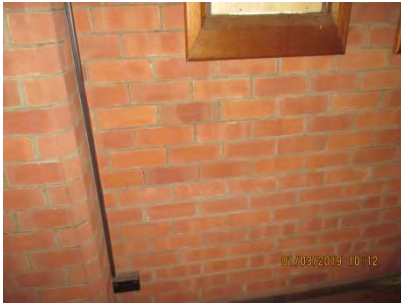
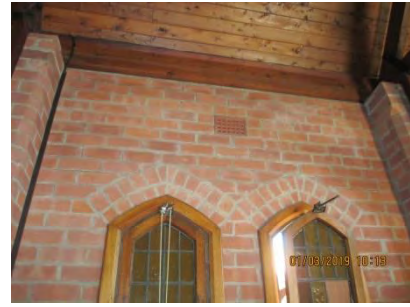
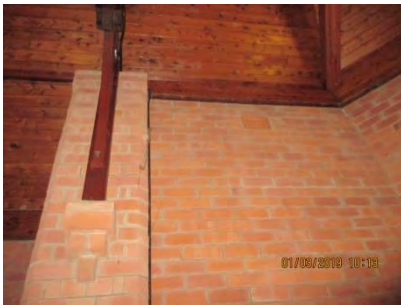
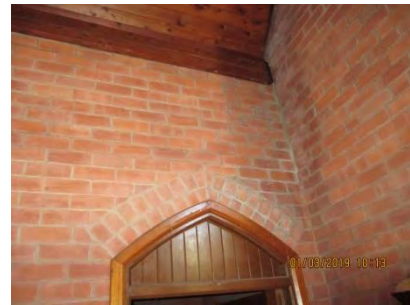
The internal inspection revealed Category 3 damage (range 0-4) throughout the dwelling in accordance with AS2870 Appendix C-Table C1 (vertical and stepwise cracks 5-15mm in width).

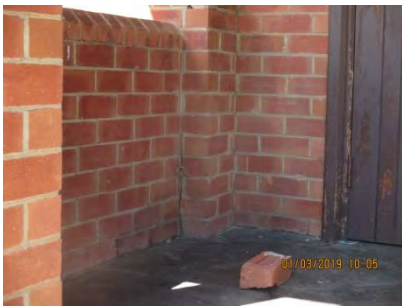
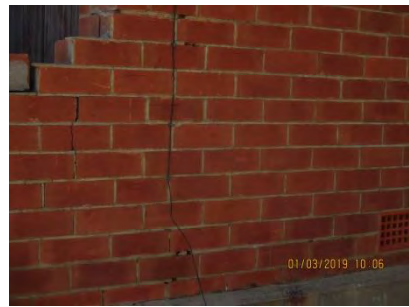
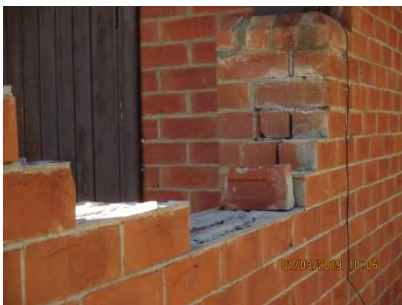
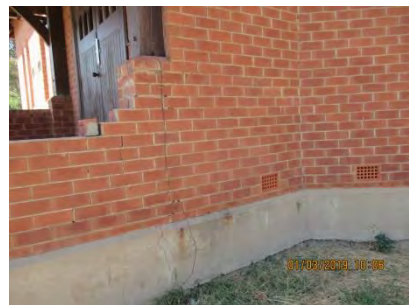
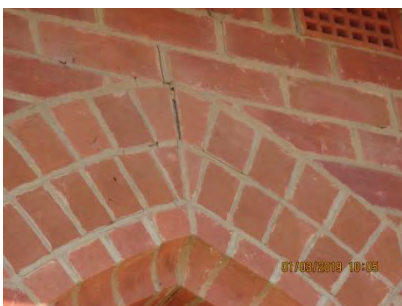
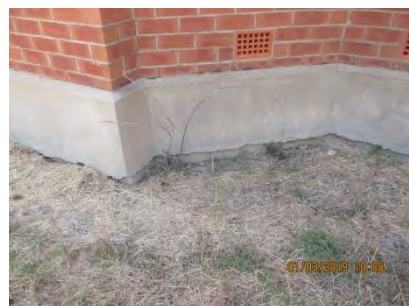
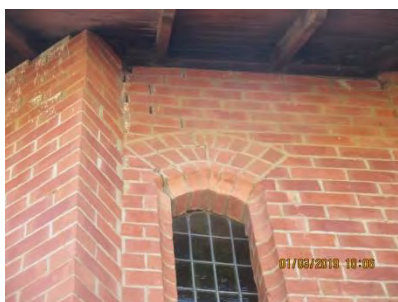
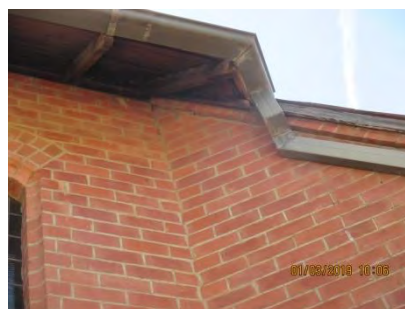
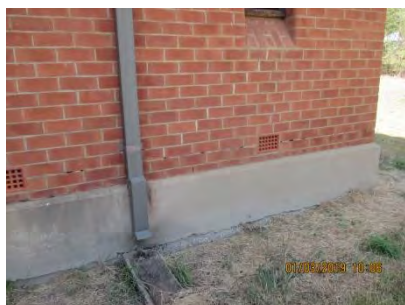
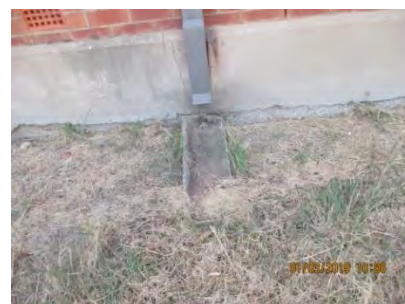
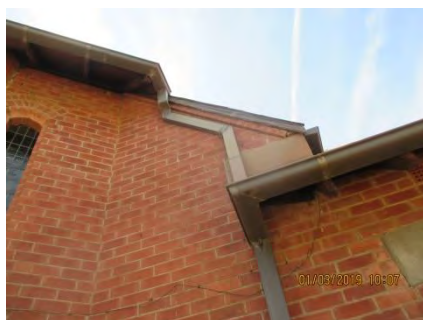
The external inspection revealed some crack damage to the external masonry, up to Category 4 damage (range 0-4) in accordance with AS2870 Appendix C-Table C1 (vertical and stepwise cracks 15-20mm in width).

Our inspection has revealed that the building is structurally adequate, but has suffered moderate damage due to reactive clay movement, which is a typical scenario for many buildings in the Bathurst area.

It appears that the subject building foundation soil has experienced extreme moisture variations due to insufficient roof drainage and general climatic conditions.

NOTE :- Repairs to damaged masonry walls shall be carried out using traditional mortars and bonds. When repointing, use the general style of the original construction, the thickness of joints, colour and materials and the way the joints are expressed and struck. Don't overdo the restoration work - repair only as much as necessary.

1. Check soundness of roof gutters and downpipes and ensure adequate discharge of all roof water to appropriate stormwater pits.
2. Investigate possible damaged roof tiles, failed roof flashing.
3. Ensure all ground/paved surfaces adjacent building slabs direct surface water away from building.
4. Monitor cracking for any further movement for 3-6 months following above procedures.
5. Carry out maintenance of damaged structure.
6. Remove mortar at crack locations and fit “Helifix” ties as required as per manufacturer’s recommendations.
7. Check underfloor piers and repair as necessary
